REPUBLIC OF THE MARSHALL ISLANDS

Office of the Maritime Administrator

DEEPWATER HORIZON MARINE CASUALTY INVESTIGATION REPORT

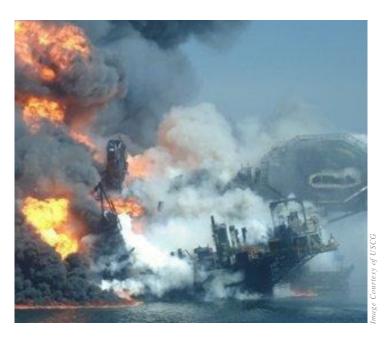
- 2.128 During the incident two sources of fluid made it onto the decks of the Unit. The first is fluid from the well itself; and the second is water sprayed by the reportedly uncoordinated firefighting vessels on the scene. 455

- 2.129 The DEEPWATER HORIZON's starboard list continued to increase. The USCG reported that the vessels spraying water onto the Unit were "backing off, due to safety concerns." The Unit was listing 10° and the "fire and smoke were out of control." 457
