REPUBLIC OF THE MARSHALL ISLANDS

Office of the Maritime Administrator

DEEPWATER HORIZON MARINE CASUALTY INVESTIGATION REPORT

Official Number: 2213

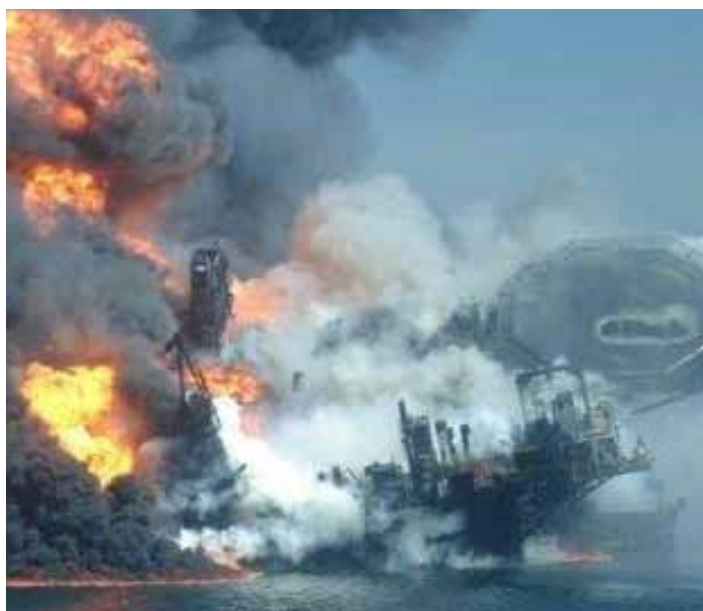
Image Courtesy of USCG

- 2.128 During the incident two sources of fluid made it onto the decks of the Unit. The first is fluid from the well itself; and the second is water sprayed by the reportedly uncoordinated firefighting vessels on the scene.⁴⁵⁵

- 2.129 The DEEPWATER HORIZON's starboard list continued to increase. The USCG reported that the vessels spraying water onto the Unit were "backing off, due to safety concerns."⁴⁵⁶ The Unit was listing 10° and the "fire and smoke were out of control."⁴⁵⁷

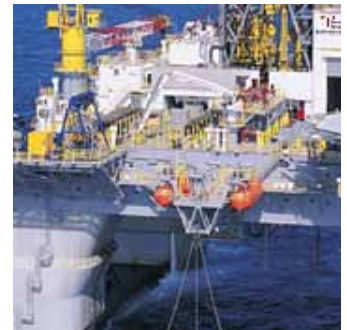
Image Courtesy of Transocean

- 3.23 Approximately 107 of the 115 personnel that evacuated the DEEPWATER HORIZON were in the two lifeboats and the one liferaft that were launched. Each lifeboat had a rated capacity of 73 persons. According to crew testimony, the lifeboats were crowded even though they were not loaded to capacity. Some of the available space in lifeboat No. 2 was reduced because injured personnel were laid out on the seats.

- 3.24 Based on testimony, some personnel were confused regarding how to use the color-coded restraints inside the lifeboats.
- 3.25 Although the Master ordered the abandon ship, the order to launch the first lifeboat was given by the Transocean Division Manager and not a crew member of the DEEPWATER HORIZON. Although the order to launch the first lifeboat was given by a person who was not part of the DEEPWATER HORIZON crew, the Administrator does not find that this had an adverse impact on the evacuation process and, in view of the extreme risks posed by the continuing explosions and intense fire onboard the Unit, the decision by the Transocean Division Manager to order the launch of the first lifeboat was an understandable and prudent reaction to the emergency conditions that threatened the lives of persons in the lifeboat.

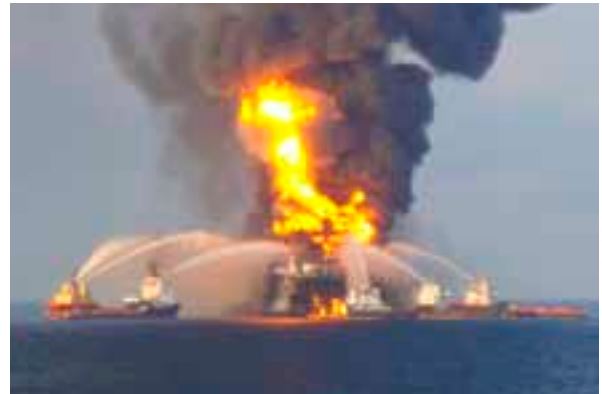
Image Courtesy of USCG

- 3.60 The Unit withstood the forces of the explosions and resulting fire, fed by the continuous release of hydrocarbons, which likely caused extensive damage to the superstructure. Although being subjected to intense heat and dynamic loading, the Unit provided a sufficiently stable and protected platform to facilitate the evacuation of 115 individuals.
- 3.61 External efforts to cool the DEEPWATER HORIZON structure or extinguish the fire led to, or at least accelerated, the eventual capsizing and sinking of the DEEPWATER HORIZON.

- 3.62 The DEEPWATER HORIZON capsized and sank approximately 36 hours after the ignition occurred. It is probable that decks, bulkheads, ventilators, and weather/water tight doors and windows were damaged and or distorted by falling debris and heat providing paths for fluids to flow below deck. The damage caused by the falling derrick increased the probability that the fluids collected in the Sack Room, causing the Unit to heel to starboard. Once the heel to starboard was established, the flow of fluid continued to favor the starboard side and collect in any accessible space. Once the heel had increased to the point of deck edge immersion, other openings, which would normally be well away from the water, were submerged under the sea's surface and flooding accelerated.

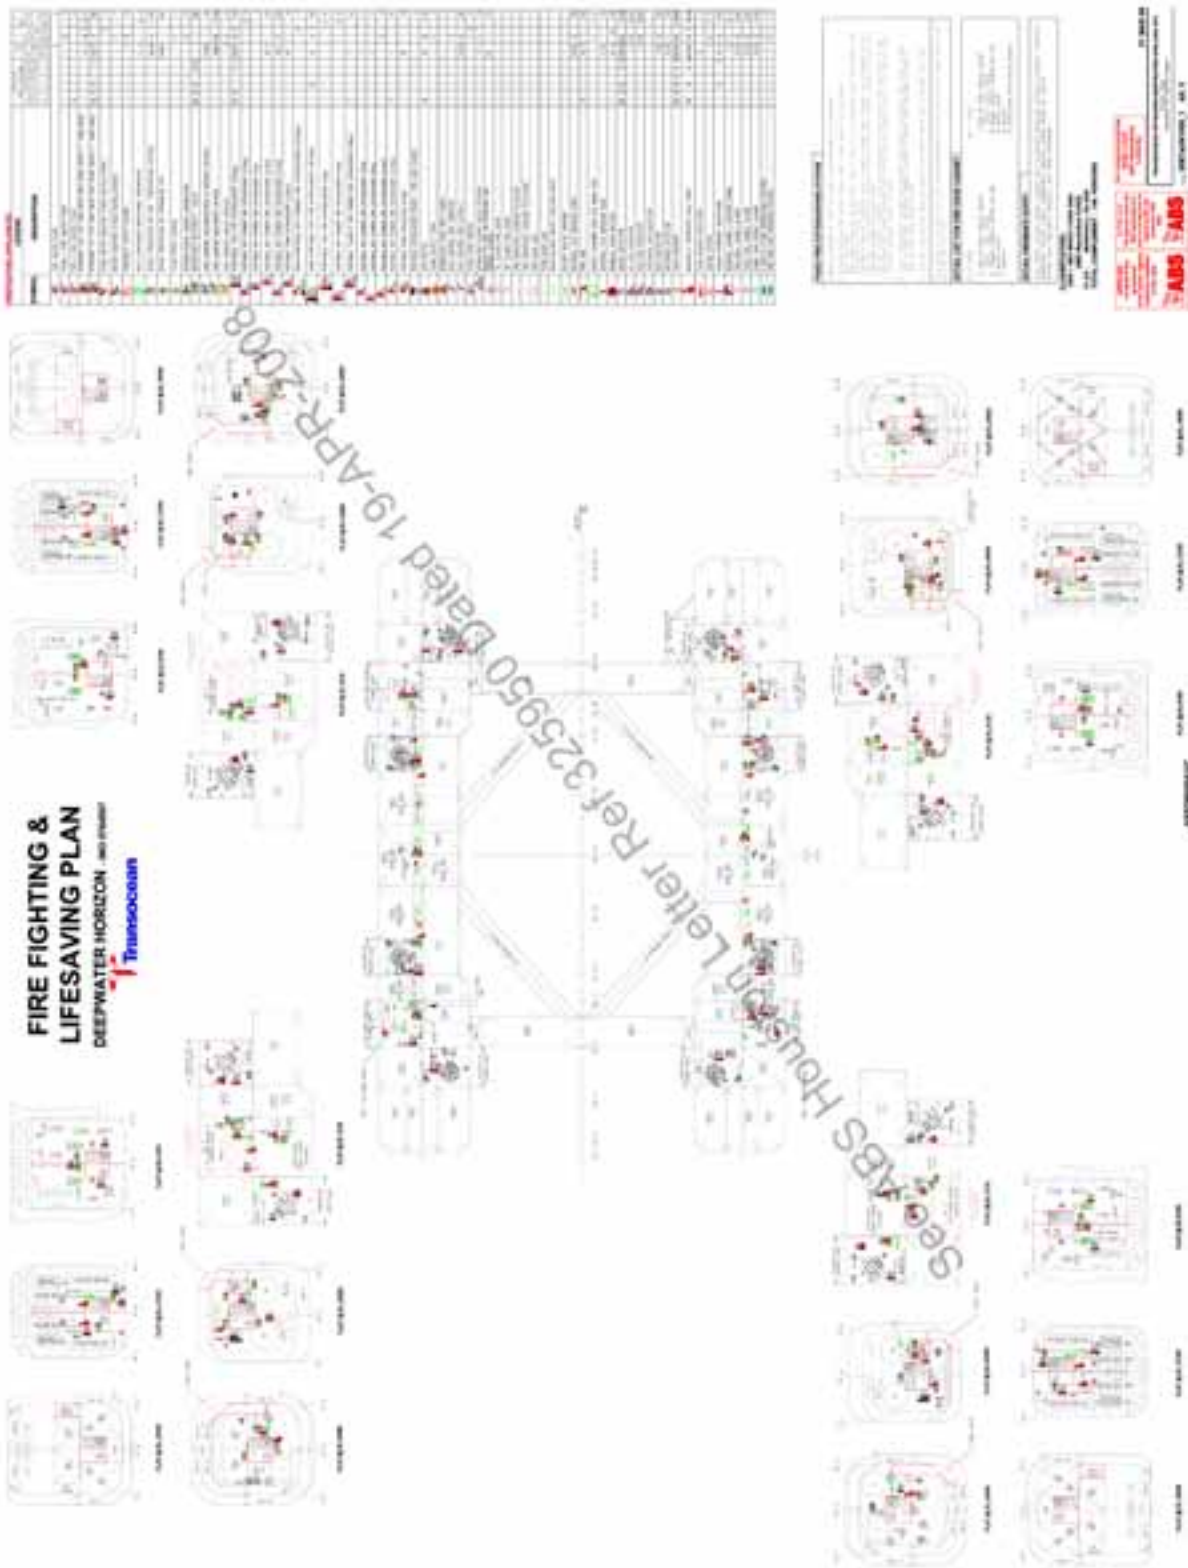
FIRE FIGHTING & LIFESAVING PLAN
DEEPWATER HORIZON and related

| P-004 | 6087aUN1000 - Firefighting & Lifesaving Plan | O339(Open) | Survivor |
| | Survivor is requested to verify appropriate quantity of "Portable Extinguisher Spare/Fire Hose Seals" that are stored on the 28500 Flat (not second deck as shown on symbol legend). | | |
