### DS SOFIE BULKER CASUALTY INVESTIGATION REPORT

Fatal Fall from Height

South Atlantic Ocean | 12 April 2021

Official Number: 6829

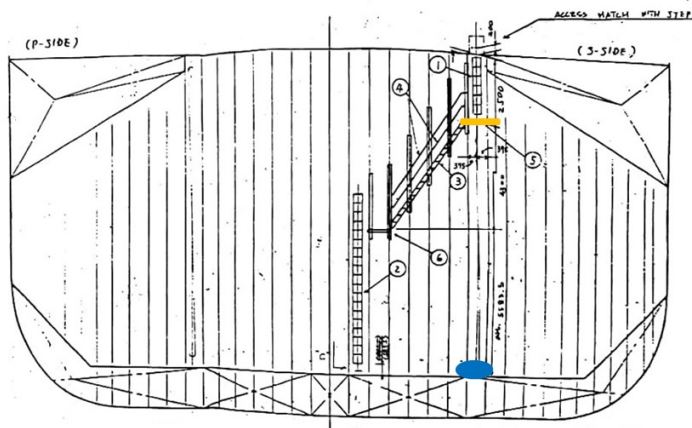
Figure 1: Schematic of the aft bulkhead and Australian ladder of Cargo Hold No. 2. The C/O's location following his unwitnessed fall is marked in blue and the upper platform in yellow.

The C/O's fall was not witnessed by any crewmembers, nor was he seen immediately beforehand. The first indication was a shout heard by crewmembers working in Cargo Hold No. 2, followed quickly by a loud noise. The crewmembers turned to see the C/O lying motionless on the tank top. He was in line with the upper platform of the Australian ladder and about 3 m forward of the aft bulkhead. Based on the location where the C/O landed, it is presumed that he fell about 10.8 m from either the vertical access ladder or the upper platform of the Australian ladder. The determined cause of death is consistent with a fall from this height.

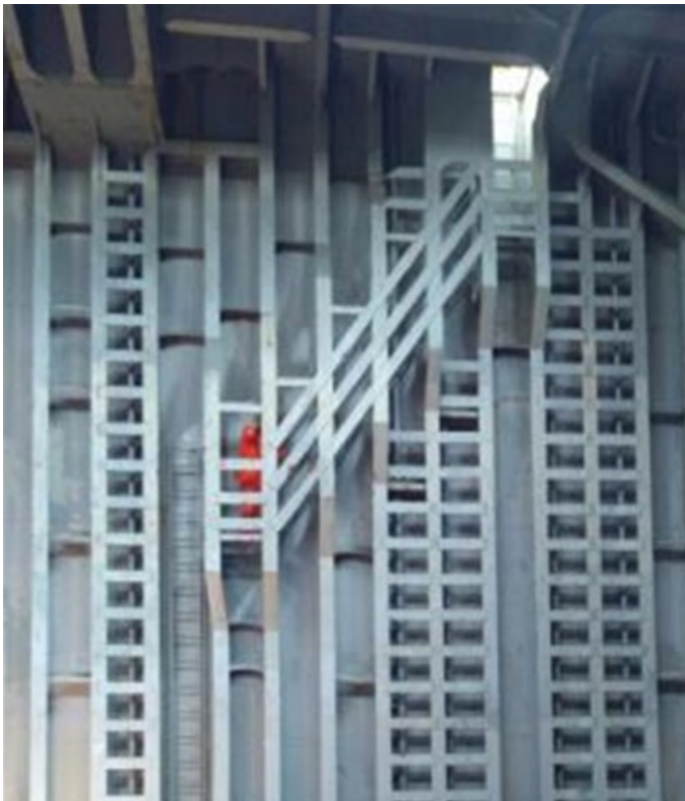
20. The aft access ladder of Cargo Hold No. 2 is an Australian ladder consisting of two sections of vertical ladder connected by landings and an inclined ladder (see Figure 2). The ladder is located on the aft bulkhead, starboard of the centerline.

Figure 2: Photo of the Australian ladder of Cargo Hold No. 2.

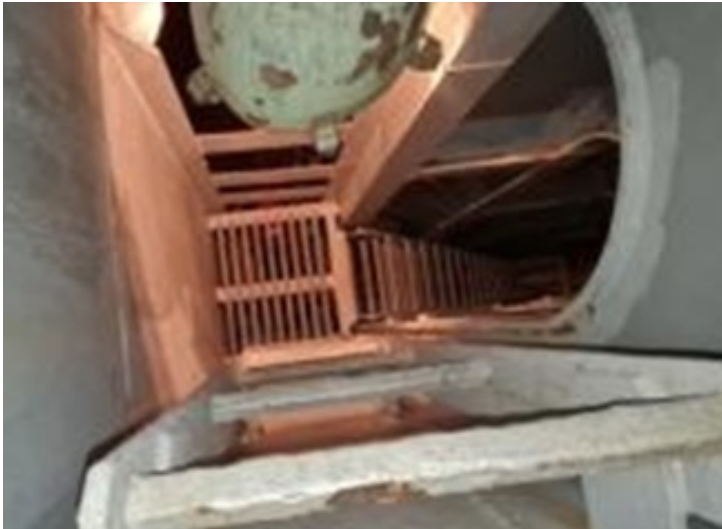
21. The upper section of vertical ladder is 3.1 m long extending from the main deck access to the upper platform inside the hold. This upper platform is 73 cm x 73 cm and about 10.8 m above the tank top (see Figure 3).

Figure 3: Photo of the upper platform of the Australian ladder for Cargo Hold No. 2, taken from the main deck access hatch.

22. A two-tier guard rail protects the forward side of the platform and extends down the inclined section of ladder. The rails are constructed of 15.5 cm wide flat steel bars, with a 30 cm opening below the lower rail and between the two rails. The top of the upper rail is 100 cm above the platform.
23. The vertical ladder from the main deck to the upper platform is attached to the aft bulkhead, between two vertical frames.
24. The section of vertical ladder between the top of the platform railings and the access hatch was unguarded.
25. Following the incident, the upper platform was found to be clean and free of debris.

The upper platform railing is 100 cm high. The distance between the top of this railing and the overhead transverse beam is 144 cm. The railing for the upper platform is 72 cm from the aft bulkhead (and the vertical ladder from the main deck). With the C/O reported as being 190 cm tall and the railing 100 cm above the platform, almost half of the C/O's body would have been above the railing. It is not known what caused his unwitnessed fall from the area of the upper platform. It is possible that he lost his balance while climbing down the vertical ladder and fell backwards over the railing. However, it is also possible that he fell while standing on the platform and possibly attempting to look over the railing at the crew working beneath. This could happen if his feet were to slip or if he lost his balance.

The platform was found to be clean and clear of debris when inspected following the incident. Additionally, the Australian ladder was designed and constructed in accordance with relevant requirements. Therefore, the ladder or platform condition is not considered a causal factor of this incident.

1. The lessons learned were circulated to all ships in the Company's managed fleet.
2. The Company has increased the frequency of onboard audits and strengthened the oversight of ships in the Company's managed fleet to ensure the effectiveness of the risk assessments conducted on board.
3. All manholes and access hatches leading to ladders were marked with a reminder that three points of contact must be maintained at all times when ascending and descending ladders.
4. The Company implemented a policy requiring that toolbox talk forms and permits to work be signed by all involved crewmembers.
