Office of the Maritime Administrator

M/V MOONRAY CASUALTY INVESTIGATION REPORT

Provisions Lift – Occupational Fatality

North Sea | 22 May 2016

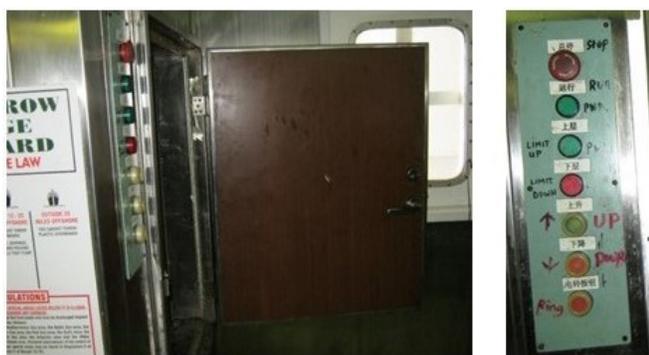
Figure 1: Access door (left) and control panel (right) in the Galley for the Provisions Stores lift. The door and control panel in the Provisions Stores are similar.

Based on the manual for the provisions lift, it should not have been able to operate when either or both of the two (2) access doors were open. However, neither of these doors were fitted with the door limit switches shown on the circuit diagram included in the manual for the provisions lift that was available on board MOONRAY. See Figure 2. As a result, the electric motor for the provision lift could be activated when a button on either of the two (2) control panels was pressed, whether or not the access doors were closed. Further, because the buttons operate by touch only, it was not necessary for them to be held depressed for the lift to operate. Therefore, it was possible for a person who was loading or unloading the provision lift to cause it to move up or down by accidentally pressing a button on the control panel.

The door limit switches should have been fitted when the provisions lift was installed when MOONRAY was being constructed in 2009. The electric panel that provided electric power to the provisions lift included wiring for the door limit switches. However, there were no mounting brackets, holes on either the doors or frames, or wiring in the lift shaft indicating that these door limit switches had been installed at any time since the MOONRAY was built in 2009. Why the door limit switches were not fitted when the ship was built cannot be determined based on the information available.

1. Primebulk elected to take the provisions lift permanently out of service. This was accomplished by welding steel bars across the access doors in the Galley and the Provisions Stores.
2. The training schedule in Primebulk's SMS was revised to include topics specific to training in risk assessments and safe work practices.
3. A Circular was sent to all ships in Primebulk's managed fleet emphasizing the importance of safe work practices and the need to conduct a risk assessment even when conducting routine tasks. Masters were directed to hold special Safety Committee meetings to review the Circular and conduct training on safe work practices.
4. Masters were instructed to inform Primebulk of any shipboard equipment that was not included in their ship's PMS.
5. Primebulk is evaluating electronic systems to enhance the Company's oversight of onboard compliance with PMS requirements.

1. On 24 May 2016, the Administrator recommended that ship management not place the provisions lift back in service until door limit switches were installed on the both of the access doors.
2. On 26 May 2016, the Administrator issued Marine Safety Advisory No. 20-16 recommending that ship managers of Republic of the Marshall Islands registered vessels have all lifts on board their managed ships inspected to ensure that safety devices, including limit switches and interlocks as required by the manufacturer, are fitted and operating properly. Other recommendations included locking lifts out of service on the applicable electrical control panel until any missing safety devices are installed or improperly functioning safety devices are repaired.

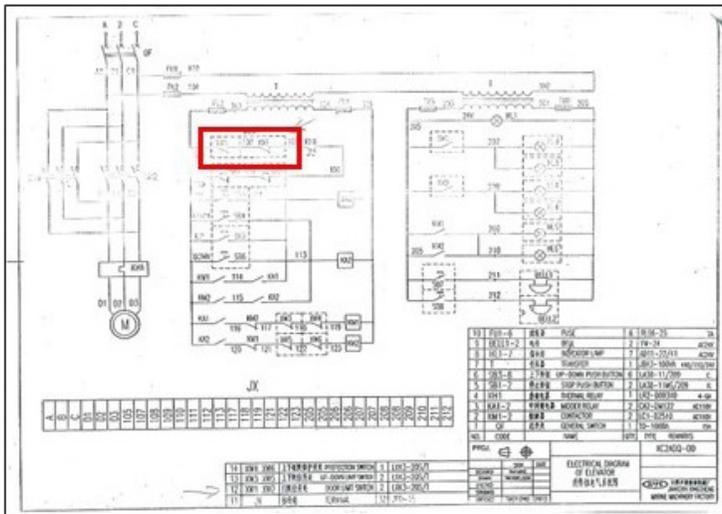
12. The circuit diagram included in the manual for the provisions lift that was available on board MOONRAY indicates that two (2) door limit switches should have been fitted. See Figure 2. Based on the circuit diagram, these limit switches would cut off the power to the lift's electric motor when either of the two (2) access doors were opened. When examined in Southampton following this incident, the door limit switches shown on the circuit diagram for the provisions lift were found not fitted. In addition, there were not any mounting brackets, holes on either the doors or frames, or wiring in the lift shaft indicating that the door limit switches had been installed at any time since the MOONRAY was built at Hantong Ship Heavy Industry's shipyard in 2009. However, there was wiring fitted in the breaker box for the door limit switches.

Figure 2: Electric diagram for the provisions lift. The door limit switches are outlined in red. (Source: Jiangyin Xingcheng Marine Machinery Factory, 500kg Marine Food Elevator Final Drawing, drawing No. XC2A500-00)

It is acknowledged that since there were no mounts, holes, or other visual indications, the absence of door limit switches could go unnoticed even if the provisions lift was inspected regularly. However, since the circuit diagram that is included in the manual for the provisions lift does show the door limit switches, Primebulk's technical staff and the ship's engineers had the information necessary to determine that they were missing.
