Republic of the Marshall Islands

MARINE SAFETY ADVISORY No. 06-24

Subject: INCIDENTS INVOLVING THE STORAGE AND HANDLING OF STEEL PLATES

Date: 20 June 2024 (renewed for 2026)

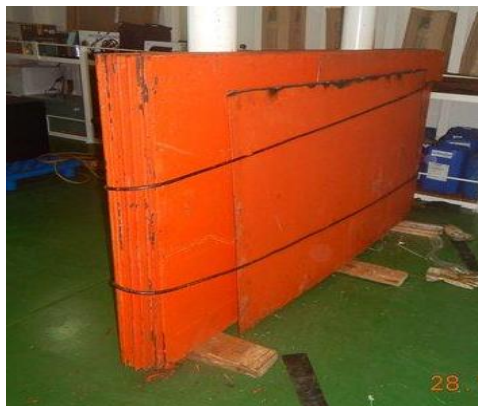
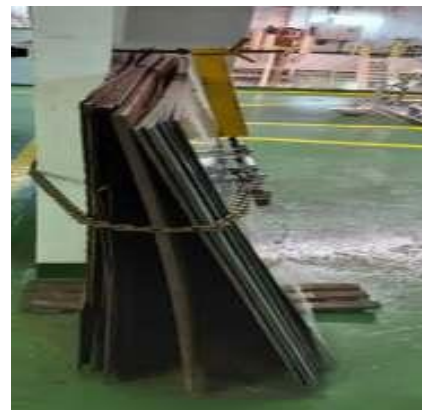
- In eight of the reported incidents, steel plates were stored vertically by leaning them against a stanchion or bulkhead and secured using lashings or a retaining bar¹ to hold them in place (see Figure 1). Materials used for lashings included rope, web straps, and chain. If a retaining bar was used, it was typically secured using studs that were welded to the bulkhead and held in place with nuts. In the other three incidents, the steel plates were stored on purpose-built storage racks that used a retaining bar located along the length of the storage rack to hold the plates in place. The retaining bars were secured using either bolts or studs and nuts. The lashings or the retaining bars had to be removed to handle the steel plates. As a result, there was always the potential for the steel plates to fall whenever they were being handled.

Figure 1: Examples of steel plates stored using lashings.

- In several of the incidents, the steel plates were stored so that the length of the plates were parallel to the ship's longitudinal axis. This increased the risk of the plates falling due to the ship rolling when the securing mechanism was removed.
- In each incident, crewmembers had to manually handle the steel plates rather than use lifting² or manual handling equipment.
- In each incident, handling steel plates was considered a routine task that did not warrant conducting a pre-task hazards assessment.
- In every case, there were insufficient materials and resources at the work site.

- Whenever possible, steel plates are stored horizontally in a location where lifting equipment can be used to lift and move the plates.
- If steel plates must be stored vertically, they are stored on racks that have a mechanical means of preventing the plates from falling prior to removal of the securing mechanism, and before being handled.
- Racks designed for storing steel plates vertically are oriented athwartships rather than along the ship's longitudinal axis.
- A Toolbox Talk and pre-task risk assessment is conducted to identify and remove the risk of personal injury before handling steel plates.
- The crewmembers are encouraged to use their Stop Work Authority to challenge any unsafe practices.
- Adequate lifting and/or manual handling equipment is located at the work site.
