MARINE SAFETY ADVISORY No. 01-19

Subject: LIFEBOAT EXHAUST SYSTEM PIPING

Date: 02 January 2019

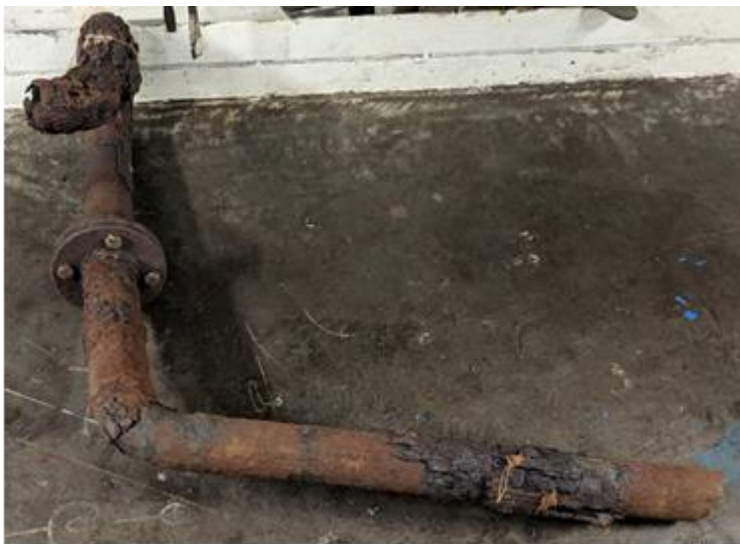
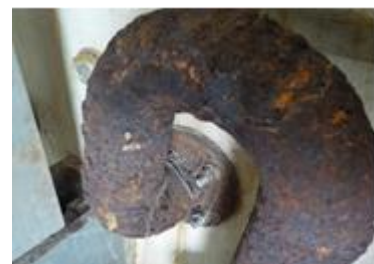
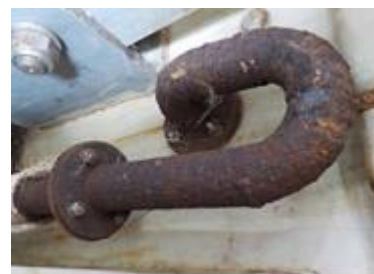
The exhaust piping arrangements are typically concealed behind insulation and, as a result, overlooked during inspections on board and during periodical service checks. This can result in corrosion to the piping arrangements which in turn may lead to the potential leaking of noxious fumes internally within the lifeboat.

Examples of issues found are provided in the photographs below.

Owners and operators are urged to ensure exhaust piping checks are carried out rigorously and that they are covered in the vessel's maintenance plans.
