REPUBLIC OF THE MARSHALL ISLANDS

Office of the Maritime Administrator

ROYAL DIAMOND 7 CASUALTY INVESTIGATION REPORT

Explosion with Fire and Explosion with Loss of Life

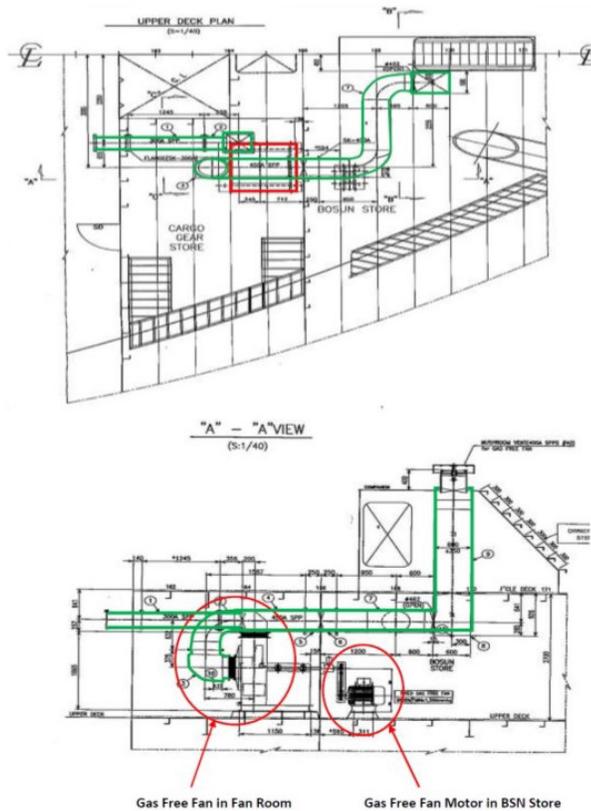
4. The fan room for the gas freeing system is located on the main deck on the starboard side, aft of the Bosun Stores. The fan is powered by an electric motor located inside the Bosun Stores. The shaft for the fan penetrates the bulkhead separating the fan room from the Bosun Stores. The shaft penetration is fitted with a gas tight gland. The suction, or supply, side of the gas free fan is connected to ducting that runs through the bulkhead in the Bosun Stores to a mushroom vent located on the forecastle deck. There is an air vent for the Bosun Stores in the supply duct for the gas freeing fan. Access to the fan room is through a watertight door in the aft bulkhead leading directly to the main deck. *See Figure 2.*

Figure 2: General arrangement of gas freeing fan room and Bosun Stores showing location of the piping for the supply air (green) along with the gas free fan and motor (red circles).
