Office of the Maritime Administrator

F/V KOO'S 101 CASUALTY INVESTIGATION REPORT

Main Boom Structural Failure with Loss of Life

18 June 2011

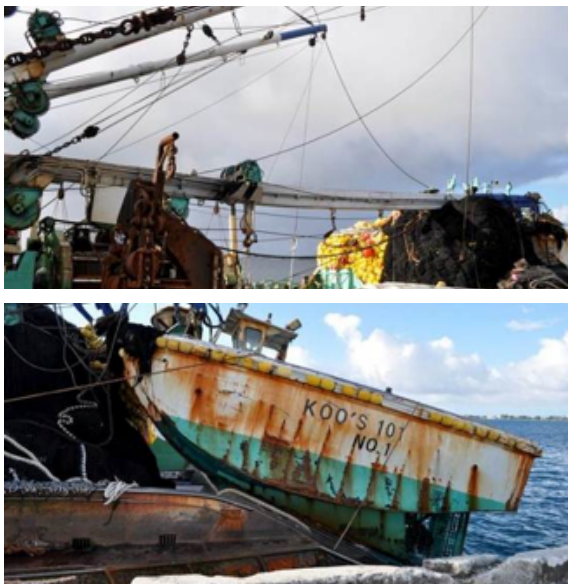
using the double winch, and it was reported to have hardly moved 5 centimeters when suddenly the main boom crashed down and landed on the skiff boat. *See Figure 2.* The chief of the skiff boat, who was in the forward position of the skiff boat standing by the quick release hook, was hit by the power block, which is located at the end of the main boom.

Figure 2: Main boom in collapsed position (top); the power block can be seen laying on the forward end of the skiff boat (bottom).

nearest the mast was bent and the power block was cracked. No other damage was reported.

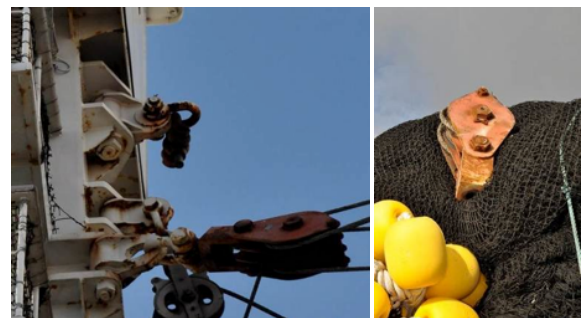
9. Following the collapse of the main boom, the crew observed that the main boom upper topping lift swivel pin had sheared off. *See Figures 2 and 3.* The topping lift is a three (3) sheave block; the diameter of the swivel pin is 58 millimeters. The lower third of the main boom

Figure 3: Upper topping lift, swivel pin remains attached to the joining shackle (left); fallen topping lift laying on fish net on the main deck (right).

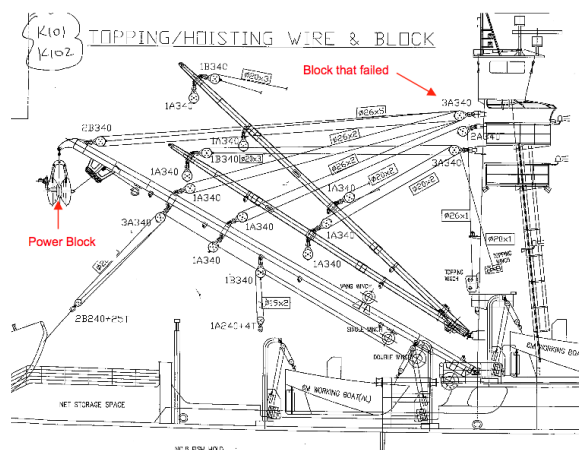
10. There was a Rig Plan depicting the sizes and dimensions for all three (3) booms and their fittings. See Figure 4.

Figure 4: Rig Plan for KOO'S 101.

3. It is recommended that the Rig Plan for KOO'S 101 and other vessels operated by Koo's Fishing Company Limited be reviewed and, as appropriate, revised by a competent person as defined in ILO 152 to verify it is appropriate for the loads imposed during all vessel evolutions. As appropriate, the lifting gear of the vessel should be modified at the earliest opportunity.

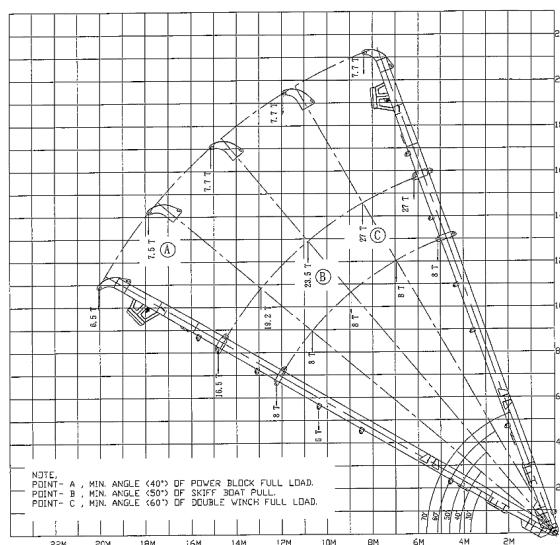
Figure 5: Main Boom Load Chart.

13. Based on the Load Chart for the main boom, the minimum angle for pulling the skiff boat was 50°; the maximum angle was 70°. The potential maximum allowed load when pulling the skiff boat varied based on the angle of the boom: it was 23.5 tons (T) at 50° and 27 T between 60° and 70°.

EVERY LOADING ON CHART MEANS ONE POINT LOAD ONLY TO BOOM.
IT'S NOT ALLOW TWO AND MORE LOAD ON BOOM.

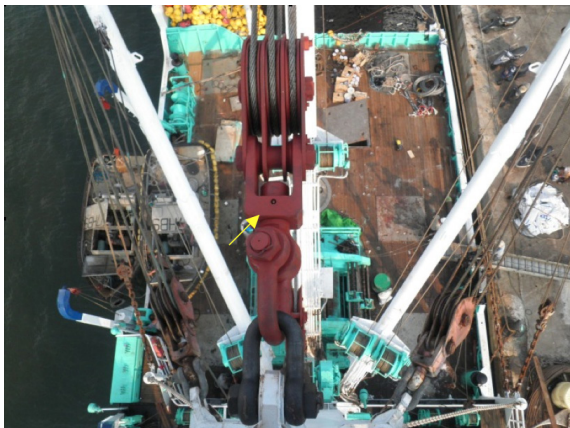
18. The crew of the vessel reported that the auxiliary and main boom wires were renewed at or about every six (6) months. It was also reported that the wires and blocks were greased once a month. However, as there were no maintenance records kept on board, it was not possible to verify the frequency of the boom wire renewals or when the wires and blocks were greased. When examined after the casualty, the wires were observed to be satisfactorily greased; however, the blocks did not appear to have been regularly greased. Access to some of the blocks was difficult due to their location on the mast. *See Figures 4 and 6.*

Figure 6: Location of grease fittings on swivel of main boom topping lift (replacement after casualty). Note the location and height above the deck.

19. The manufacturer of the swivel blocks recommend they be properly greased in order for the swivel to work normally and thus reduce the bending forces that would otherwise occur.

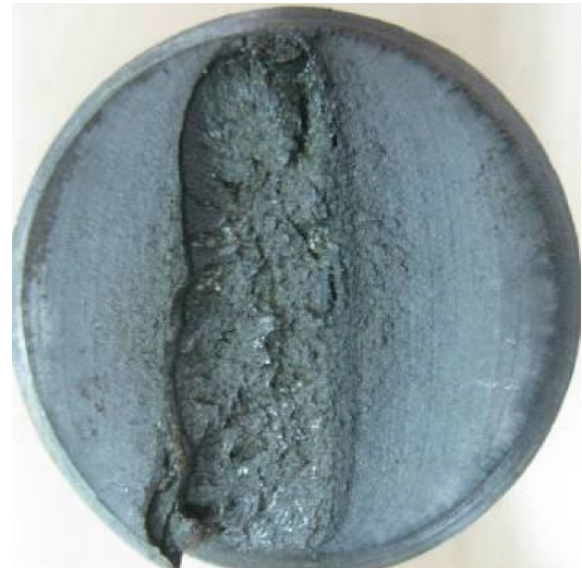
Figure 7: Cross section of main boom topping lift swivel pin showing final fracture zone in the center (Source: UITL Report, page 4).

22. The visual examination of the swivel pin determined that the fracture was in the center of the pin. *See Figure 7.*

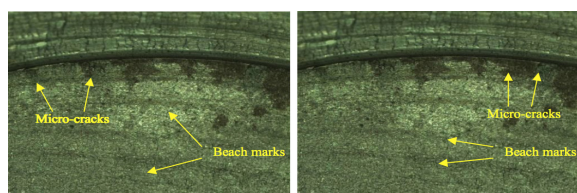
23. The macroscopic examination identified micro cracks and beach marks³ on the swivel that initiated from the right and left sides of the fracture, growing towards the core. *See Figure 8.* This was confirmed by the SEM and EDS analysis.⁴ The breaking pattern is indicative of a fatigue fracture caused by alternating stress.⁵

Figure 8: Macroscopic images of the topping lift swivel pin on the left (left image) and right (right image) sides of the fracture zone (Source: UITL Report, page 5).

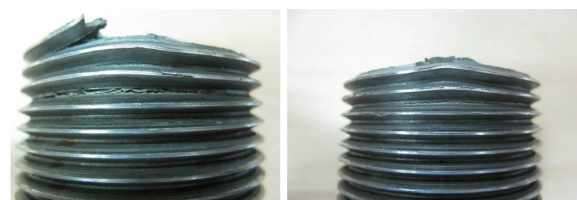
Figure 9: Threads on lower (left) and upper (right) pieces of the main boom topping lift (Source: UITL Report, page 6).

24. The macroscopic examination and magnetic particle testing also identified numerous cracks on both the threads and the thread roots.
