MATISSE CASUALTY INVESTIGATION REPORT

Crewmember Overboard and Missing While Underway Pacific Ocean Offshore the Columbia River

21 April 2012

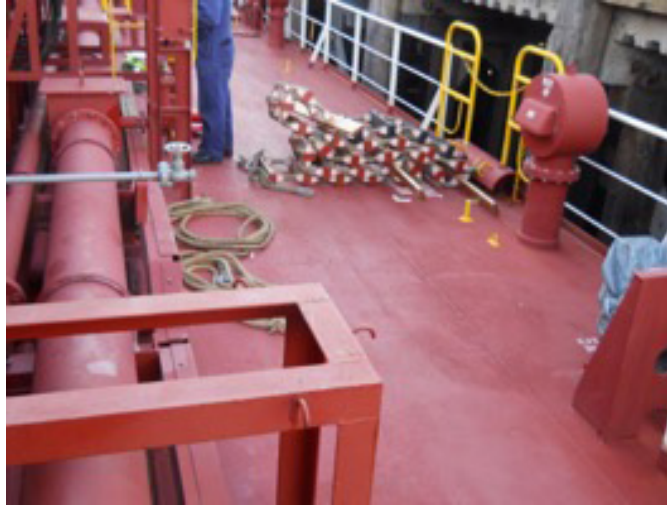
the Bosun fall overboard through the opening in the railing. The Second Officer stated that the ship rolled to port at the time the Bosun fell. The two (2) OS's, who were facing inboard as they stowed the pilot ladder, reported hearing the Bosun call for help and when they turned he was gone. At this time, the ship's speed was 9.6 knots and the heading was 018° T.

Figure 1: Portside pilot embarkation location with the yellow removable railing in place and pilot ladder on deck.

Absent his direct testimony, it cannot be determined with certainty why or how the Bosun fell overboard. Based on witness statements, it is reasonable to assume that the Bosun, who was working close to the deck edge, was likely thrown off balance or slipped as a result of the ship's roll, and then fell through the opening in the railing he was attempting to secure. Similarly, it is not known why he was not wearing a lifejacket or a safety belt with a lifeline secured to the ship.

1. The immediate cause of the Bosun falling overboard, resulting in his being lost at sea and presumed dead, is not known. It is considered likely that he slipped or lost his balance due to the ship's rolling movement while he was attempting to replace the removable section of guardrail in way of the port pilot station.

1. It is recommended that the Company review and, as appropriate, revise, its procedures to:
 - a. re-familiarize senior officers with the requirements of the SMS, including their responsibility for ensuring onboard compliance; and,
 - b. ensure that the Company's shore staff takes an active role in verifying shipboard compliance with the Company's SMS, including if not already done, witnessing and evaluating drills during regular shipboard visits.
2. It is recommended that the Company review and, as appropriate, revise, their SMS procedures in order to:
 - a. reduce the necessity for ship's crew to lean over the side while rigging and recovering pilot ladders; and,
 - b. ensure that safety harnesses and lifejackets are worn by ship's crew who may need to lean over the ship's rail or near an opening in the rail.

Any modifications to how pilot ladders are rigged must be consistent with the requirements of SOLAS Chapter V, regulation 23.

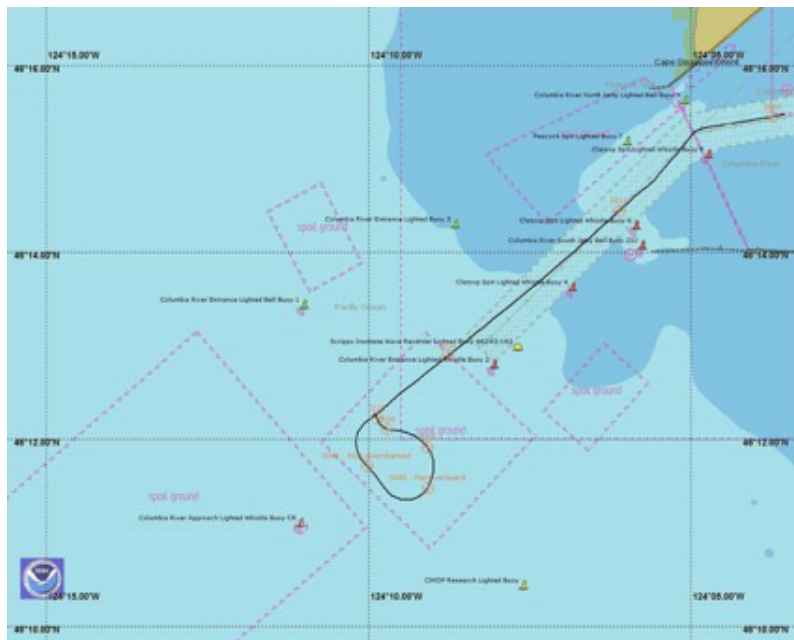
6. According to the Master's statement, in lieu of performing a Williamson Turn⁵, he ordered the main engine "All Stop" and continued the ship's turn to port. *See Figure 2*. He stated that this would allow the ship to drift back to the MOB location. The Master stated that his decision not to launch the rescue boat was due to sea conditions being too rough. The MOB lifebuoys mounted on the bridge wings were not deployed; no explanation was given for why they were not deployed. It is noted that the crew did execute other functions appropriate to this stage of the response as specified in the Safety Management System (SMS) Man Overboard Checklist, such as posting lookouts and energizing the ship's searchlight.

Figure 2: MATISSE's outbound transit across the Columbia River Bar; the location where the Pilot disembarked, and the MOB position (based on MATISSE's voyage data recorder (VDR)).

10. At 0110, the crew of MATISSE advised the pilot boat that a light had been seen off the ship's stern; based on the VDR information the bearing off the stern was approximately 230° T. At 0111 the pilot boat, which was in the vicinity of the position where the Bosun was reported to have fallen overboard, confirmed seeing a light in that direction and began to proceed toward MATISSE. It was subsequently determined that the source of the light was likely the Columbia River Approach Lighted Whistle Buoy CR. *See Figure 2.*

According to the Master's statement, the Williamson Turn was not attempted because he felt that with the prevailing seas and the ship's turning motion that by coming to a main engine "All Stop," the ship would drift back to the position of the MOB. It is noted that the Columbia River Bar can be difficult to navigate due to the unique confluence of the Columbia River current and opposing forces of the Pacific Ocean.

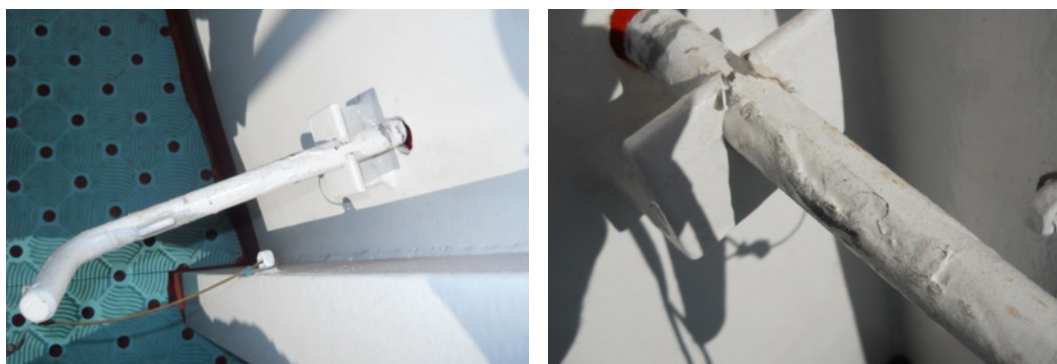
16. Crewmembers reported that all of the ship's lifebuoys, except those at the port pilot station and on the bridge, were removed from the main deck during the Columbia River transit and stored in the ship's tally room. This was reported to be at the order of a Deck Officer following the ship's departure from Portland; this was not corroborated by the ship's officers.
17. The bridge wing MOB lifebuoys were inspected as part of the investigation to verify their operability. The MOB lifebuoy release pins were able to be successfully removed. However, two (2) items which could hinder their smooth operation were observed: there was heavy corrosion on both release pins, and the tether cable for each of the pins was very short. *See Figure 3.*

Figure 3: MOB lifebuoy release pin showing the length of the tether (left) and the painted over corrosion (right).
