### ALTHEA CASUALTY INVESTIGATION REPORT

Fatal Accommodation Space Fire

South Atlantic Ocean | 22 November 2021

IMO Number: 9396309

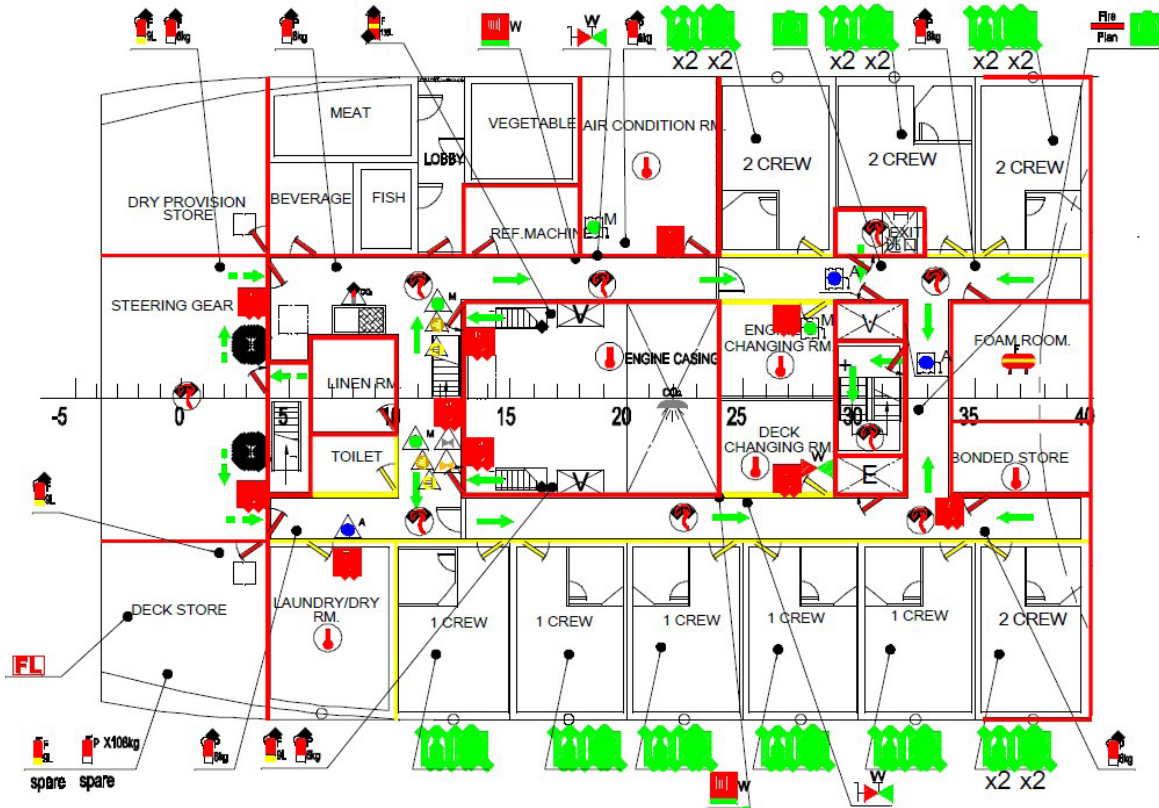
Figure 3: Fire control plan for ATLHEA's upper deck.

7. The bulkheads between the crew cabins and the passageway are “B-0” class divisions.<sup>2</sup> The doors for each of the crew cabins are “B-0” class self-closing doors.
8. The bulkheads encasing the forward stairway are “A-0” class.<sup>3</sup> The door between the stairway and the upper deck passageway is an “A-0” class self-closing door.
9. The bulkheads between the crew cabins are “C” class divisions.<sup>4</sup>

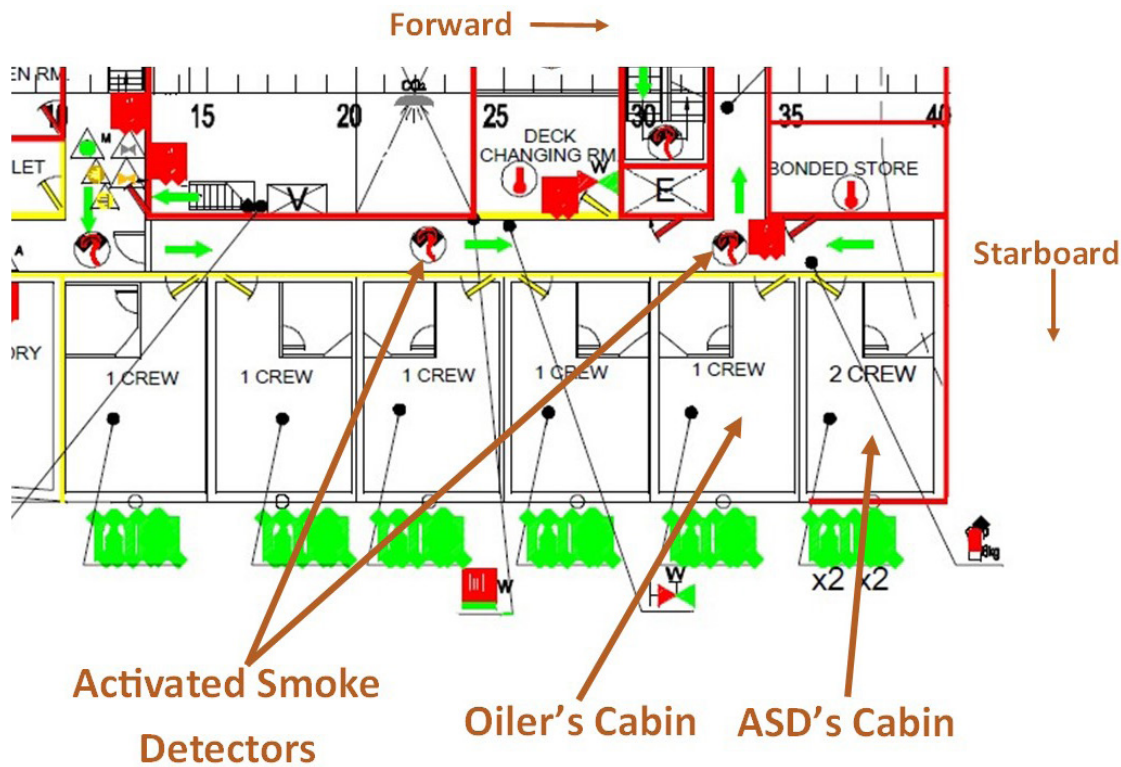
18. At about 2020, it was determined that the Oiler1 and ASD1 had not reported to the muster station. The Master immediately used the PA system to direct the Oiler1 and ASD1 to report to the muster station. Both of the unaccounted crewmembers' cabins were next to each other on the starboard side of the upper deck (*see Figure 4*).

Figure 4: Locations of the unaccounted crewmembers' cabins and the activated smoke detectors on the starboard side of the upper deck.

The ASD1's cabin was located all the way forward, on the starboard side of the upper deck (*see Figure 4*). This cabin had one means of egress through the cabin door. It is reported that the porthole in his cabin was not large enough to allow him to pass through. In order to exit the upper deck, the ASD1 would have had to turn aft after exiting through his cabin door. He would then have had to turn inboard into the forward, athwartships passageway. The main staircase would then be on his left, a short distance down the passageway.

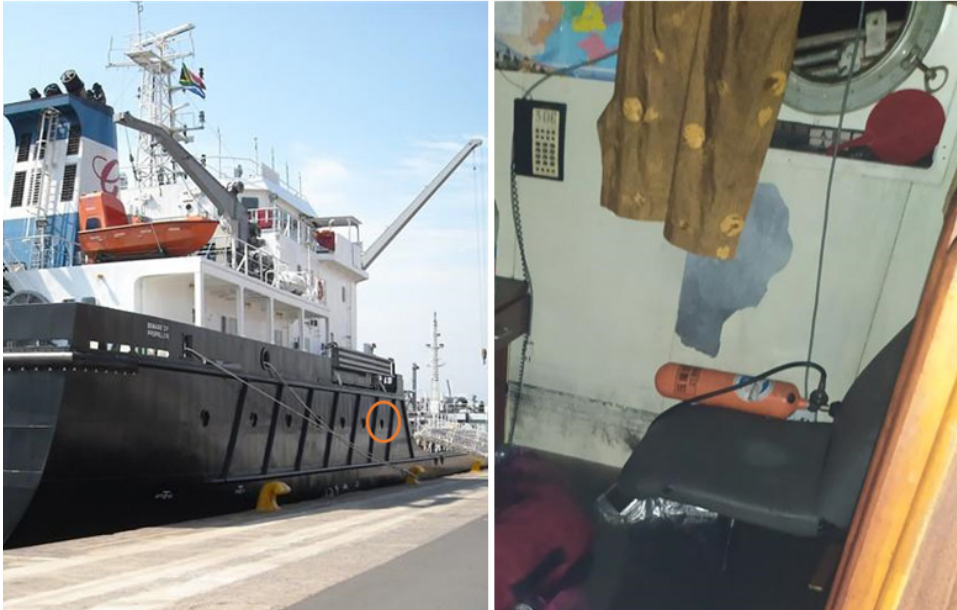
24. At about 2100, crewmembers used a rope to lower an EEBD through the open porthole to the ASD1's cabin. There is no direct access to this porthole from the exterior of the ship (see Figure 5). The ASD1 reported that he was still unable to leave his cabin due to the flames and heat in the passageway. Additionally, the 39 cm porthole was too small for the ASD1 to exit through or to allow an SCBA to be passed into the cabin.

Figure 5: Photo of the starboard side of ALTHEA, with the porthole to the ASD1's cabin circled in orange (left). Photo of the EEBD that was lowered to the ASD1, taken following extinguishment of the fire (right).

The FSS Code defines an EEBD as "a supplied air or oxygen device only used for escape from a compartment that has a hazardous atmosphere" which is required to have a serviceable duration of at least 10 minutes. The FSS Code further states that SCBAs are required to be capable of functioning for at least 30 minutes. The crew were able to pass an EEBD to the ASD1; however, the porthole to his cabin was not large enough to fit an SCBA through.

1. Based on the above Conclusions and in consideration of the Preventive Actions taken, it is recommended that the Company:
  - (a) review the number and placement of EEBDs within the Accommodation to ensure they are readily available to crewmembers when exiting their cabins; and
  - (b) conduct additional training during routinely scheduled fire drills regarding the rescue of crewmembers from spaces with no exterior access (such as the cabins on the upper deck) and the use of SCBAs to extend survivability.

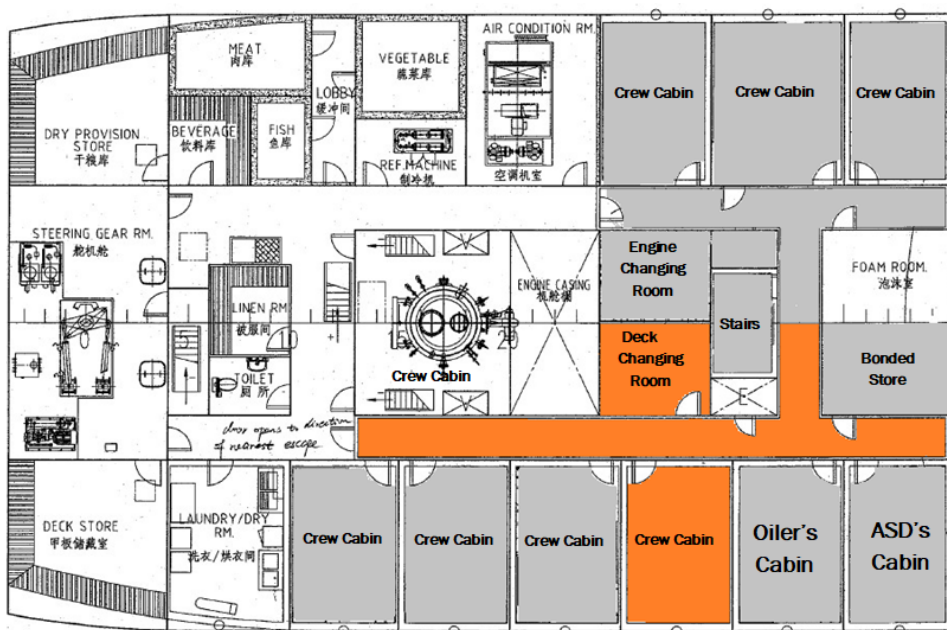
35. The heaviest fire damage was located on the forward, starboard side of the upper deck (see Figure 6). The port side had smoke damage but no signs of direct flame impingement. The self-closing fire doors on the port and starboard sides of the upper deck passageway largely prevented smoke and flame from spreading into the aft portion of the passageway.

Figure 6: Diagram of the impact on the upper deck, with fire damage indicated in orange and smoke damage indicated in grey.

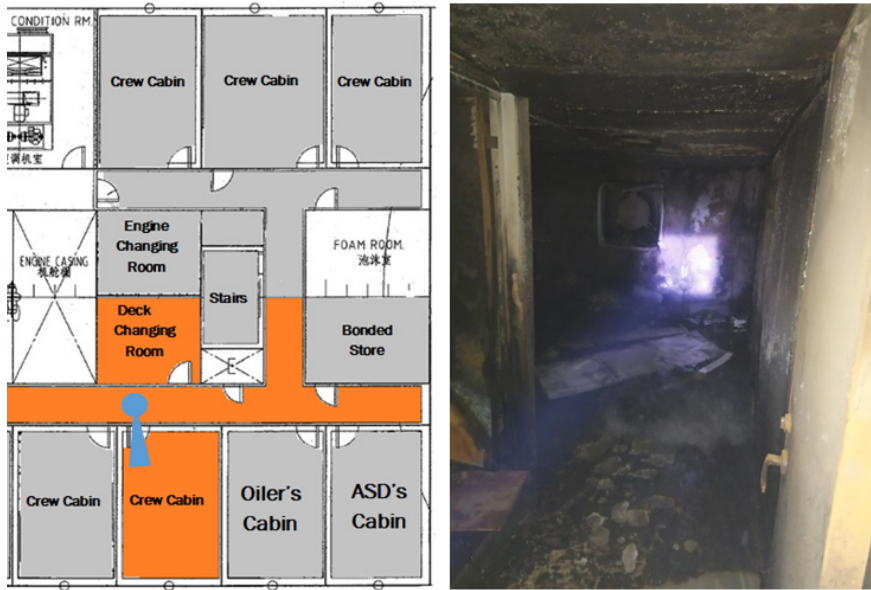
36. One crew cabin on the starboard side had significant fire damage, with all surfaces showing evidence of direct flame exposure. Most contents were completely burned (see Figure 7). This cabin was aft of the ASD1's cabin. The heaviest fire damage was observed on the interior side (towards the cabin) of the bulkhead and overhead paneling. Burn patterns indicate that the door to this cabin was closed when the fire started. The crewmember assigned to this cabin was not occupying it when the fire started as he was on duty. It is customary for crewmembers to keep their cabin doors closed when they are not occupying the space.

Figure 7: Photo of the crew cabin with the heaviest fire damage. Orientation of view is indicated in blue. The bathroom inside this cabin can be seen to the left of the photo.

Fire and intensity patterns indicate the fire originated in a crew cabin on the upper deck, starboard side (*see Figure 7*). Less damage was observed on the upper deck as distance from the cabin of origin increased. The exact origination location within the cabin of origin could not be determined due to the extent of damage, combined with the impact from firefighting. However, fire patterns indicate that the fire likely originated within the livable space of the cabin and not within the bulkhead or overhead paneling.

A possible cause of the fire was an electrical fault which provided the source of ignition. This could have involved a portable electronic device or its power cable in the cabin of origin. Following the incident, the crewmember assigned to the cabin of origin could not recall if any personal electronic devices were left plugged in when he left the cabin. Personal electronic devices and their associated chargers left unattended while plugged in have the potential to be a source of ignition, having been identified as the probable cause of recent shipboard fires.<sup>11</sup>

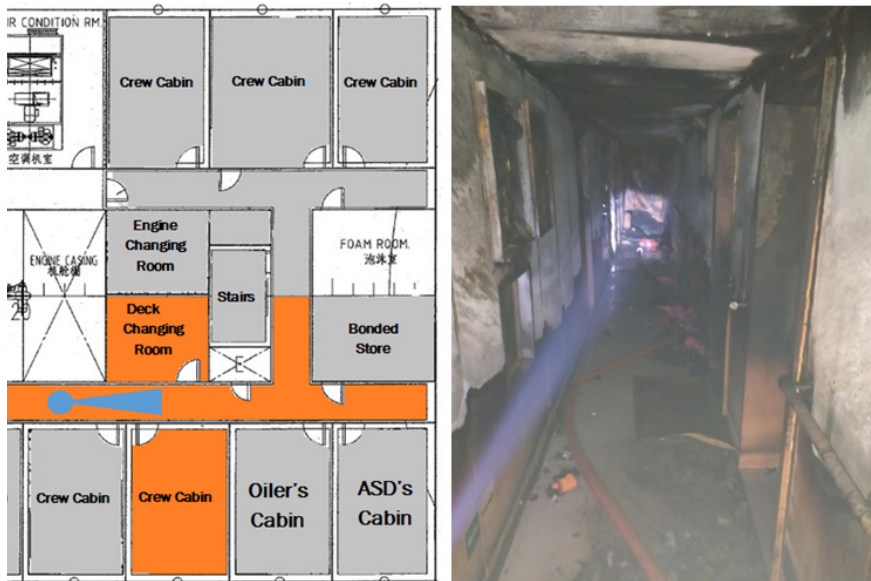
38. The starboard passageway had significant fire damage (see Figure 8). Fire damage decreased with distance from the seat of the fire within the crew cabin.

Figure 8: Photo of the forward, starboard side passageway of the upper deck. Orientation of view is indicated in blue.

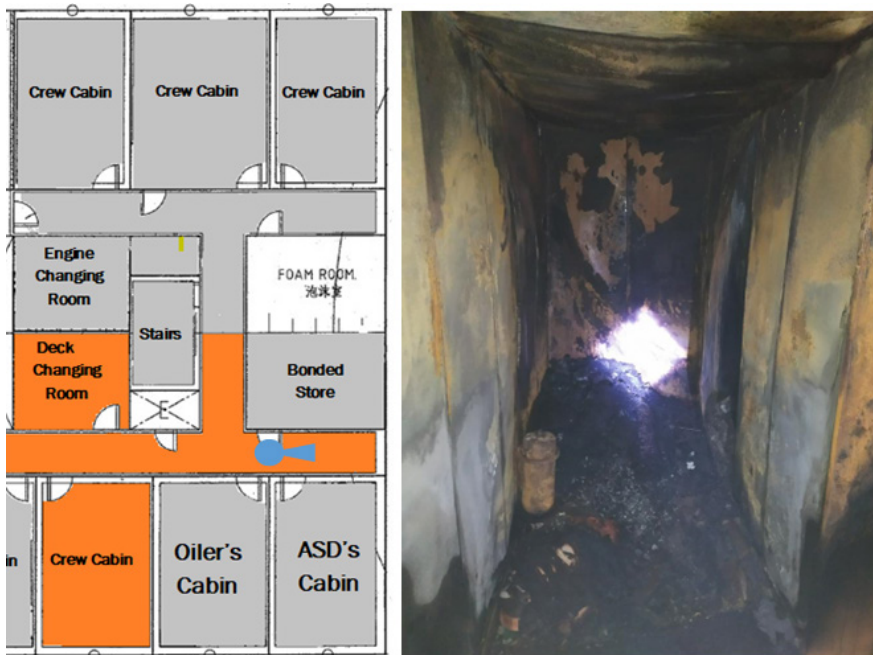
39. The passageway directly outside the ASD1's cabin had significant fire damage which extended from near deck level up to the overhead (see Figure 9). The overhead and bulkhead paneling were deformed due to heat. A large pile of fire debris had collected at the end of the dead end corridor adjacent to the ASD1's cabin.

Figure 9: Photo of the passageway outside the ASD1's cabin. Orientation of view is indicated in blue.

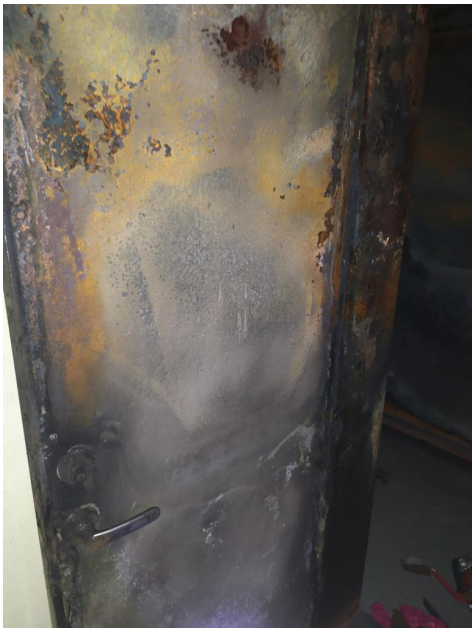
40. The door to the ASD1's cabin was closed when the fire started and was found closed when he was removed by crewmembers. Fire damage was present on the exterior of the door (see Figure 10).

Figure 10: Photo of the exterior of the door to the ASD1's cabin.

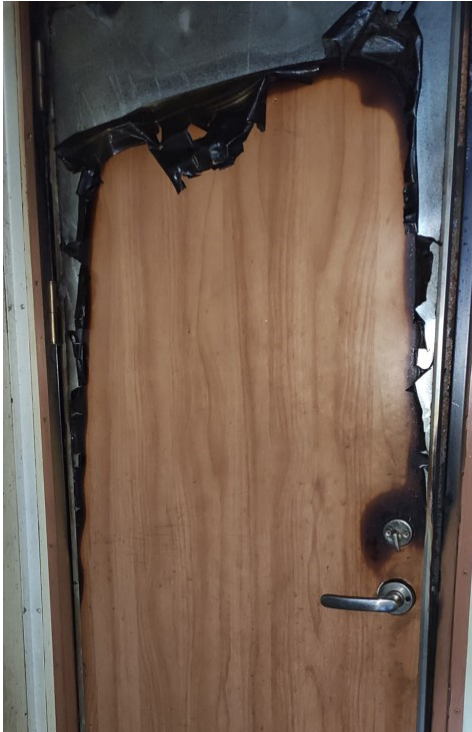
41. The upper half of the inside of the door to the ASD1's cabin shows signs of exposure to high temperatures, as evidenced by the melted veneer (see Figure 11). No evidence of direct flame contact was observed on the inside of the door, frame, or surrounding areas.

Figure 11: Photo of the inside of the door to the ASD1's cabin.

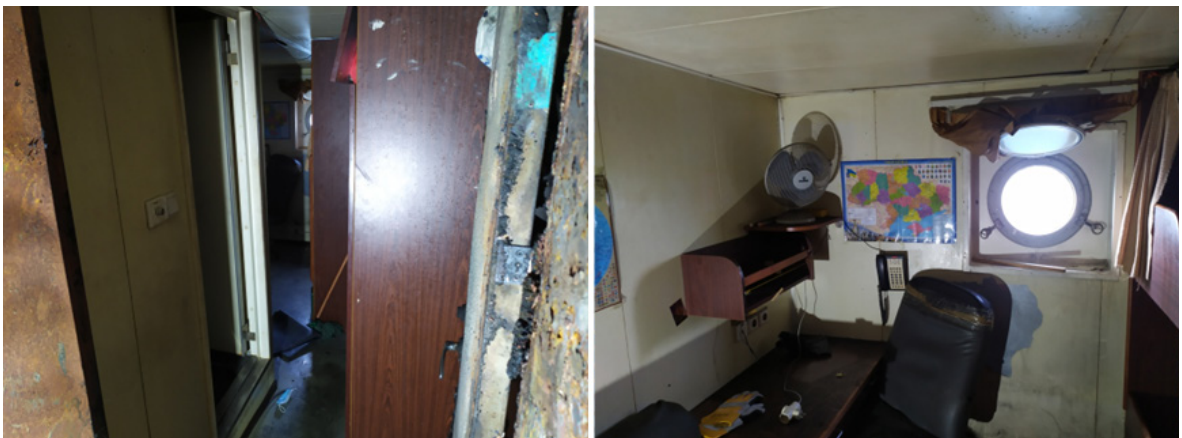
42. Soot had collected on the bulkheads, overhead, and furniture in the ASD1's cabin (see Figure 12). There was no fire damage, aside from the peeling veneer on the inside of the door.

Figure 12: Photos of the ASD1's cabin, taken after firefighting water had been removed.
