REPUBLIC OF THE MARSHALL ISLANDS

AMPHITRITE MARINE SAFETY INVESTIGATION REPORT

Occupational Fatality – Crushed by Anchor

Java Sea | 10 March 2025

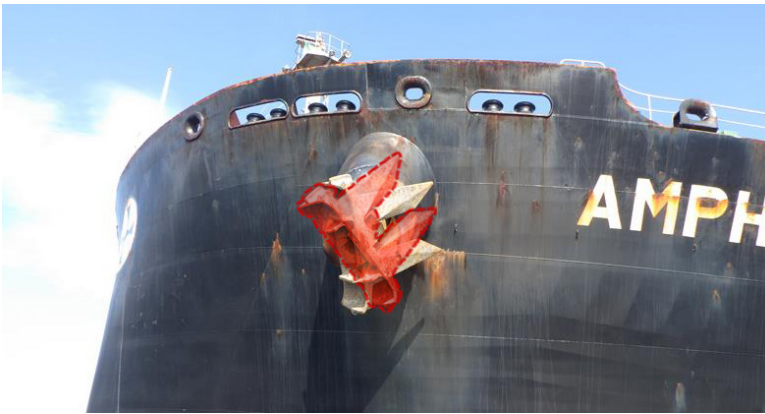
The anchor, when brought into the hawse pipe, did not align properly and became stuck, so it was not possible to either lower or bring the anchor completely home. The crewmembers then secured the port anchor using the windlass brake, chain stopper, and lashings (i.e., wire rope). Neither the Master nor any of the ship's other management level officers (i.e., the C/O, C/E, and 2/E) reported having seen such a situation in their time at sea.

the flare of the bulwarks (see Figure 2).³ They then used mooring winches to heave on the mooring lines, alternating between the line that led forward and the line that led aft, to try to free the anchor. The effort was not successful.

Figure 2: Photograph of AMPHITRITE's port anchor showing the position of the flukes when the anchor was stuck in the hawse pipe. The normal position of the flukes is indicated by the red image, which was added.

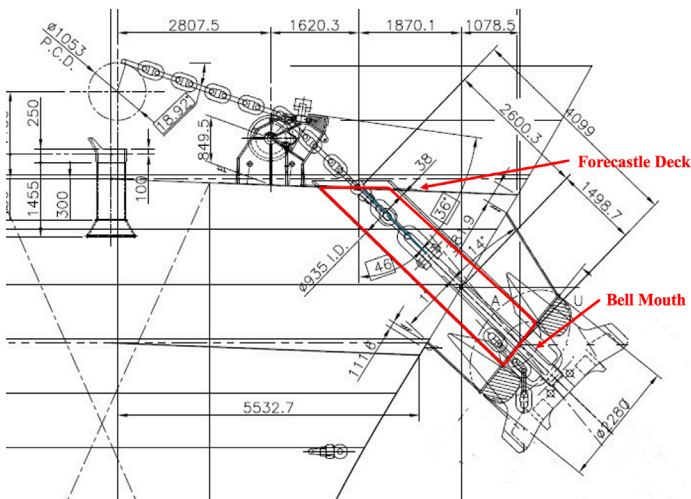
Figure 3: Drawing of the hawse pipe (outlined in red). The length of the hawse pipe was 2,600 mm from the forecastle deck to the side shell and 1,499 mm from the side shell to the bell mouth. The interior diameter of the hawse pipe was 985 mm.

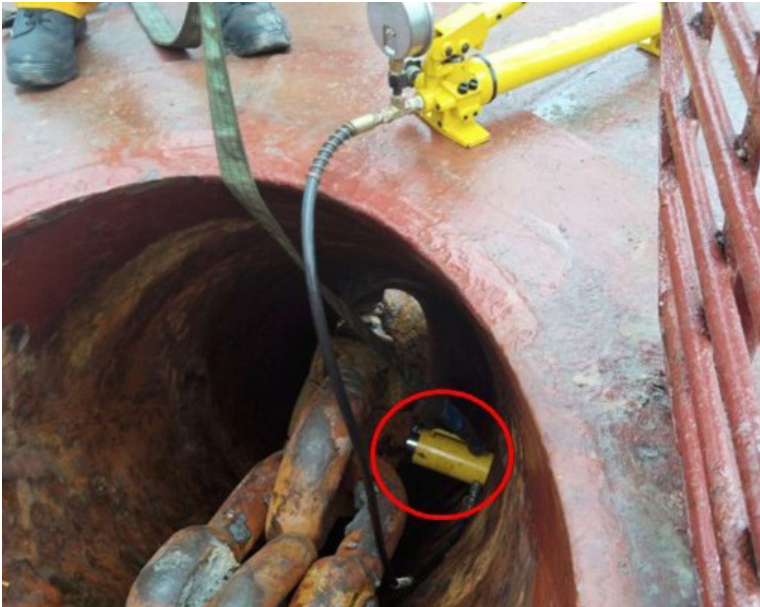
At approximately 1030, the Master, C/O, C/E, 2/E, and other crewmembers went forward to try to free the anchor, which was still secured by means of the windlass break, chain stopper, and lashings. The 2/E and Fitter climbed or reached down into the hawse pipe and placed a portable hydraulic jack in position on the forward side of the anchor shank just below the shackle for the anchor chain (see Figure 4).

Figure 4: The port side hawse pipe showing the hydraulic jack (circled in red) in position on the forward side of the anchor shank. The hand pump for the hydraulic jack is on deck.

After the 2/E and the Fitter were clear of the hawse pipe, the 2/E worked the hand pump to operate the hydraulic jack. He continued pumping until the gauge on the handpump showed there was 20 bar of pressure on the hydraulic jack. There was no indication that the anchor had moved, so it was decided to not continue trying to free the anchor.

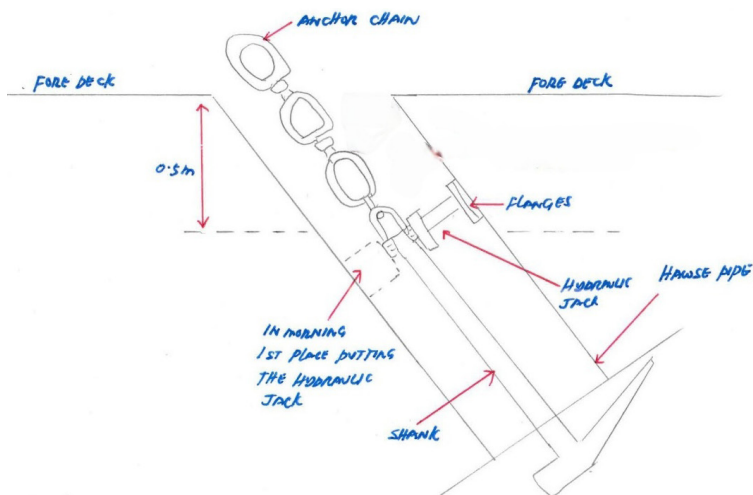
The Fitter and Bosun, both of whom were wearing safety harnesses with lifelines secured to the guardrail, climbed down into the port hawse pipe to put the hydraulic jack in place on the aft side of the anchor shank. They could not put the hydraulic jack in place because the gap between the hawse pipe and the aft side of the shank was larger than on the forward side of the shank. Either the C/E or 2/E then directed one or more of the crewmembers who were on the Forecastle to get some flanges to place between the side of the hawse pipe and the base of the jack (see Figure 5).

Figure 5: Sketch prepared by the 2/E showing the location of the hydraulic jack when it was put in place for the second attempt to free the port anchor on 10 March 2025. The drawing does not show how far the ram was extended from the cylinder.

At approximately 1715, the port anchor moved suddenly as the Fitter and Bosun were climbing out of the hawse pipe. The Bosun, who was closest to the deck, had his abdomen and legs caught between the anchor chain and the hawse pipe, and immediately yelled for help. The Fitter, whose torso was pinned between the anchor shank and the hawse pipe with his head toward the anchor flukes, was not responsive.
