### ANTARES CASUALTY INVESTIGATION REPORT

Fatal Electrocution During Hold Cleaning

Indian Ocean | 7 September 2018

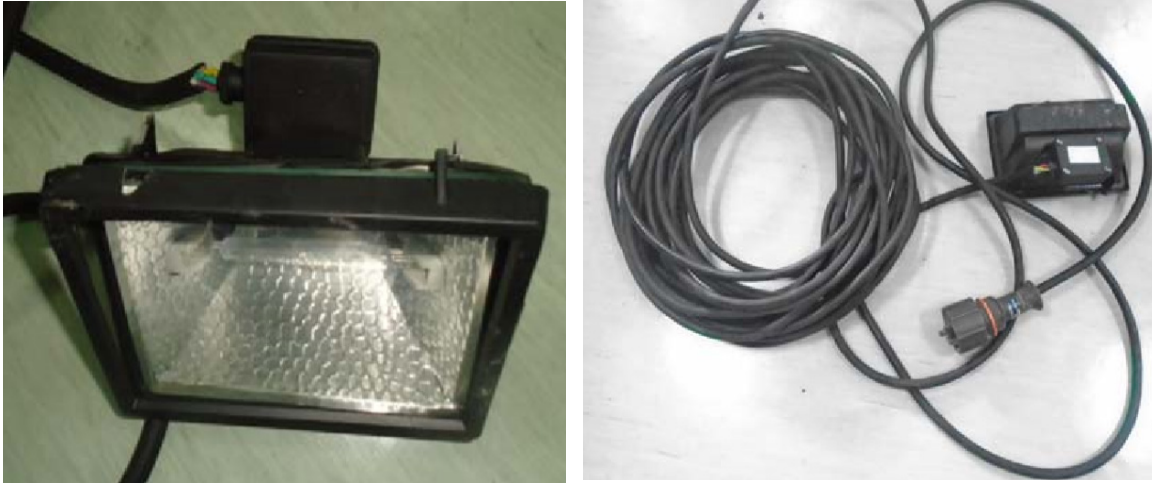
23. The floodlight the OS was setting up at the time of the incident was an IP44-rated 220/240-volt, 50/60 hertz halogen light designed for fixed installations.<sup>9</sup> The unit had a cable and appropriate male plug for the intended receptacle (*see Figure 1*).

Figure 1: The halogen flood light found with the OS.

It is noted that the electrical halogen lamp selected by the OS was not designed for portable use. The unit was fitted with a bracket for permanent mounting to a fixed surface. The light was delivered to the ship as a replacement for other inoperable portable cargo hold lights. However, it was not ensured that the lights were of the proper design for their intended use prior to placing them in service on board. The Company reports that the requisition for the replacement lights did not specify the end use (i.e., portable versus fixed) nor was the intended use questioned by the Company.

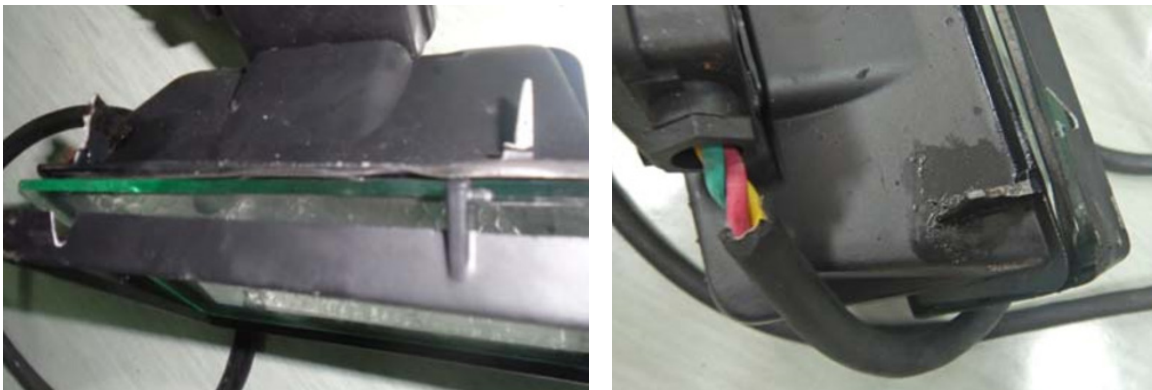
27. Following the incident, the lamp held by the OS had damage to the housing (which holds the glass cover in place) and the mounting bracket. The outer insulation of the cable was found pulled back from the weathertight connector on the lamp housing, exposing the individually insulated wires inside (see Figure 2).

Figure 2: Damage to halogen flood light.

The light held by the OS when he was discovered had damage to the housing and the electrical cable. It is unclear when this damage occurred. Both or either of these defects could potentially have compromised the device's designed electrical insulation, creating an electrocution hazard.

3. The Company's preventive maintenance system will be amended to include a requirement that all portable flood lights on managed ships be inventoried and inspected.
