### AP DUBRAVA CASUALTY INVESTIGATION REPORT

Fatalities During Enclosed Space Entry

South Atlantic Ocean | 17 July 2019

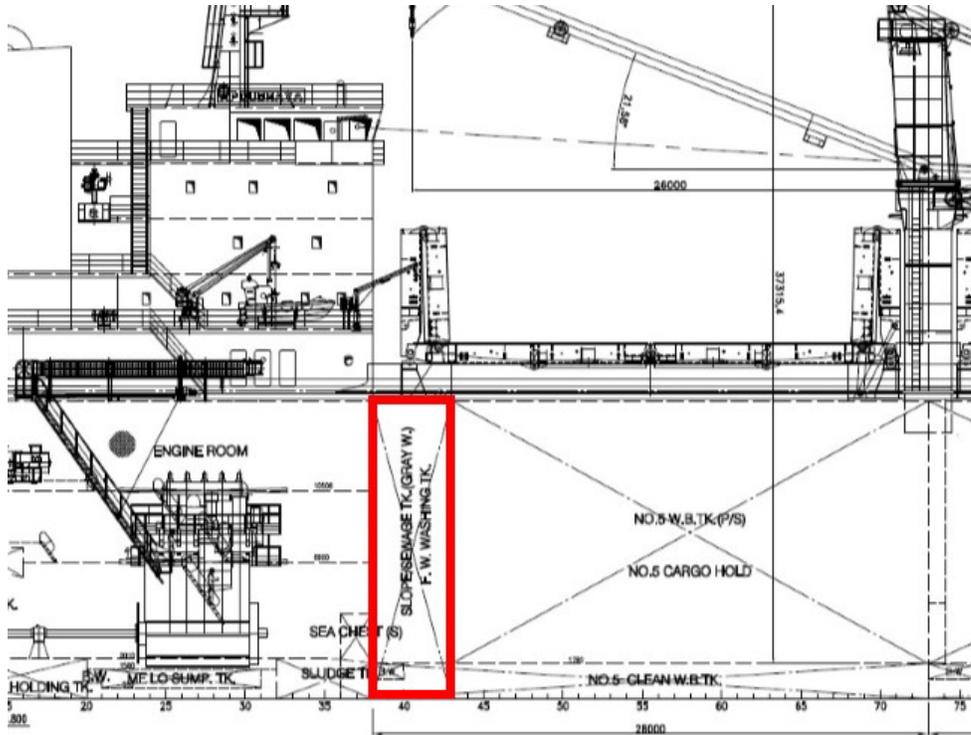
Figure 1: Location of Tank No. 801.

- Tank No. 801 is a designated slop and greywater storage tank located between the No. 5 Water Ballast Tank and the Engine Room forward bulkhead, immediately forward of the Accommodation (see Figure 1).

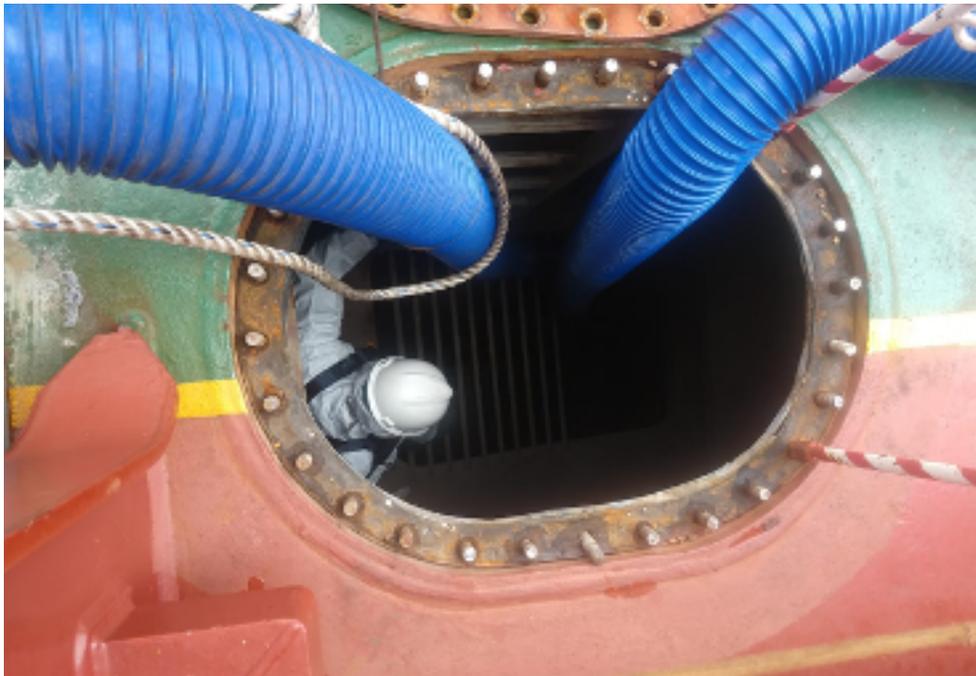
Figure 2: Tank No. 801 access hatch and first platform.

- The tank is accessed through a watertight manhole cover on the port side Main Deck near the aft end of the Cargo Hold No. 5 hatch cover. The manhole cover is marked with “SLOP” and secured with nuts around its perimeter (see Figure 2).

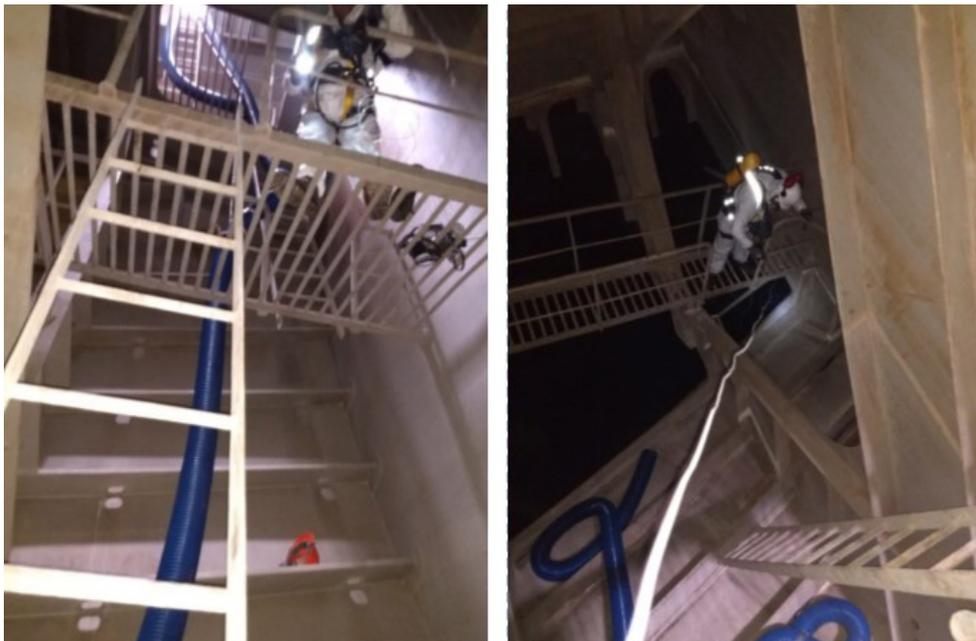
Figure 3: View towards Upper Deck from mid-level of Tank No. 801 (left). View towards bottom of Tank No. 801 from mid-level (right).

7. There are several platform levels connected by straight ladders within Tank No. 801, extending from the Main Deck to the bottom of the tank (see Figure 3).

In addition, the design of the space would limit the effectiveness of natural ventilation. Tank No. 801 extended from the Main Deck to the bottom of the hull. Natural ventilation through the open manhole would provide little, if any, air exchange at the lower levels of the tank. The C/O and the ASD1 were not rendered unconscious until they descended to the second platform. This may be an indication that the natural ventilation was effective at the top of the tank but not lower levels.
