### ASTERIS MARINE SAFETY INVESTIGATION REPORT

Fatal Fall from Height

South China Sea | 17 April 2024

IMO Number: 9384796

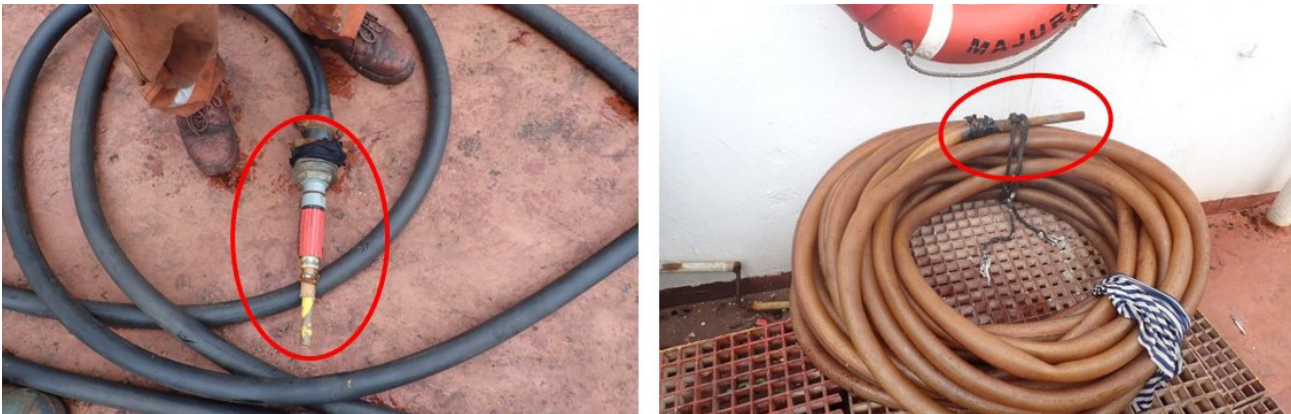
Figure 2: Hoses and nozzles that were used for cleaning the cargo holds.

The hoses used for washing the cargo holds were fitted with nozzles and a fitting so they could be connected to fire hydrants. Each of the hoses was approximately 25–30 m long. The nozzles were pieces of pipe connected to the hose by a hose clamp (*see Figure 2*). The flow of water was controlled by opening or closing the fire hydrant. Crewmembers needed to stand on either the platforms that were part of the vertical ladder or on the Australia ladder while cleaning

the bottom of the hatch covers and underdeck since the hoses could not be effectively handled with one hand when the water was flowing.<sup>4</sup>

The ASD2 fell soon after the OS2 opened the fire hydrant in response to the ASD2's direction to turn on the water. The hoses used to wash the cargo holds could not be handled with one hand when the water was running so it would not have been possible for the ASD2 to hold onto the vertical ladder while the water was turned on and running. Therefore, he most likely had been standing on the upper intermediate platform, which was open on the side that faced the intermediate vertical ladder, just before falling.

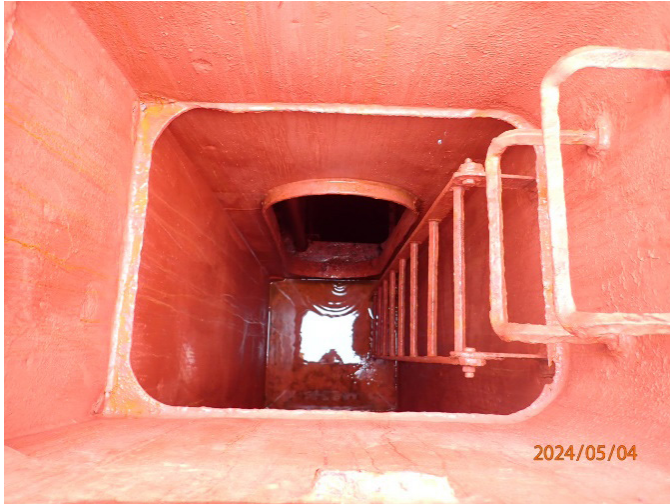
Figure 3: Vertical ladder and manhole leading to the catwalk at the top of Cargo Hold No. 4.

as he climbed down the ladder. The OS2 lost sight of the ASD2 when he stepped through the manhole at the bottom of the ladder on to the catwalk at the top of the cargo hold (see Figure 3). The OS2 remained on deck next to the booby hatch.

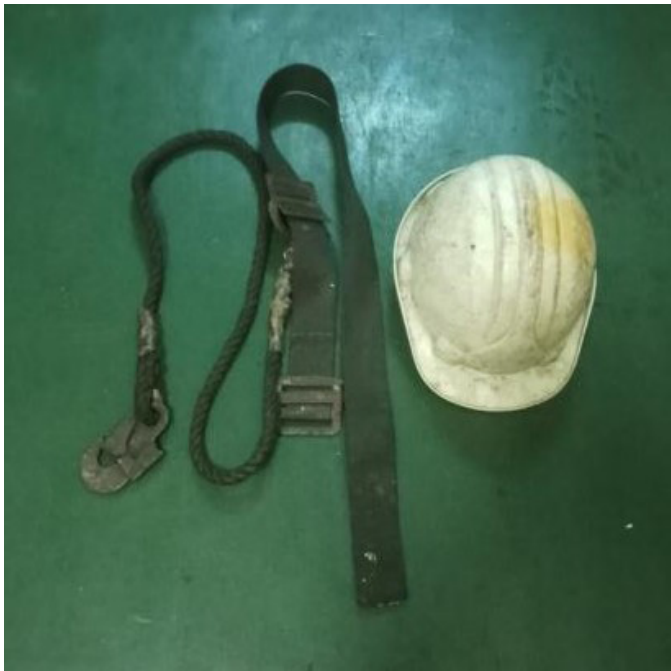
Figure 4: Safety belt with lifeline and safety helmet worn by the ASD2.

The ASD2 was wearing a safety belt with an attached lifeline when he was found lying on the tank top inside of Cargo Hold No. 4. The safety belt and lifeline were both intact and the clip (i.e., carabiner or snap hook) on the lifeline was operational (*see Figure 4*). The ASD2's safety helmet was on the tank top about 1 m away from him.

The ASD2 was wearing a safety belt with an attached lifeline and clip when he was found lying on the tank top inside of Cargo Hold No. 4. Both the safety belt and the lifeline and clip were intact when found (*see Figure 4*). This indicates the ASD2's fall was not due to a failure of either the safety belt or the attached lifeline and clip. It also indicates the lifeline was not connected to a strong point (i.e., guardrail on the platform or a rung on the vertical ladder) immediately before he fell. Why the lifeline was not connected to a strong point cannot be determined.

Seafarers frequently use safety belts and safety harnesses interchangeably to protect against the consequences of a fall from height. This is contrary to recommended best practice, which is to use a safety harness.<sup>15</sup> It is noted that US OSHA has prohibited the use of body belts (i.e., safety belts) for arresting or stopping a fall since 1998 because they may damage the spine and internal organs.<sup>16</sup>

The safety harnesses and safety belts on board ASTERIS were fitted with a single lifeline. The fact that there was only one lifeline made it necessary to disconnect the lifeline when moving it from one strong point to another while aloft. This would have increased the likelihood of falling since the lifeline would have been disconnected for the length of time required to disconnect the clip from one strong point and then reconnect it to another strong point.

It is possible to maintain continuous, positive fall protection by using a safety harness with two lifelines and clips since one lifeline can remain connected to a strong point while the other one was being connected to the next strong point. Continuous, positive fall protection can also be maintained by using a safety harness connected to a portable fall arrester.

- (a) require the use of two lifelines or fall arresters when climbing vertical ladders or while working on elevated platforms that have an open side;
- (b) remove safety belts from the ships in their fleet;
- (c) revise the Company's procedures for working aloft or over the side to address:
  - (i) the Company's expectations for securing lifelines when climbing vertical ladders or while on an elevated platform; and
  - (ii) when it may be necessary or appropriate to use a safety net.

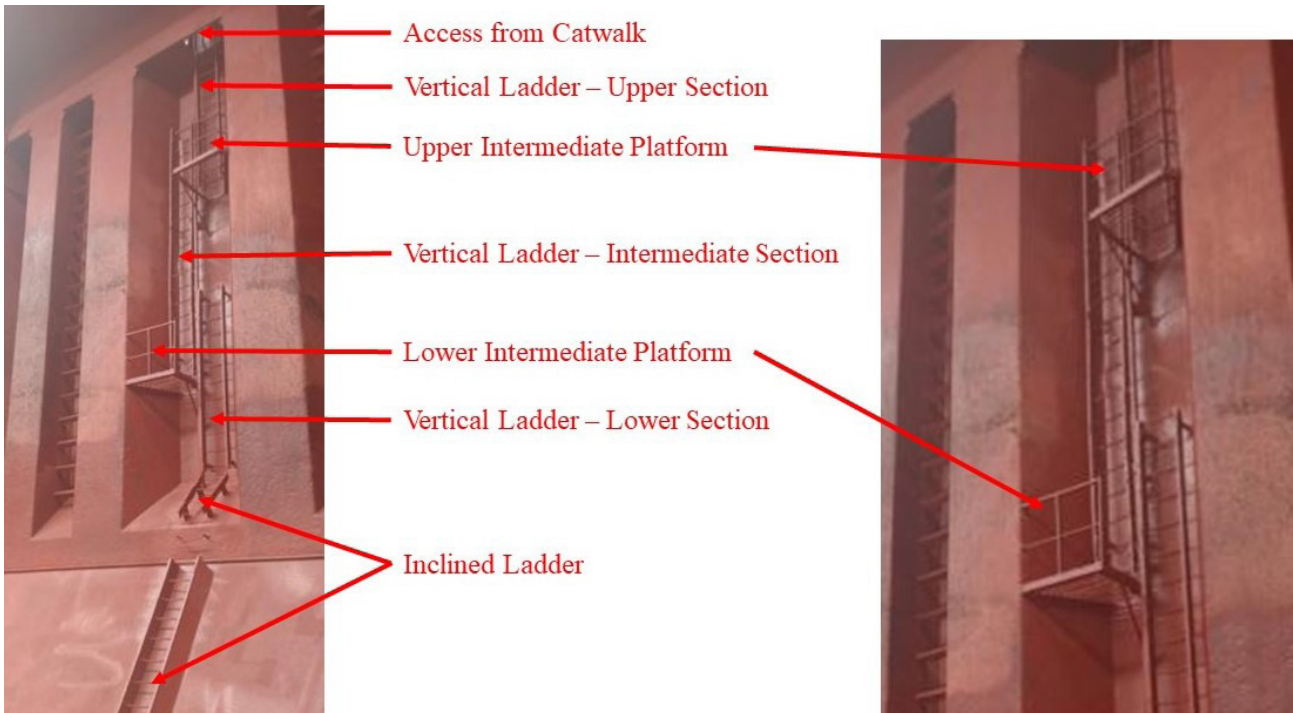
Figure 5: Vertical ladder at the forward end of Cargo Hold No. 4.

The forward access ladder for Cargo Hold No. 4 consisted of three vertical ladders, two intermediate platforms, and a two-piece inclined ladder (*see Figure 5*).<sup>13</sup>

The aft side of the upper and lower intermediate platforms were fitted in the corrugated bulkhead at the forward end of the cargo hold. There was a guardrail along the side of both intermediate platforms that was open to the cargo holds. The side of the platforms that faced the intermediate section of the vertical ladder was not fitted with a guardrail.<sup>14</sup>

The forward access ladder for Cargo Hold No. 4 was found in good condition and free of defects when inspected after the ASD2 fell.
