# REPUBLIC OF THE MARSHALL ISLANDS

### AVIATOR AND ATLANTIC GRACE MARINE SAFETY INVESTIGATION REPORT

#### Collision

Gulf of Kachchh | 26 November 2021

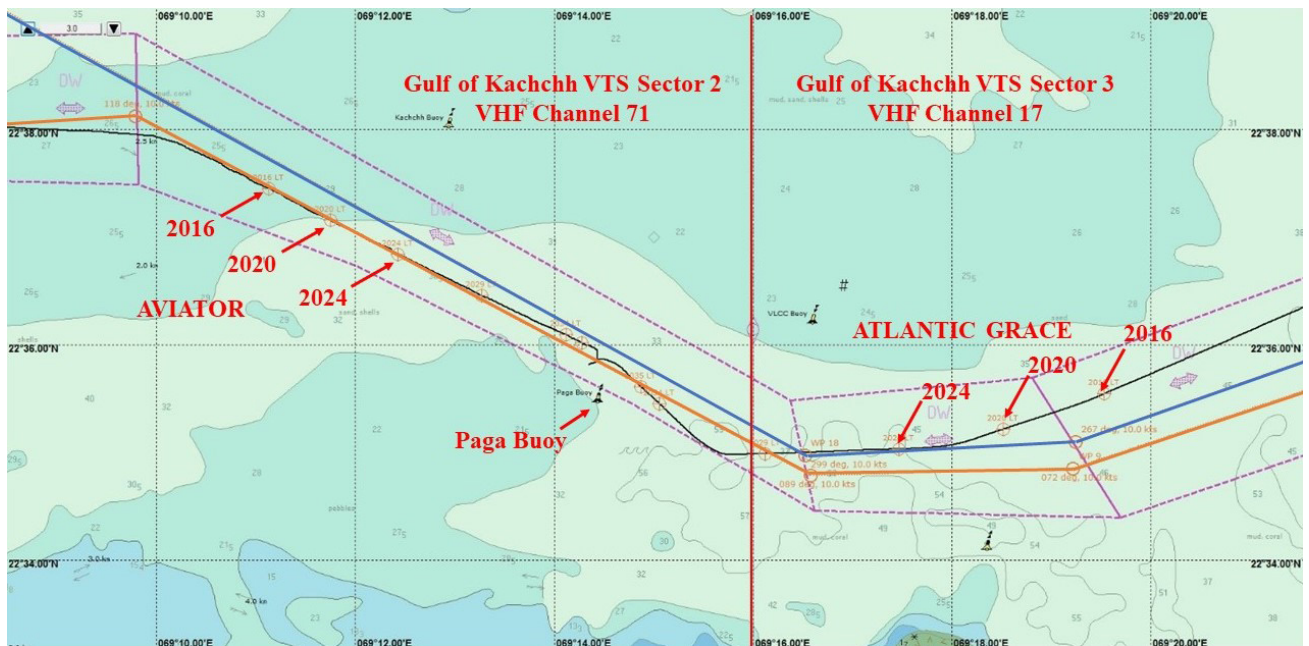
Figure 3: Positions of AVIATOR and ATLANTIC GRACE from 2016–2024 on 26 November 2021. AVIATOR's planned route is shown in orange and ATLANTIC GRACE's planned route is shown in blue. The vertical red lines indicate the boundary between the Gulf of Kachchh VTS Sectors 2 and 3. The ships' actual routes are depicted by the black line.

AVIATOR's Master directed the OOW to monitor ATLANTIC GRACE. The Master also told him that they could pass south of the Paga Buoy (see Figure 3) if necessary to avoid a close quarters situation with ATLANTIC GRACE. The Master then went behind the bridge curtain to use a computer at the back of the Bridge to send departure messages. AVIATOR's OOW stated he monitored ATLANTIC GRACE on radar and ECDIS but did not acquire it on the ARPA. The OOW also stated that he thought, based on ATLANTIC GRACE's radar vector, that it would leave the Deep Water Route and pass south of the Paga Buoy.

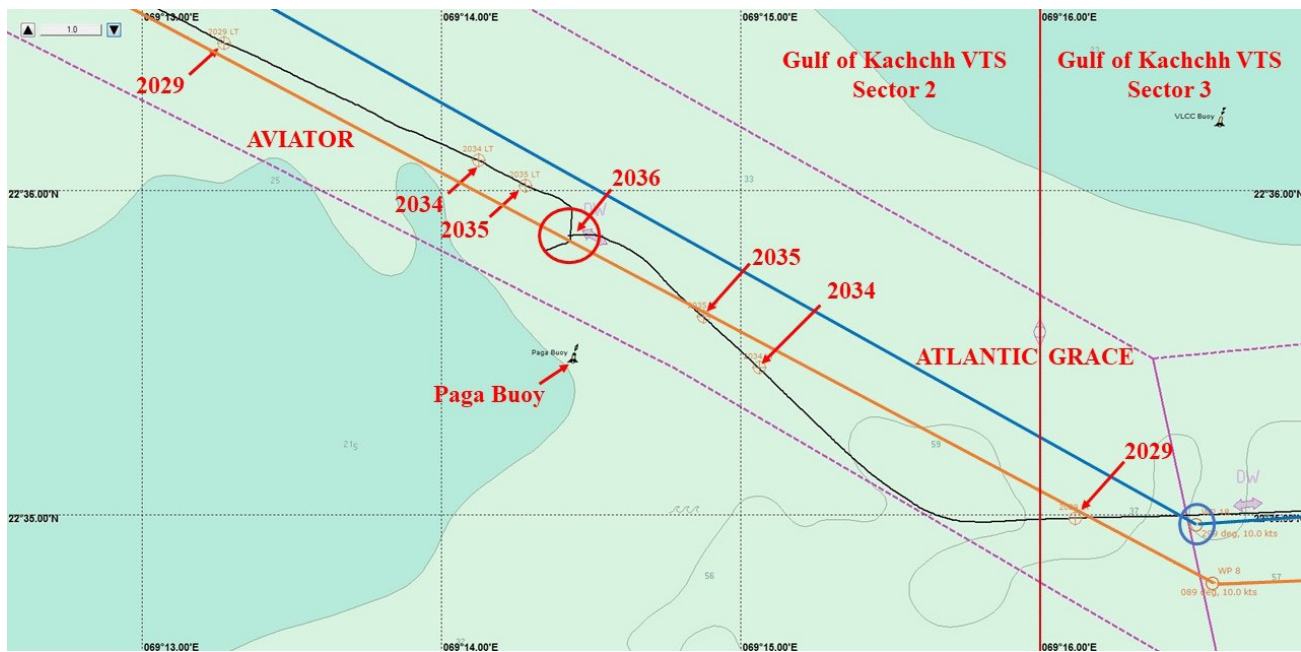
Figure 4: Positions of AVIATOR and ATLANTIC GRACE from 2029–2036 on 26 November 2021. AVIATOR's planned route is shown in orange and ATLANTIC GRACE's planned route and the waypoint where the ship was supposed to turn to course 299° T are shown in blue. The ships' actual routes are depicted by the black line. The location where the ships collided at 2036 is marked by the red circle.

GRACE visually and on radar, directed the Lookout to assume the duties of Helmsman and shift to hand steering. The distance between AVIATOR and ATLANTIC GRACE was approximately 1 NM (see Figure 4).

At 2035, AVIATOR's Master ordered his ship's rudder hard to starboard and ATLANTIC GRACE's OOW ordered his ship's rudder hard to port (see Figure 4). ATLANTIC GRACE's OOW stated he turned to port to prevent his ship from colliding with AVIATOR in way of that ship's Accommodations. ATLANTIC GRACE's OOW then immediately called the Master, who had been working on a computer in the Chart Room at the back of the Bridge since 1945, for assistance. ATLANTIC GRACE's Master promptly went forward. He said that he saw a masthead light off his ship's starboard bow and a second masthead light off the port bow as the OOW told him that there was another ship directly ahead.

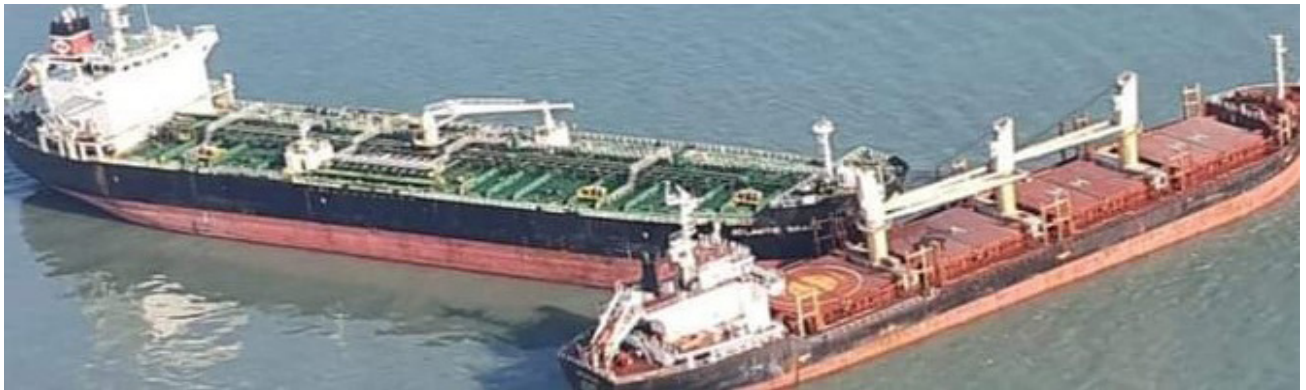
Immediately after the collision, the Master of ATLANTIC GRACE ordered the ship's main engine stopped. The Masters of AVIATOR and ATLANTIC GRACE both directed that their ships' emergency alarms be activated, and the crewmembers mustered. They subsequently directed the crewmembers to assess the damage to their ships, which were entangled with ATLANTIC GRACE's bulbous bow caught inside of AVIATOR's Cargo Hold No. 3 (see Figure 5).

Figure 5: ATLANTIC GRACE (on the left) and AVIATOR (on the right) on 27 November 2021. (Source: India Coast Guard)

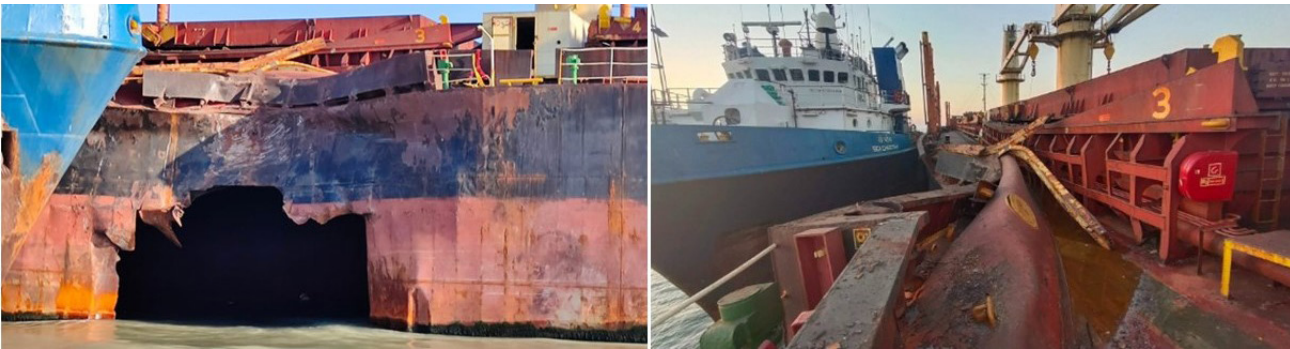
AVIATOR incurred serious structural damage on the ship's port side in way of Cargo Hold No. 3. The damage included the watertight envelope being breached, permitting flooding of Cargo Hold Nos. 3 and 4, and buckling of the main deck (see Figure 6). The ship was determined to be a constructive total loss.

*Figure 6: Damage to AVIATOR's port side shell and main deck.*

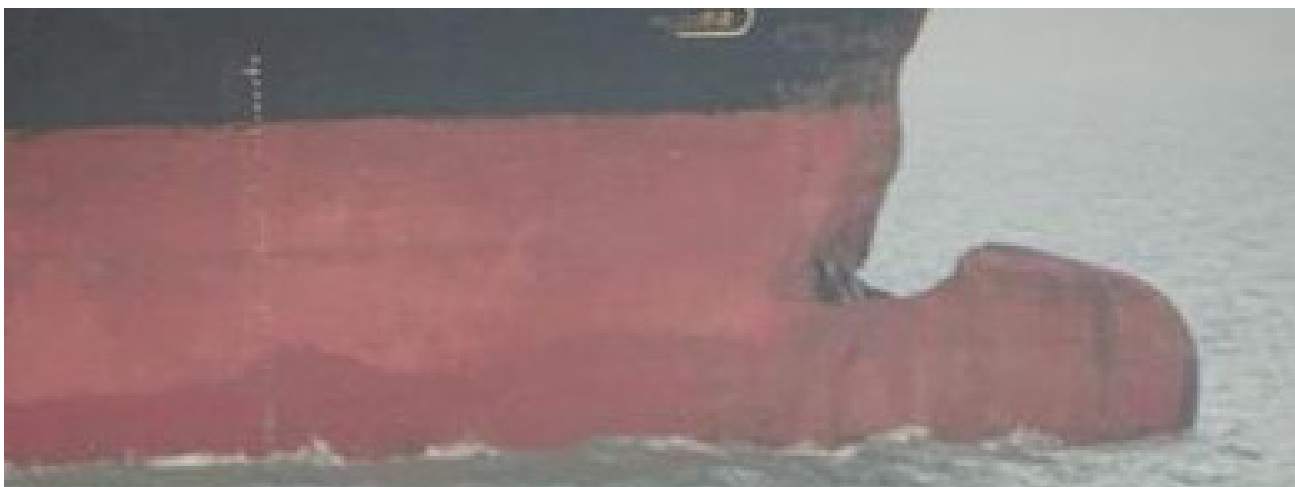
ATLANTIC GRACE suffered significant structural damage forward in way of the stem and bulbous bow (see Figure 7). The ship's hull was breached above the waterline. ATLANTIC GRACE underwent repairs and resumed trading.

Figure 7: ATLANTIC GRACE's starboard side hull forward showing damage to the stem and bulbous bow. (Source: Indian Coast Guard)
