CHEM SINYOO CASUALTY INVESTIGATION REPORT

Fitter Fatal Injury

South China Sea | 21 December 2020

IMO Number: 9248461

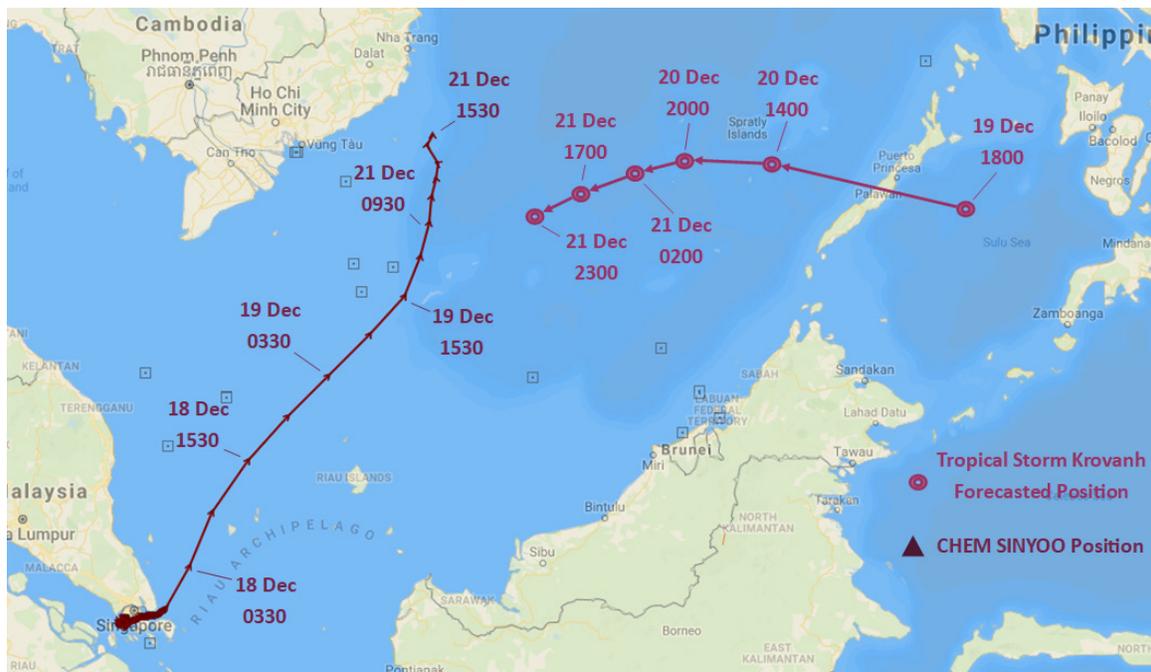
Figure 2: Forecast positions for Tropical Storm Krovanh between 19–21 December 2020.

5. On 18 December 2020, the tropical system was upgraded to a tropical depression and named Krovanh. At about the same time, CHEM SINYOO began experiencing worsening seas while sailing on a north-northeasterly course at an average of about 11.5 knots.
6. CHEM SINYOO received NAVTEX weather reports several times per day between 19–21 December 2020. These reports included the storm’s actual position, anticipated heading and speed, observed weather and sea conditions, and the forecast position after 24 hours (*see Figure 2*). The storm’s actual path closely matched the forecasts received by CHEM SINYOO.

CHEM SINYOO was sailing on a north-northeasterly course in the South China Sea. The tropical system that became Tropical Storm Krovanh was first identified around the time the ship departed from Singapore and therefore was not considered in the voyage plan. Shortly after departure, the Company sent a storm notification to the ship, along with the actions that were required.

The voyage plan was amended to include a course change to the north and a speed reduction in anticipation of adverse sea conditions. These changes were implemented on the evening of 20 December 2020, however, the ship was already experiencing seas of 6 m and winds up to 50 knots. An earlier course deviation or speed reduction, or both, may have increased the distance between the ship and the center of Tropical Storm Krovanh, lessening the exposure to its effects.

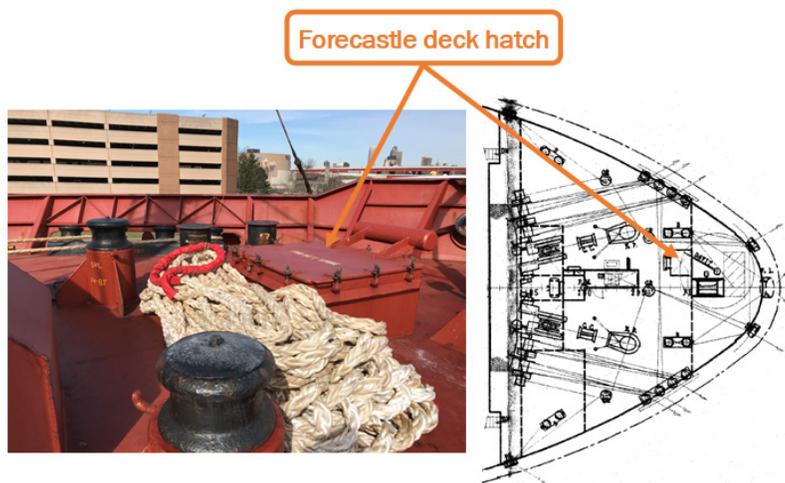
Figure 3: General arrangement and photo of CHEM SINYOO's forecastle, showing the deck hatch to the Bosun's Store.

12. The condition of the hatch or if it was properly secured before being damaged is not known. DNV GL conducted the last load line annual survey on 15 November 2020. No issues with the forecastle deck hatch were noted. Additionally, no damage or defect to the hatch had been reported to the Administrator before the incident.

19. When they got to the forecandle, all crewmembers attached the lifelines of their safety harnesses to strong points on the forecandle.
20. They investigated and found that the forward edge of the deck hatch and coaming had been slightly deformed inward. This created a small gap between the hatch cover gasket and the hatch coaming which was allowing water to flow into the Bosun's Store with each wave that broke over the bow.

When the crewmembers arrived at the forecastle and inspected the hatch, they found the forward coaming edge deformed inwards slightly. This created a small gap between the compression bar of the hatch coaming and the hatch cover packing, allowing water to enter the Bosun's Store.

The condition of the hatch before the heavy weather is not known. Additionally, it is not known if the hatch was properly secured prior to being damaged by the shipping water.

1. A safety alert was sent to all ships in the Company's managed fleet to share the lessons learned from this incident.
2. A safety campaign was carried out to ensure that watertight openings on all ships in the Company's managed fleet are properly sealing and in good condition.
3. The Company has amended its orientation program for joining crewmembers to ensure increased familiarization with the SMS.
4. The Company sent a monsoon advisory to all ships in the Company's managed fleet. The advisory included a checklist for pre-departure preparations when storm conditions are expected.
