CHRIS CASUALTY INVESTIGATION REPORT

Seafarer Lost Overboard

Baltic Sea | 24 May 2018

IMO Number: 9381172

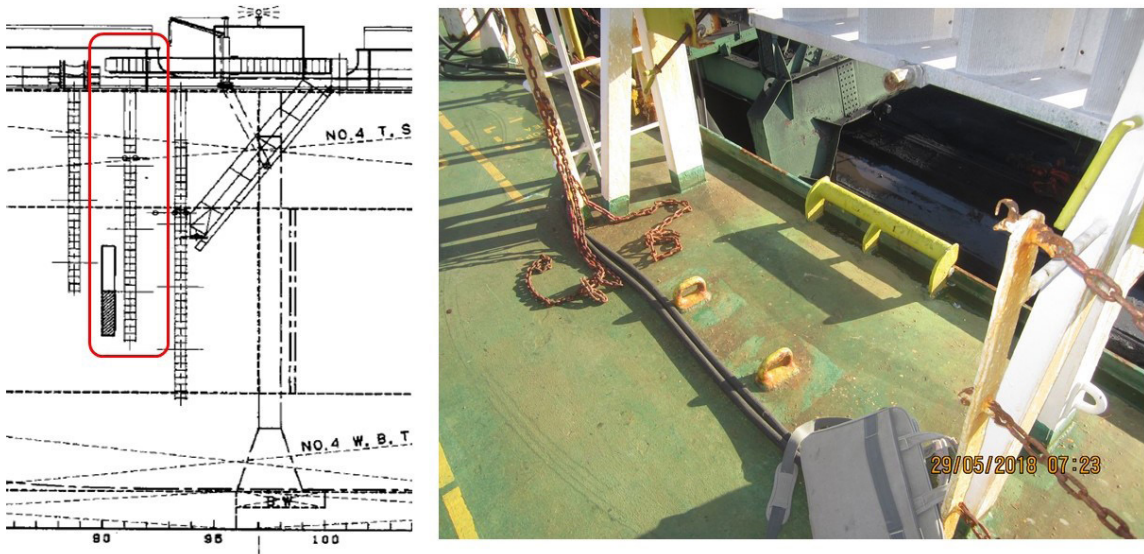
8. The pilot ladder can be rigged at one of three positions (see Figure 1). The after-most position is used when the ship's freeboard at midships is 9 m or less. The two forward positions are used when the freeboard is more than 9 m and rigging a combination pilot ladder is required.⁴ On 24 May 2018, the pilot ladder was rigged in the middle position. Access to the pilot ladder was through an opening in the ship's side rail that could be closed using chains. These chains had to be open when rigging or recovering the pilot ladder.

Figure 1: On the left is a portion of the General Arrangement drawing showing the location of the pilot boarding area on the ship's starboard side. The arrangements on the port side are identical. On 24 May 2018, the pilot ladder was rigged in the middle position, which is circled in red.⁵ On the right is a picture of this position on the port side while looking aft showing the opening in the rail. The picture was taken after the ship arrived at Riga. The chains used to close this opening are open. The two pad eyes on the deck are for securing man-ropes when required by the pilot. The electric cables and bag were not present on 24 May 2018. The accommodation ladder is in the stowed position outboard of the rail.

The Bosun and ASD1 were near the ship's rail opening while recovering the pilot ladder (*see Figure 1*). The beginning of the Bosun's fall overboard was not seen by either of the ASDs who were working with him. Although it cannot be determined with certainty how or why the Bosun fell overboard, possibilities include, that he tripped on one of the two pad eyes welded on the deck (*see Figure 1*) or lost his balance. As discussed below, the Bosun's fall overboard might also be related to the effects of fasting on his physiological functions and cognitive performance.

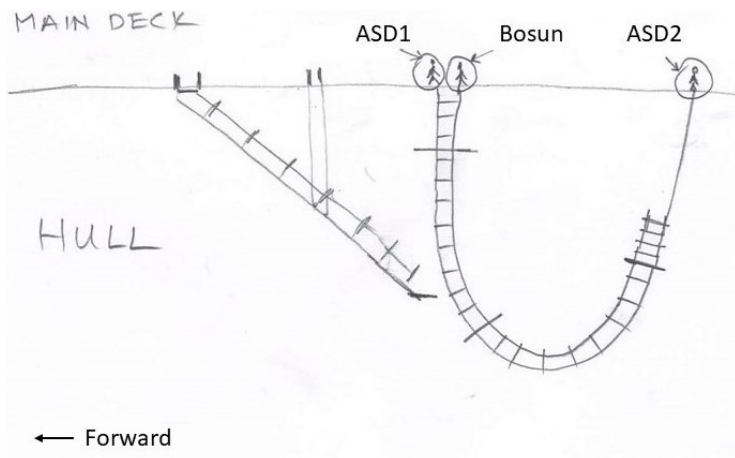
9. The ASD2 descended the accommodation ladder to release the pilot ladder from the accommodation ladder.⁶ After he came back up on deck, the three crewmembers began to recover the pilot ladder. The Bosun and ASD1 were standing in or near the ship's rail opening when heaving on the pilot ladder (see Figures 1 and 2). The ASD2 was standing inboard of the rail while heaving on the line attached to the bottom of the ladder (see Figure 2).

Figure 2: Location of the Bosun, ASD1, and ASD2 while recovering the port side pilot ladder. The ship's rail is not shown.
