DERBY CASUALTY INVESTIGATION REPORT

Fall From Height

Indian Ocean | 13 February 2021

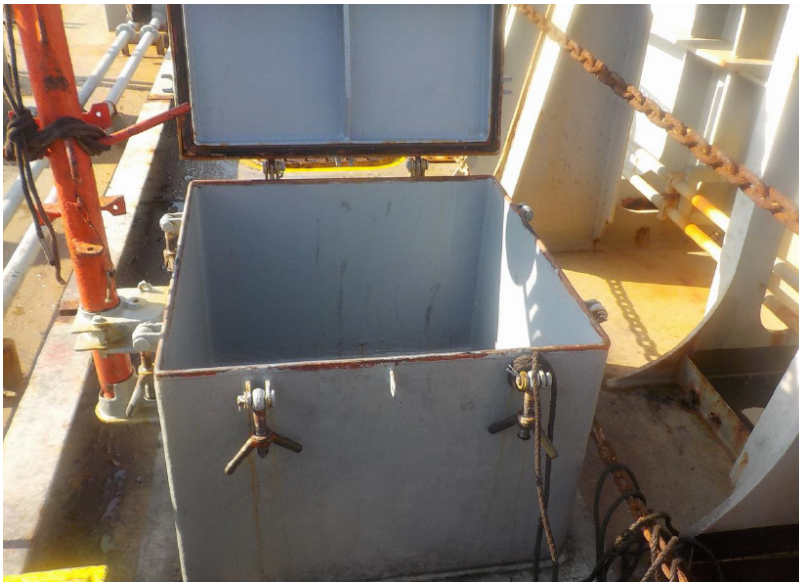
8. The sludge hatch for Cargo Hold No. 3 is located on the main deck at the aft end of the hold, on the ship's centerline. The hatch opening is 82 cm x 82 cm, with a coaming extending 65 cm above the deck (*see Figure 2*).

Figure 2: Sludge hatch of Cargo Hold No. 3.

The sludge hatch for Cargo Hold No. 3 is on the ship's centerline, aft of the hold. The hatch is used to remove cargo residues from the hold, as well as raising and lowering tools. The hatch opening is 82 cm x 82 cm with a 65 cm coaming. The aft side of the coaming has a permanent mounting bracket for the mucking winch.

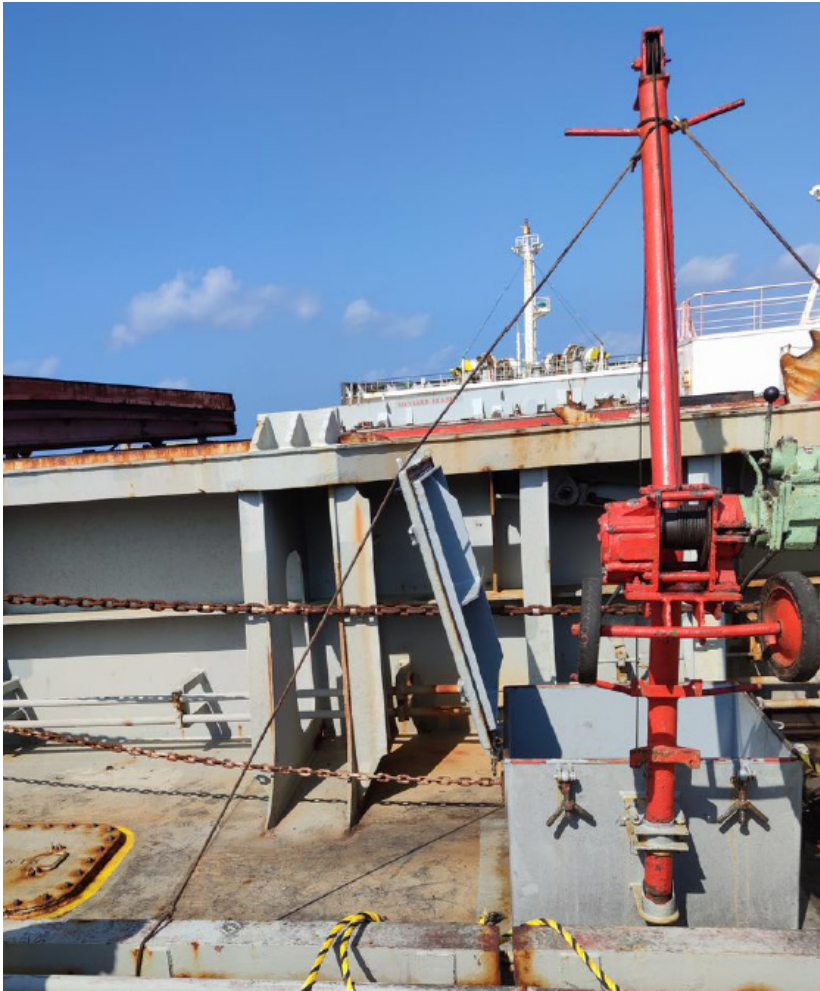
9. The mucking winch is comprised of a portable davit with a pneumatic winch attached (*see Figure 3*). The control for the winch is located directly on top of the winch motor. The mucking winch was secured by metal brackets on the sludge hatch (*see Figure 2*). It is used to lower items into and hoist items out of the cargo hold. The hoisting wire has a swiveling hook. The davit is secured with two stays to keep it stationary over the hatch opening.

Figure 3: Mucking winch mounted over Cargo Hold No. 3 sludge hatch. Photo taken from aft, facing forward.

At the time of the incident, the mucking winch was secured to the hatch's mounting bracket with two stays used to keep the davit stationary over the opening. The mucking winch's hoisting wire had a weighted hook with swivel and safety latch. The hook was suspended over the open sludge hatch when the Bosun was attempting to attach the bucket of tools.

To mitigate the risks associated with holding the full bucket over the open hatch, the Bosun could have requested assistance from another crewmember. The mucking winch could have been rotated from over the opening, attached to the bucket, and then rotated back over the hatch. Alternatively, the hoisting wire could have been payed out so that the hook was attached to the handles while the bucket was on the deck. The bucket could then be guided up and over the hatch coaming before being lowered into the hold.

1. The lessons learned from this incident were shared with all of the ships in the Company's managed fleet.
2. A special safety training was held with DERBY's crewmembers to review the risk assessments associated with working aloft, cargo hold cleaning, and hatch cover operations. The importance of maintaining situational awareness at all times was also discussed.
3. The Company's SMS was updated to include cargo hold cleaning as a high-risk task requiring a Permit to Work. This designation requires conducting a task specific risk assessment that is discussed during the Toolbox Talk.
4. The Company's procedures for cargo hold cleaning were updated to include the requirement for two crewmembers to be present whenever the mucking winches are being used to raise or lower items.

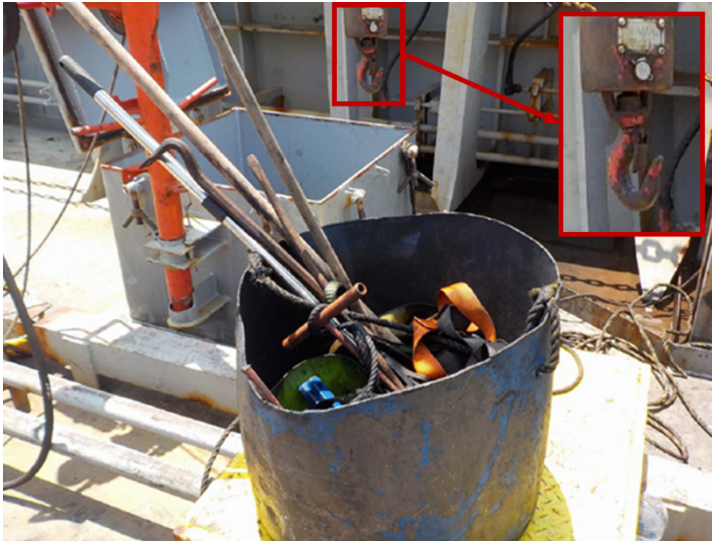
Figure 4: A photo of a bucket of tools aboard DERBY similar to what was being lifted by the Bosun. The mucking winch hook is highlighted in red.

13. At about 0910, the Bosun was holding the bucket of tools over the open sludge hatch and trying to connect it to the hook when the OS1 saw him fall through the hatch. At the time, the OS1 was standing on deck near the hatch to the Australian ladder and assisting the ASD2 with moving a hose. The Bosun and the bucket of tools fell about 18.5 m to the tank top below.

The cause of the Bosun's fall is not known. The area around the hatch was dry and clear of debris. The Bosun may have lost his balance or footing while attempting to attach the bucket onto the mucking winch hook, which was suspended over the open sludge hatch. The Bosun was reported to be 169 cm tall, while the hatch coaming was 65 cm in height. More than half of his body would have been above the coaming, likely creating a pivot point below his waist. His center of gravity likely being above the coaming, along with the weight of the bucket being held away from his body, may have contributed to him falling into the opening.
