REPUBLIC OF THE MARSHALL ISLANDS

DS WISCONSIN CASUALTY INVESTIGATION REPORT

Fatal Fall Overboard

Visakhapatnam, Republic of India | 8 August 2019

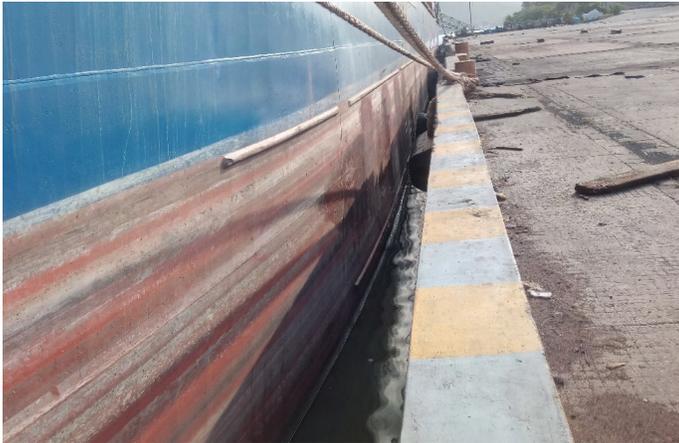
3. On 1 July 2019, DS WISCONSIN was moored at Visakhapatnam, Republic of India and discharging bags of ammonium nitrate from all holds. During the discharge, panels 2-3 and 2-4 of the Cargo Hold No. 2 aft hatch cover were damaged. It was reported this damage occurred during frequent opening and closing of the hatch covers to protect the cargo from the periodic rainfall that was occurring at the time.²
4. On 19 July 2019, DNV GL issued a Condition of Class requiring that the damaged hatch cover panels be repaired and water tightness be verified prior to departure from Visakhapatnam. DS WISCONSIN shifted to a lay berth, where shore-based workers started to repair the damage.
5. DS WISCONSIN was moored port side alongside the lay berth. Fixed fendering was holding the ship about 1.5 meters (m) off the quay (*see Figure 2*).

Figure 2: DS WISCONSIN (looking aft) moored port side to the quay at Visakhapatnam lay berth. This shows the approximate distance of the ship off the quay.

The postmortem examination determined that the ASD1's cause of death was asphyxia due to drowning following a head injury. DS WISCONSIN was only about 1.5 m off the quay when moored at the lay berth. It is likely that the ASD1's fall trajectory caused his head to hit the guard rail and/or concrete quay as he was falling. This would have rendered him unconscious and unable to keep his head above water.

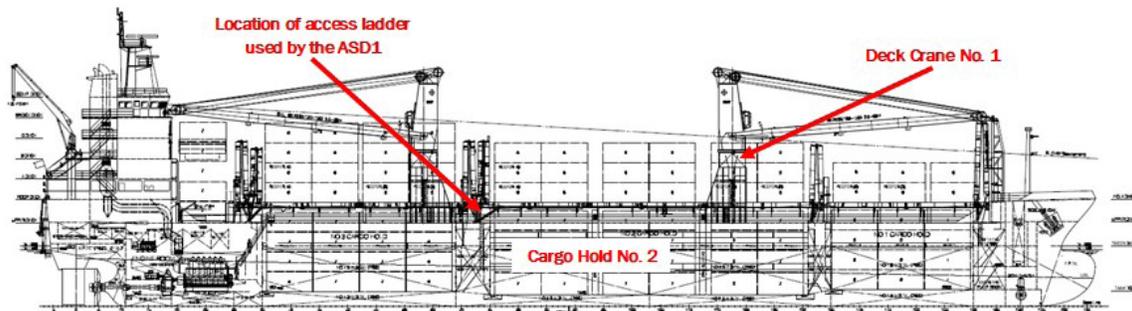
17. The vertical access ladder used by the ASD1 is on the port side, aft end of the Cargo Hold No. 2 hatch coaming. The ladder for Deck Crane No. 1 is accessed from the main deck, forward of Cargo Hold No. 2 (see Figures 1, 3, and 4).

Figure 3: Location of the access ladder that the ASD1 fell from and Deck Crane No. 1. The locations of these are the same on the port side of DS WISCONSIN.

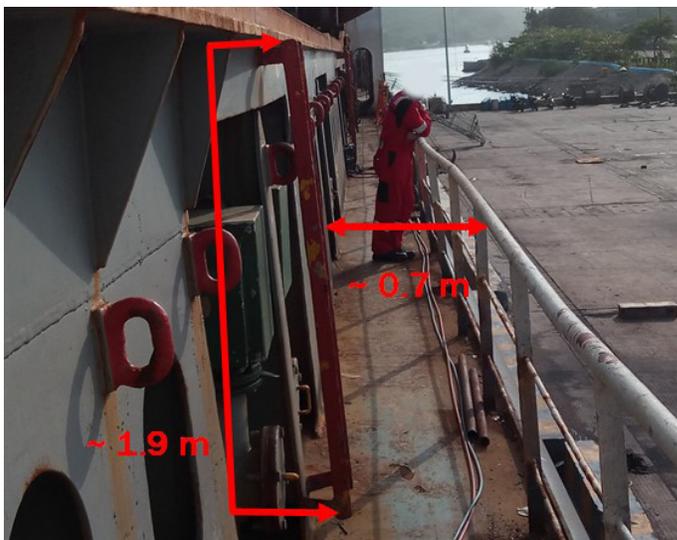
Figure 4: Dimensions of the access ladder.

18. The access ladder is about 1.9 m in height and located about 0.7 m from the guard rail (see Figure 5).
19. The top of the guard rail was about 5.4 m above the water. The access ladder ends below the top of the hatch cover and there are no handrails on the hatch cover top (see Figures 4 and 5).

Additionally, the access ladder terminates below the top of the hatch cover and there are no handrails on the hatch cover top. It is possible that the ASD1 lost his balance while attempting to transition from the hatch cover to the access ladder.

1. It is recommended that the Company review the design and placement of hatch cover access ladders on ships in their managed fleet to assess the risk of going overboard in the event of a fall from the ladder.

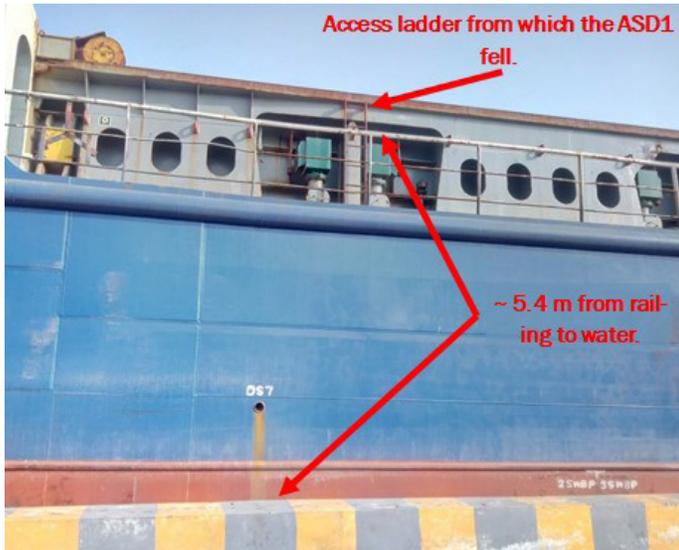
Figure 5: Port side of DS WISCONSIN while moored at the Visakhapatnam lay berth.

The Bosun saw the ASD1 begin to climb down the access ladder and a few moments later saw when he was falling. However, the Bosun did not see the start or cause of the ASD1's fall. Based on the information available to the Administrator, the cause of the ASD1's fall could not be definitively determined. It is possible that he lost his grip or slipped from a rung while on the upper half of the access ladder and fell backwards over the guard rail. Only about 0.7 m separates the rail from the access ladder.

The distance between the access ladder and the guard rail is about 0.7 m, increasing the risk of going overboard if a crewmember falls from the ladder. This is especially true when transferring from the hatch cover onto the ladder, which is well above the height of the guard rail.
