REPUBLIC OF THE MARSHALL ISLANDS

EAUBONNE CASUALTY INVESTIGATION REPORT

Ordinary Seafarer Fatality

South Atlantic Ocean | 25 June 2021

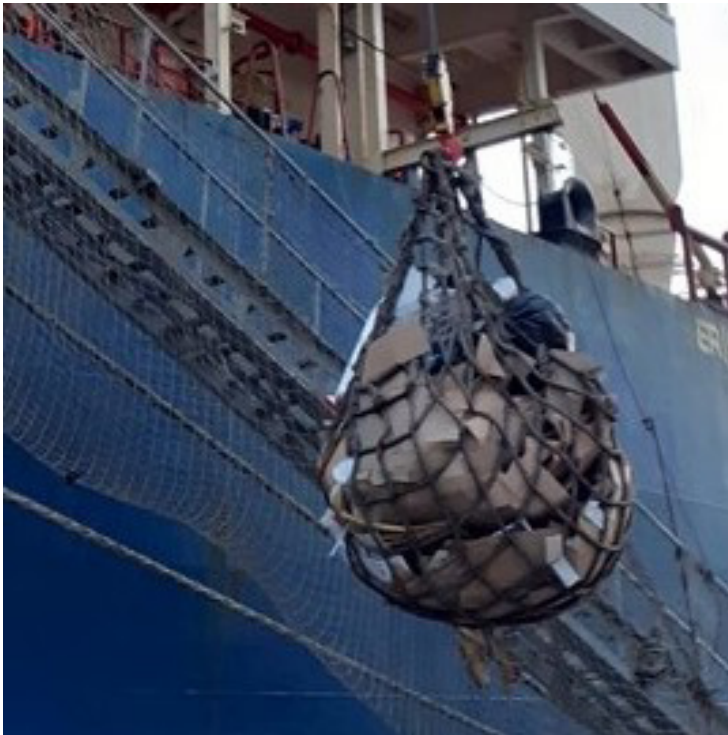
Figure 9: Photo of the garbage in the cargo net at the time of the provision crane's failure.

22. The load of garbage that was being lowered at the time of the incident was estimated to weigh about 200 kgs.
23. The Bosun immediately notified the C/O that the provision crane had failed and that crewmembers were injured.

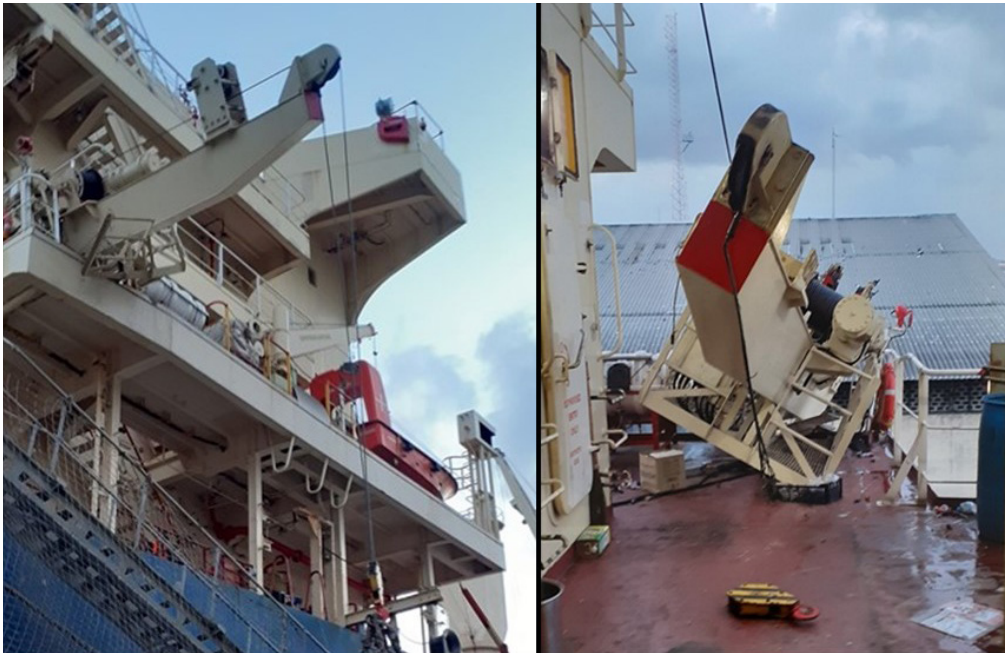
18. The Bosun used the provision crane's controller to hoist the cargo net and then extended it out over the starboard side so that it could be lowered to the quay. The empty cargo net was subsequently hoisted up and the provision crane shifted inboard. This process was successfully completed three times. It is reported that each of these loads weighed about 200 kgs.
19. The starboard accommodation ladder was located below the provision crane and lowered to the quay at the time. This required the provision crane to be fully extended overboard to clear the accommodation ladder.
20. At about 1040, a fourth load of garbage was being lowered to the quay. The provision crane was being extended out over the starboard side when it fell from the fixed monorail to the deck below (*see Figure 10*).

Figure 10: Photos of the provision crane following the incident.

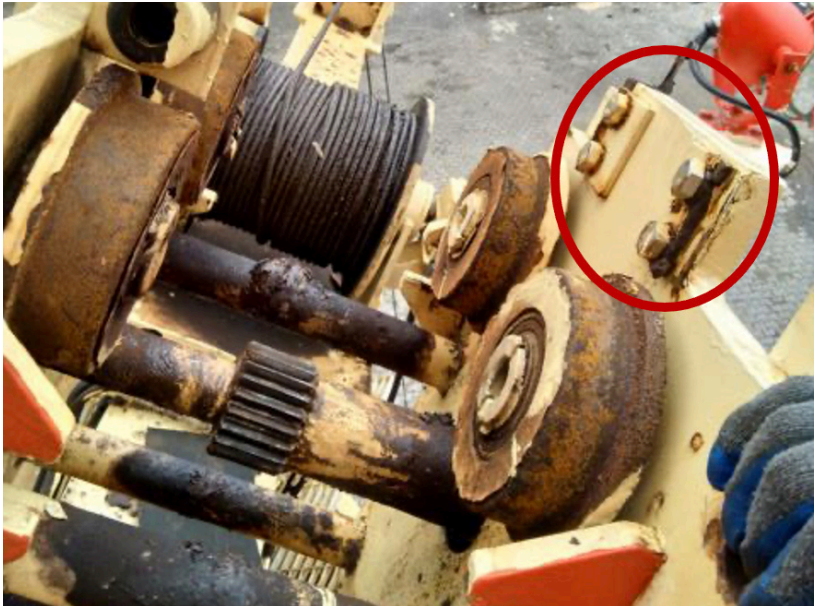
30. When inspected following the incident, all of the provision crane’s rollers were found intact, with no indication of failure (see Figure 11).

Figure 11: Photo of the travelling gear assembly. Note the missing aft stoppers circled in red.

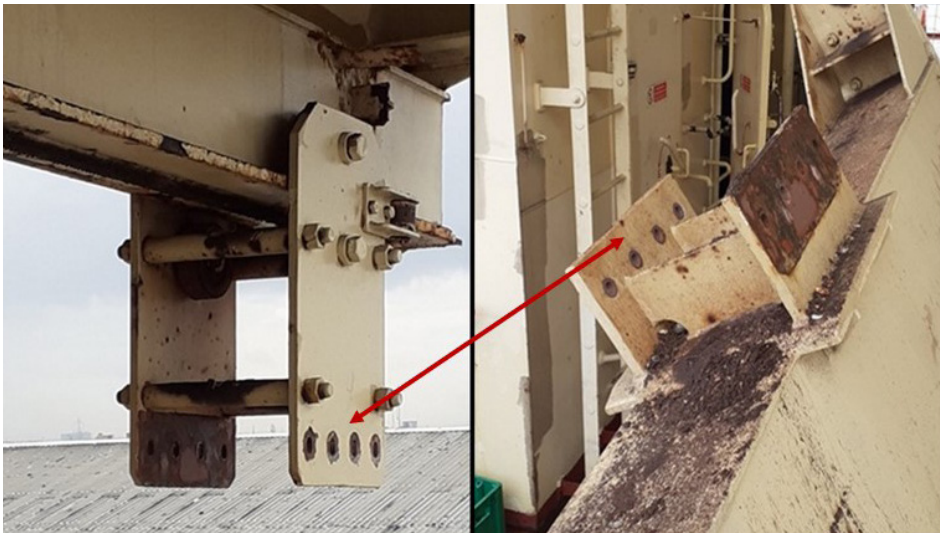
31. The bolts attaching the housing for the inboard set of support rollers were found sheared. The housing and rollers remained attached to the fixed monorail (see Figure 12).

Figure 12: Photos of the inboard support roller assembly.

When the provision crane fell, the inboard set of support rollers (port side of the provision crane) remained attached to the fixed monorail. The bolts holding the bracket for this set of support rollers had been sheared from the bracket on the provision crane. It is likely that the support roller assembly separated from the provision crane as it was falling to the deck. There is no indication that this occurred prior to the outboard side of the crane falling and, therefore, is not considered a causal factor of the incident.

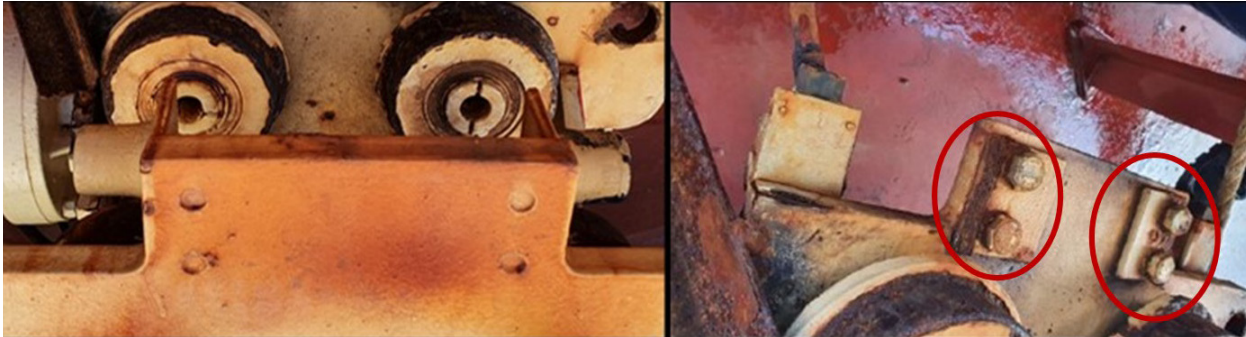
32. It was observed that both stoppers on the aft side of the travelling gear were sheared off, with the mounting bolts intact. One of the broken stoppers was found on deck immediately after the incident. The broken stoppers showed signs of rust and scale. The stoppers on the forward side were intact, with no signs of wear (see Figure 13).

Figure 13: Photos of the travelling gear assembly stoppers, showing the intact forward stoppers (left) and the broken aft stoppers (right and circled in red).

When the provision crane was examined following the incident, both stoppers on the aft side of the travelling gear assembly were found to be broken at their base while the stoppers on the forward side were intact. One of the broken aft stoppers was found on the deck below the provision crane. Both of the limit switches on the travelling gear assembly

- (c) installing stronger stoppers on both ends of the fixed monorail.
4. The provision crane will be added to the ship's cargo gear booklet, resulting in annual inspections by the Classification Society and five-year load testing.

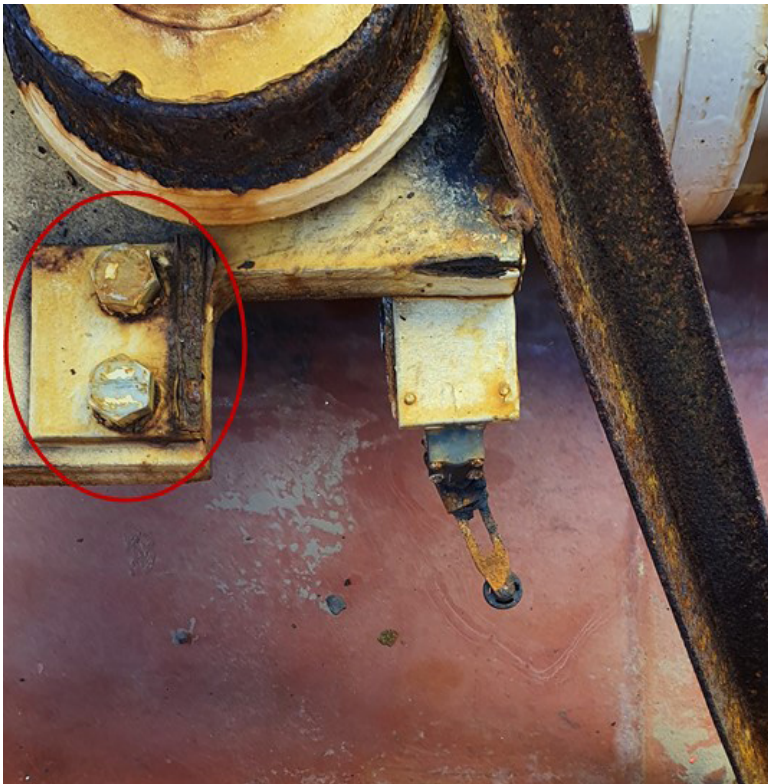
33. Both limit switches installed on the travelling gear assembly were intact and found operational following the incident (see Figure 14).

Figure 14: Photo of the limit switch on the aft, starboard side of the travelling gear assembly. The broken aft, starboard side stopper is circled in red.

- (a) moving the brackets that engage the limit switches so that the motor will be disengaged prior to the stoppers contacting;
 - (b) installing an additional limit switch on each side of the travelling gear assembly as redundancy in the event of the failure of the primary limit switches; and

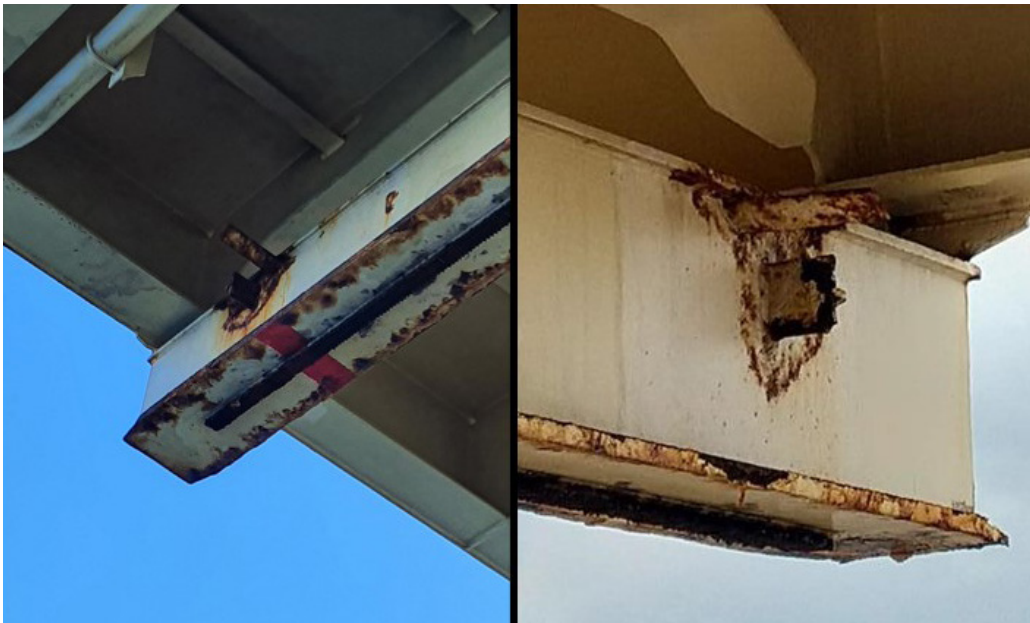
34. Stoppers and brackets for engaging the limit switches on the traveling gear assembly were fitted on both ends of the fixed monorail's aft side. These were found to be intact following the incident (see Figure 15).

Figure 15: Photos of the aft side of the fixed monorail, showing the stoppers and the brackets to engage the limit switches.

The bracket on the fixed monorail which activates the limit switch on the travelling gear assembly was fitted in a position which resulted in the limit switch activating at the same time that the stoppers made contact. This would have subjected the stoppers on the aft side of the provision crane to repetitive stress each time the provision crane was fully extended until limit switch activation.

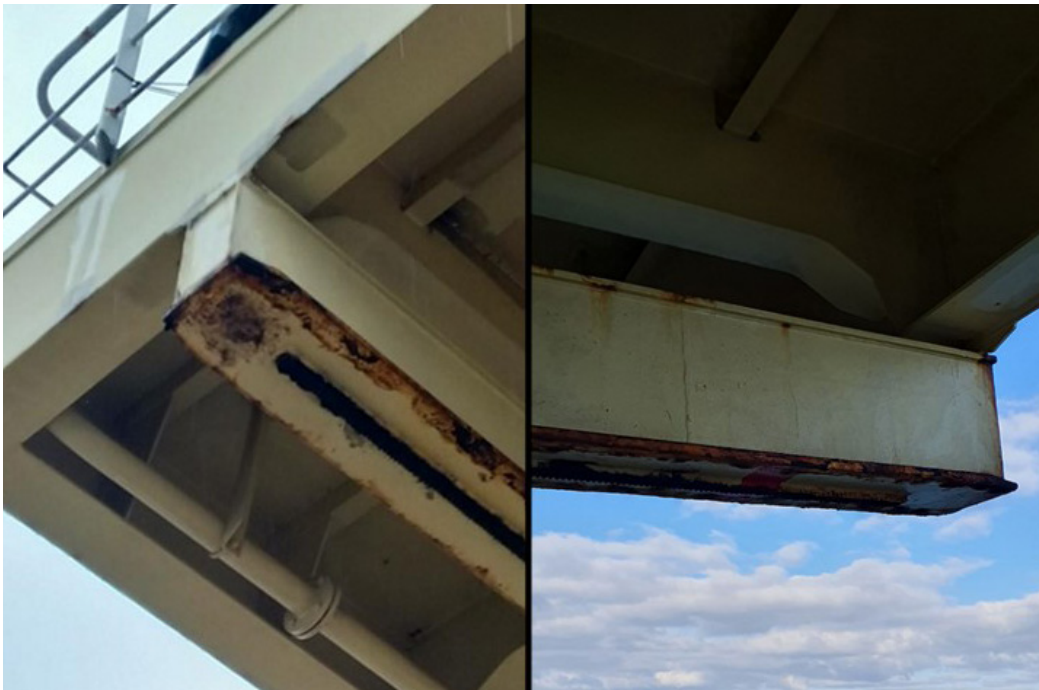
35. Stoppers were not installed on either end of the fixed monorail's forward side, nor was there any indication that they had been installed previously (see Figure 16).

Figure 16: Photos of the forward side of the fixed monorail showing the lack of stoppers.

The design plans for the provision crane specify that stoppers were to be fitted on the forward and aft sides of the travelling gear assembly and fixed monorail. However, when examined after the incident it was noted that stoppers were not fitted on the forward side of either end of the fixed monorail. Additionally, there was no indication that the stoppers had been fitted in the past. The lack of stoppers on the forward side resulted in the entire force of stopping the provision crane being carried by the aft stoppers when the crane was fully extended overboard.

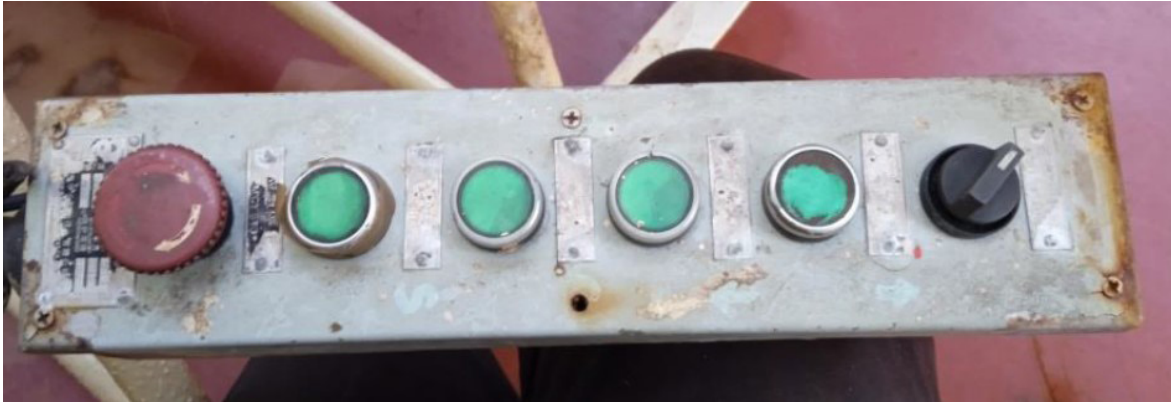
36. Following the incident, the controller was found to be intact and functioning properly (see Figure 17).

Figure 17: Controller for the provision crane.

Additionally, the provision crane controller was examined following the incident and found to be functioning properly. It is also reported that the controller was working properly during the three previous lifts conducted that morning. There is no indication that a defect of the controller contributed to the failure of the provision crane.
