REPUBLIC OF THE MARSHALL ISLANDS

ELANDRA BALTIC CASUALTY INVESTIGATION REPORT

Man Overboard

Port Approaches Fos-sur-Mer, French Republic | 13 April 2020

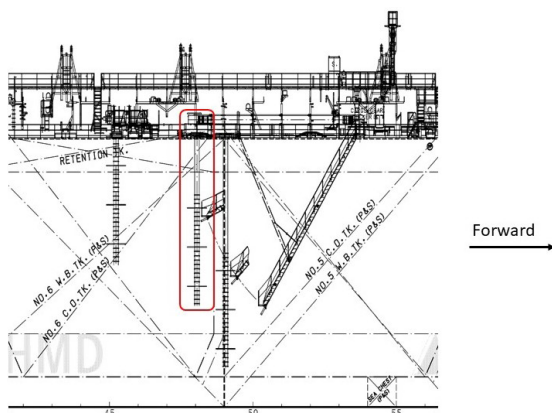
- The pilot ladder can be rigged in one of three positions (see Figure 1). The pilot ladder is located at either of the two forward positions when a combination pilot ladder is rigged. On 13 April 2020, the pilot ladder was rigged in the middle position. Access to this location was through an opening in the ship’s guardrail that could be closed using chains. The guardrail had to be open when rigging or recovering both the accommodation and pilot ladders.

Figure 1: A portion of the ship’s General Arrangement drawing showing the location of the pilot boarding area on the starboard side. The arrangements on the port side are identical. The position where the pilot ladder was rigged on 13 April 2021 is circled in red.

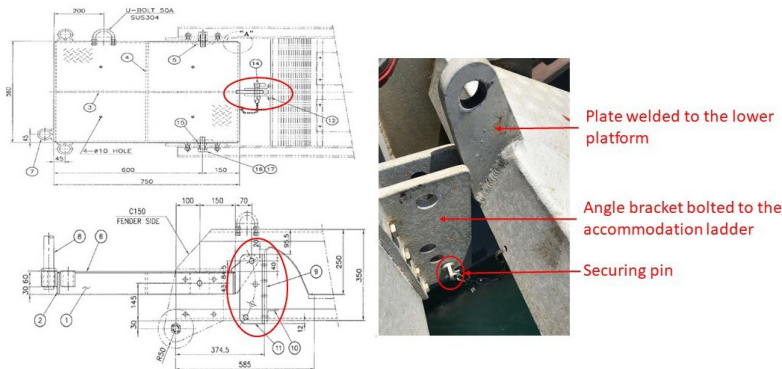
10. The Bosun reported that they decided, after rigging the pilot ladder, that the lower platform of the accommodation ladder needed adjusting to be parallel with the water. The ASD2 then went down the accommodation ladder without putting back on his lifejacket and safety harness.
11. The lower platform is held in position by a securing pin that passes through one of four sets of holes in the angle bracket, which is bolted to the accommodation ladder, and a hole in the rectangular bar welded to the lower platform (see Figure 2). The angle of the lower platform is determined by which set of holes on the angle bracket that the securing pin is passed through.

Figure 2: On the left is a drawing of the lower platform of the accommodation ladder showing the angle bracket and plate (circled in red). On the right is a picture of the angle bracket, plate, and securing pin. The lower platform was not secured in position when the picture was taken.

The platform would not have dropped if the securing pin had been passed through the set of holes in the angle bracket on the accommodation ladder and the hole in the bar welded to the platform (*see Figures 2 and 3*).

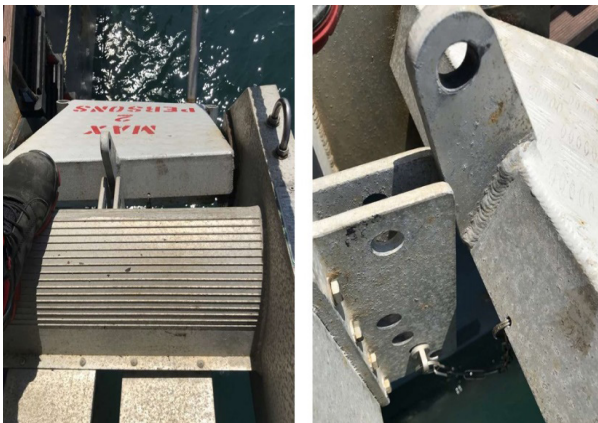
25. When the lower platform was checked by a crewmember before being secured so the pilot could board, the securing pin was found through one of the four sets of holes in the angle bracket. It did not pass through the hole in the bar welded to the lower platform (see Figure 3).

Figure 3: The lower platform of the accommodation shown as found after the ASD2 fell overboard. These pictures were taken while the ship was at anchor after the SAR operation was suspended. The securing pin had not been passed through the hole on the bar welded to the platform when it was put through the holes on the angle bracket.

The Bosun stated that the ASD2 fell overboard when the lower platform of the accommodation ladder dropped as he stood up after changing its position. After the incident, the platform was checked and it was determined that it had not been properly secured (*see Figure 3*) when adjusted by the ASD2.
