REPUBLIC OF THE MARSHALL ISLANDS

ERGUVAN S MARINE SAFETY INVESTIGATION REPORT

Occupational Fatality

Outside Port Limits Anchorage Altamira, United Mexican States | 3 May 2023

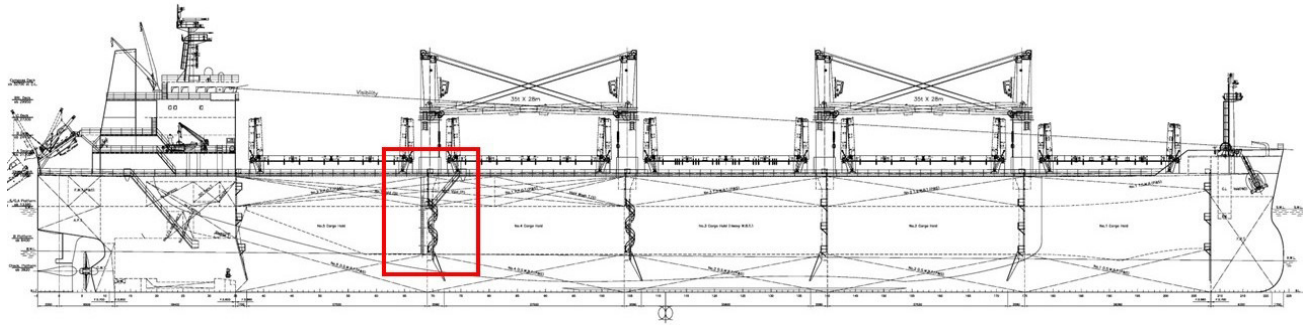
Figure 1: ERGUVAN S General Arrangement. The location of the pilot boarding area is shown in the red square.
