### HAFNIA ADAMITE SAFETY INVESTIGATION REPORT

Fatality During Enclosed Space Entry

Mediterranean Sea | 18 July 2022

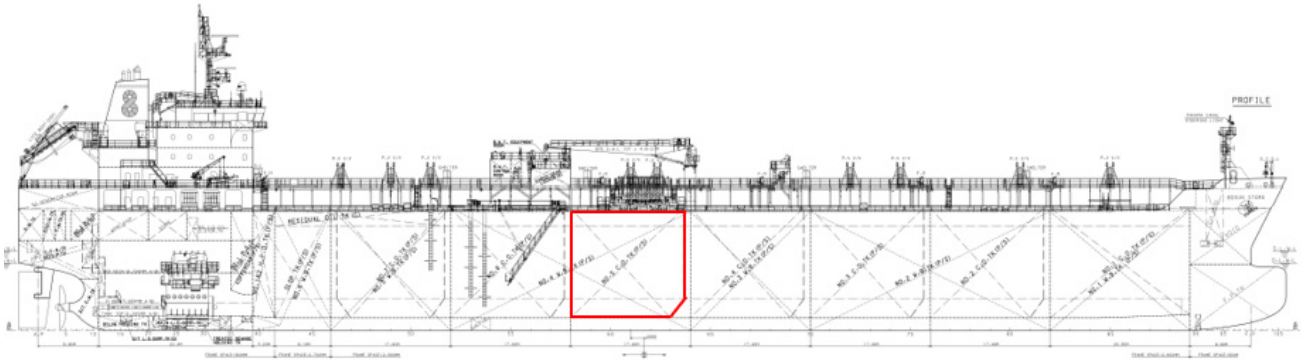
COT No. 5S is one of 14 designated cargo tanks on board HAFNIA ADAMITE and positioned midships, on the starboard side of the ship (*see Figure 1*).

Figure 1: HAFNIA ADAMITE General Arrangement plan. COT No. 5S tank outlined in red.

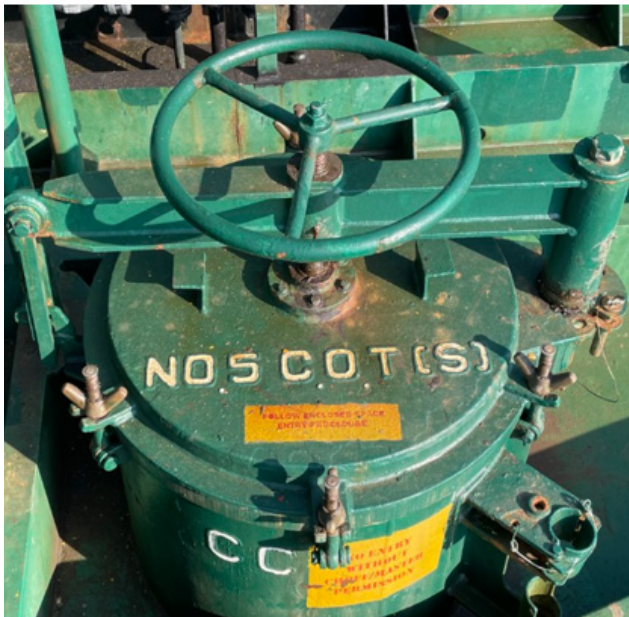
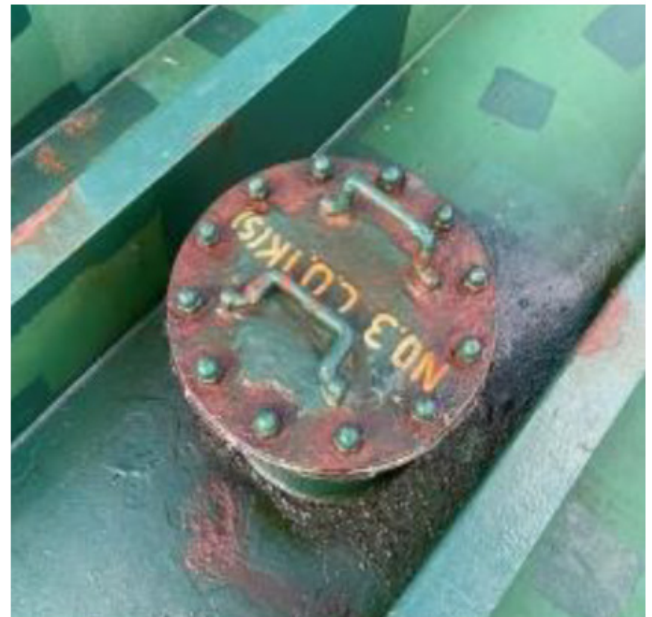
Each cargo tank is equipped with one Butterworth hatch and one hatch cover for service access (see Figure 2). The service access hatch is the only entry and egress point for the tank. The tank access hatch cover was closed prior to the casualty.

Figure 2: Tank access hatch cover (left) and Butterworth hatch cover (right) in closed condition.

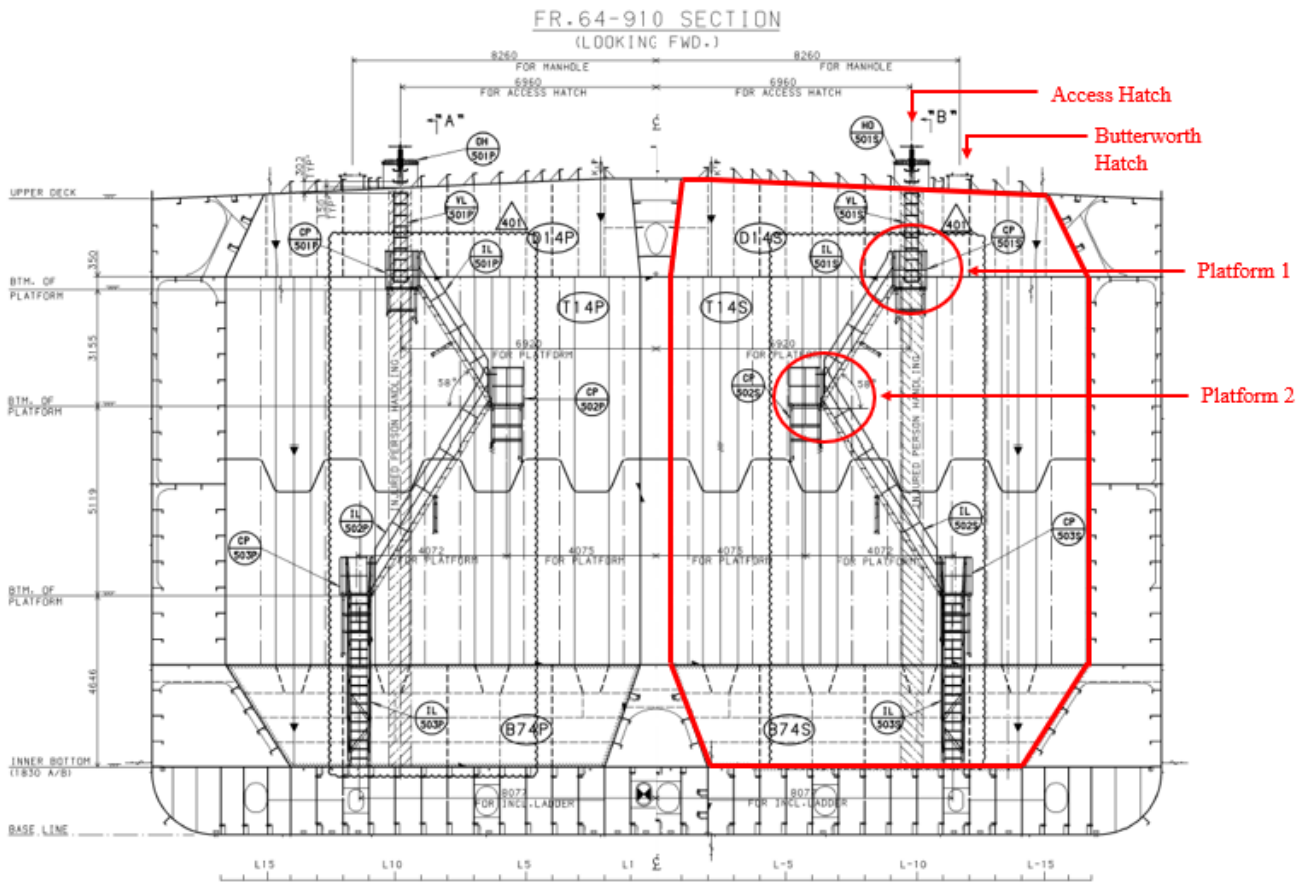
A vertical ladder approximately 3.5 m in length is situated immediately beneath the tank access hatch cover, leading to a horizontal steel platform (Platform 1). An inclined ladder, approximately 3 m in length leads from Platform 1 to a second, horizontal platform (Platform 2) (see Figure 3). The tank depth in total is approximately 17 m.

Figure 3: Access, ladder, and platform arrangement to COT No. 5S.

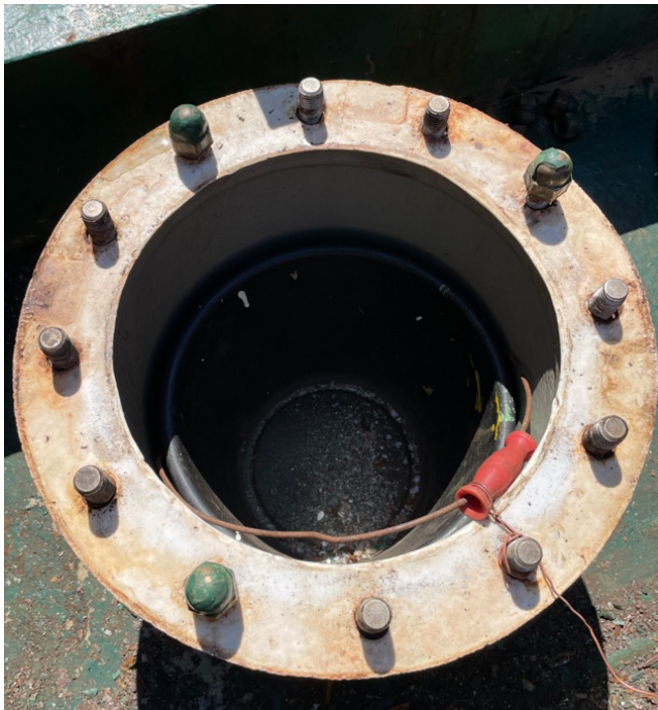
At approximately 0720, the plastic bucket used to contain the rust particles from entering COT No. 5S during the removal of rust (see Figure 4), fell into COT No. 5S and rested on the tank floor. The Bosun attempted to retrieve the plastic bucket using a rope with a hook tied on the end.

Figure 4: COT No. 5S Butterworth hatch with plastic bucket located inside and secured to threaded bolt with a wire.

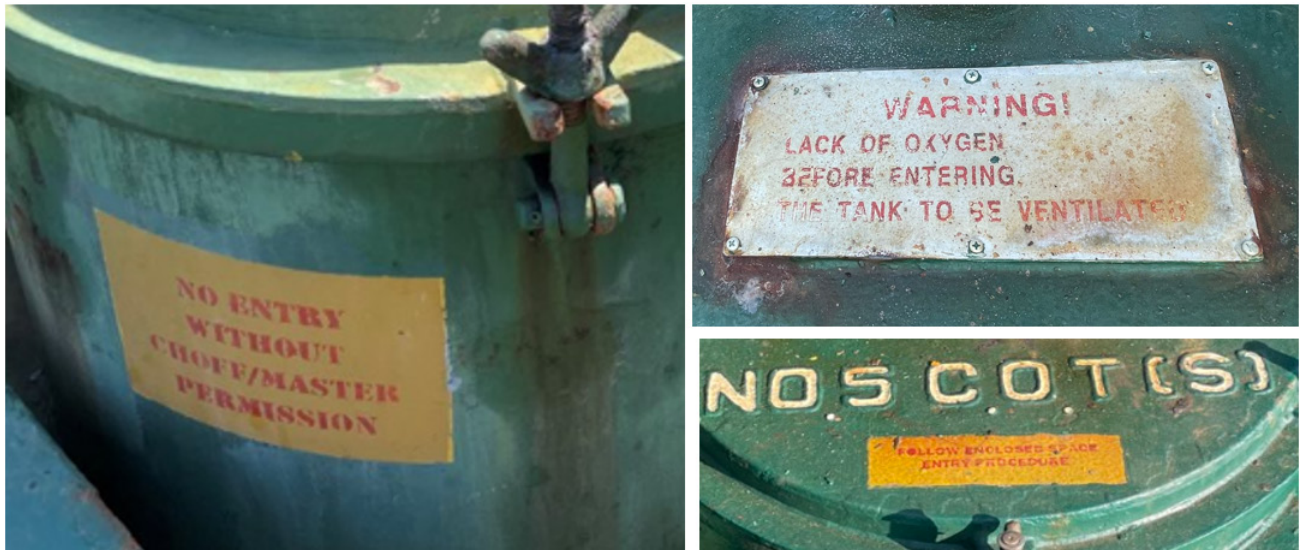
Figure 5: Warning signs located at the entrance to the access hatch to COT No. 5S.

The Bosun entered COT No. 5S disregarding the visual warnings, without the required PPE, without an enclosed space entry permit in place, and without permission from the C/O or Master. The Bosun conducted an unsafe act when entering COT No. 5S by not complying with Company procedure for an enclosed space entry.
