### HALLAM CASUALTY INVESTIGATION REPORT

Enclosed Space Entry with Fatalities

Onne, Nigeria | 13 August 2018

IMO Number: 9351749

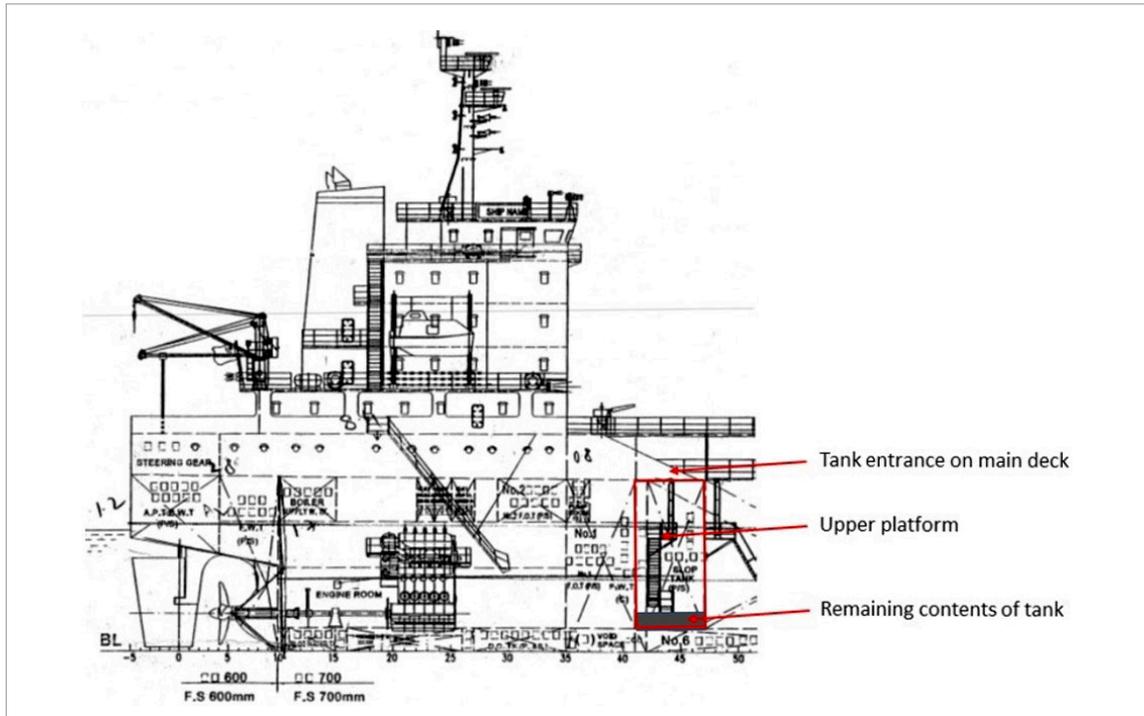
Figure 1: The slop tank is outlined in red.
