### HOUSTON CASUALTY INVESTIGATION REPORT

#### Fall From Height

North Atlantic Ocean | 10 November 2021

Official Number: 3656

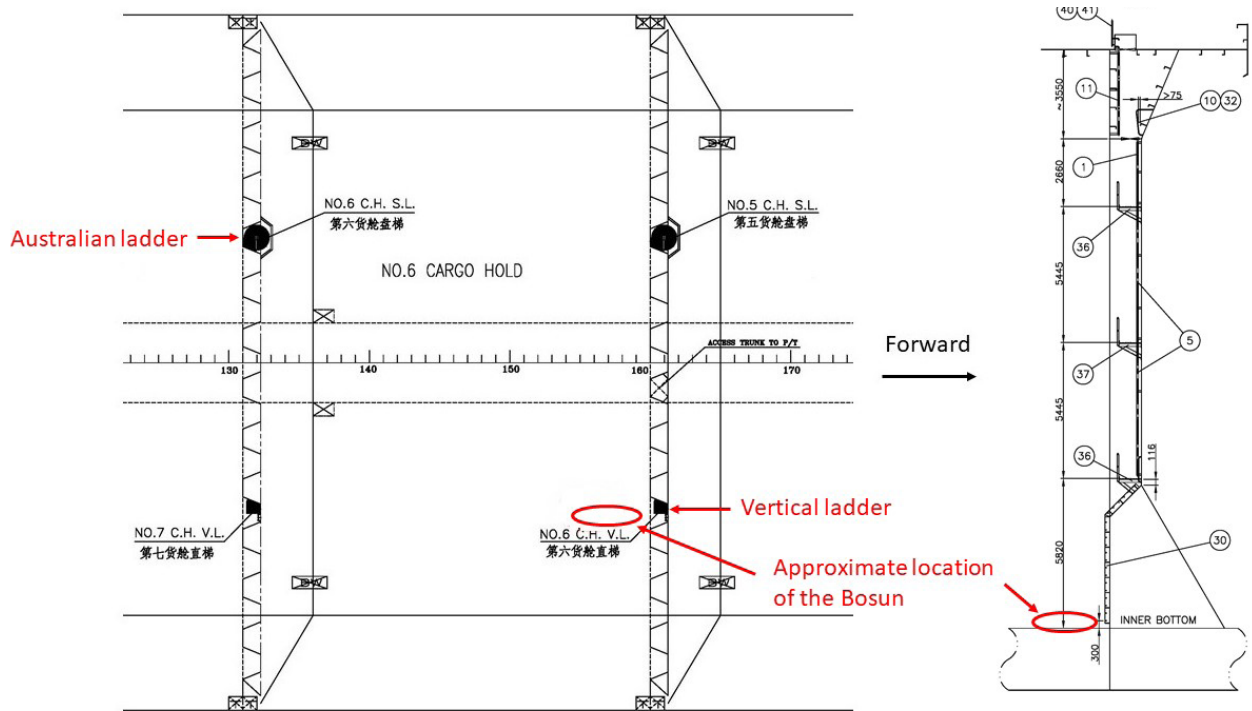
Figure 2: The approximate location where the Bosun was seen lying on the tank top in Cargo Hold No. 6 near the bottom of the vertical ladder (a sectional view is on the left and a profile view is on the right).

Although the Bosun was not seen entering the access hatch for the vertical ladder, he was found lying on the tank top in Cargo Hold No. 6 near the base of the ladder (*see Figure 2*). He had not been seen climbing on the hold coaming or hatch cover from the time he and the OSs reached Cargo Hold No. 6 until he was seen lying on the tank top inside the hold. This suggests he most likely fell either while climbing down the vertical ladder or while stepping from one of the platforms when transitioning between sections (*see Figure 3*).

It is also not known from how high he fell. Given that both of his legs appeared broken near the ankles and that bones were protruding through the bottoms of both feet near the heel suggests he landed on his feet with significant force.

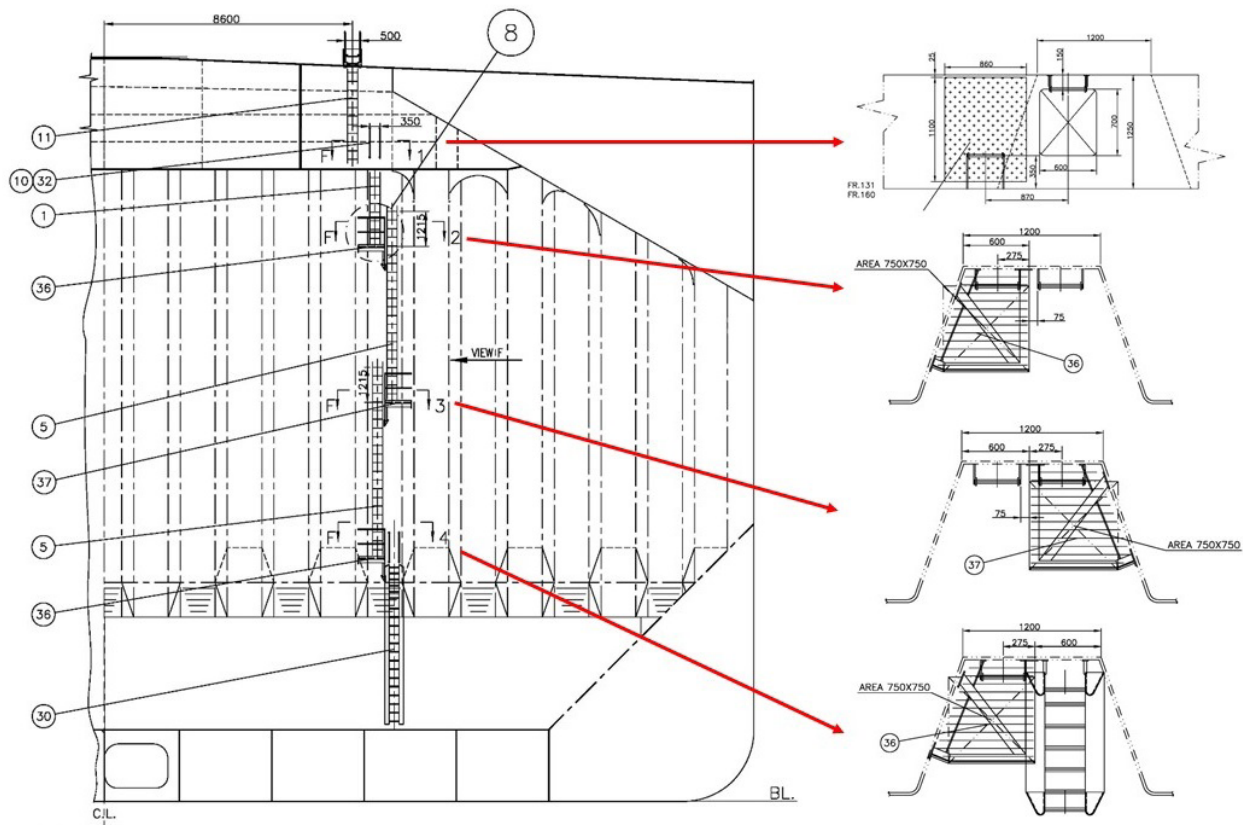
Figure 3: Drawing of the vertical ladder in Cargo Hold No. 6 (left) with plan view of the access from the upper stool and each of the three platforms (right). The side of the platform next to the ladder was open.

It is not known why the Bosun fell. There is no indication that the vertical ladder had been damaged after the 30 October 2020 survey of Cargo Hold No. 6. This indicates that the fall was not due to a structural defect. Possible explanations for why the Bosun fell include that one of his feet slipped and he was unable to hold onto the ladder. It is also possible that he lost his grip on the ladder while connecting or disconnecting the clip on the safety line to a strong point.

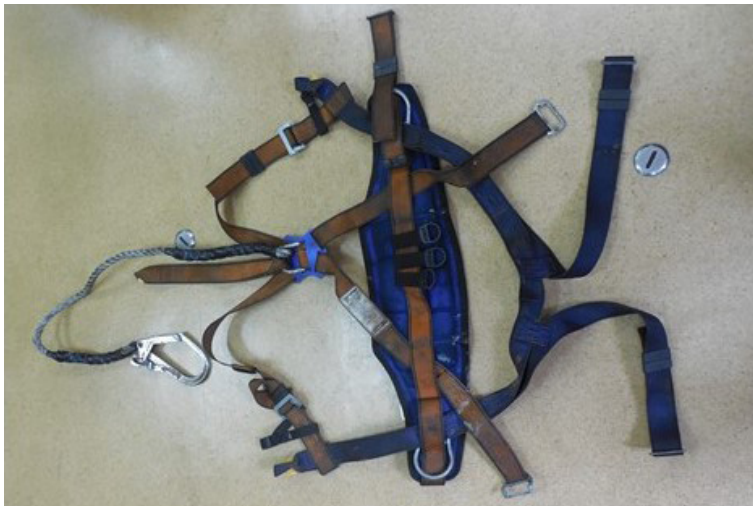
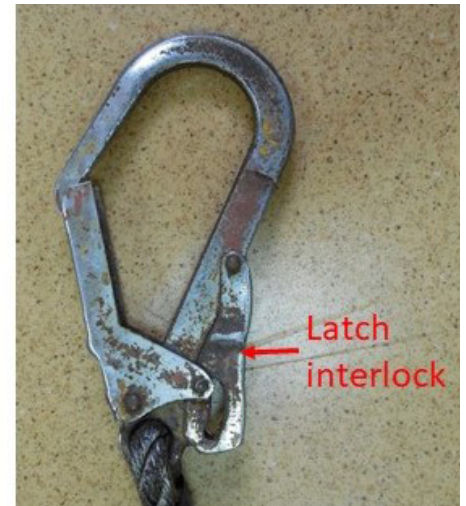
37. The safety harnesses worn by the Bosun and the deck ratings while cleaning the cargo holds had a single lifeline with clip (*see Figure 4*). When inspected, the harness and lifeline were found in serviceable condition. The latch interlock was stiff when pressed.<sup>6</sup>

*Figure 4: The safety harness worn by the Bosun when entering Cargo Hold No. 6 on 10 November 2020 (left) and the clip on the lifeline (right). The surface corrosion was in areas where the plating was missing.*

The Bosun was wearing a safety harness with a lifeline when he fell. There were no indications that the safety harness, lifeline, or clip had failed. Based on this and the observed injuries, it can be determined that the clip on the safety line on his safety harness was not secured to a strong point when he fell.

The safety harnesses worn by the Bosun and deck ratings had a single lifeline and clip. Although the interlock was stiff, it was possible to open the clip with one hand. Therefore, it would have been possible for the Bosun to maintain three points of contact when moving the clip between strong points. The fact that there was only one lifeline made it necessary to disconnect the clip when moving it from one strong point to another when climbing on a ladder. This would have increased the likelihood of falling since it would have been necessary to repeatedly disconnect and move the clip between strong points while climbing down the ladder.

1. It is recommended that the Company consider using safety harnesses with fall arrestors on board ships in their managed fleet.
