REPUBLIC OF THE MARSHALL ISLANDS

KG ASIA CASUALTY INVESTIGATION REPORT

Enclosed Space Fatality

Boryeong, Republic of Korea | 6 January 2020

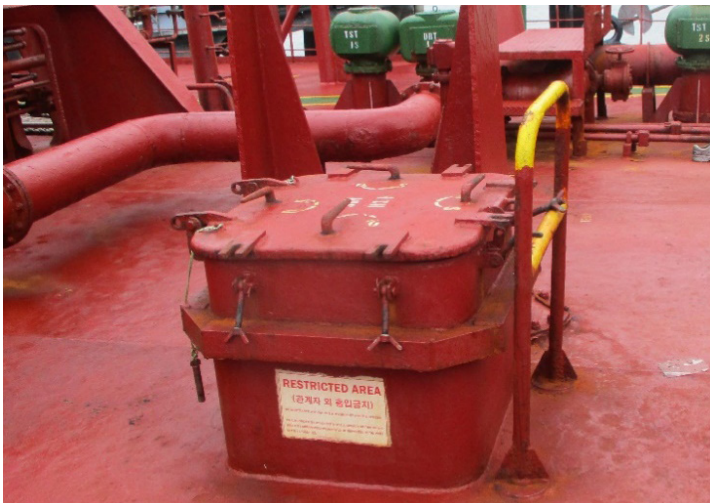
Figure 2: Access hatch to the aft ladder for Cargo Hold No. 1.

20. The aft access for Cargo Hold No. 1 leads to an Australian ladder and is located on the starboard side between Cargo Holds Nos. 1 and 2. This access hatch is 700 cm x 700 cm with a hinged cover (see Figure 2). Each cargo hold access hatch on board KG ASIA is marked with a warning prohibiting access without permission from a ship's officer.

1. Locking devices were fitted to the access hatches for all cargo holds, and other enclosed spaces on board KG ASIA.
2. The Company's SMS was updated to include the requirement to permanently post signs at the entrance to enclosed spaces to warn crewmembers of the risk of asphyxiation if entered without taking proper precautions.

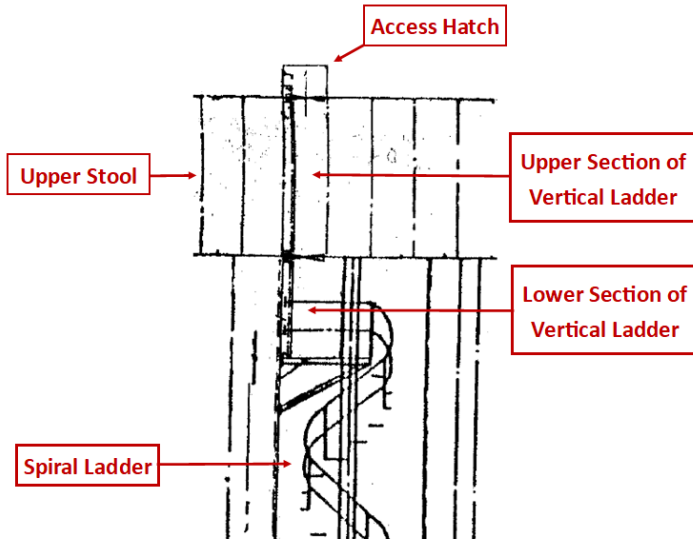
Figure 3: Diagram of the Cargo Hold No. 1 aft access ladder.

21. The access ladder consists of a vertical section which extends from the access hatch on the main deck down to a platform at the top of the spiral section (see Figure 3).

22. The upper 2.90 m of the vertical ladder runs through the upper stool space in an enclosed trunk, while the lower 1.86 m is open to the cargo hold. The platform provides access between the vertical and spiral sections of the ladder.
23. At the time of the incident, the lower portion of the vertical ladder, as well as the platform at the top of the spiral section, were covered by the coal (see Figure 4).

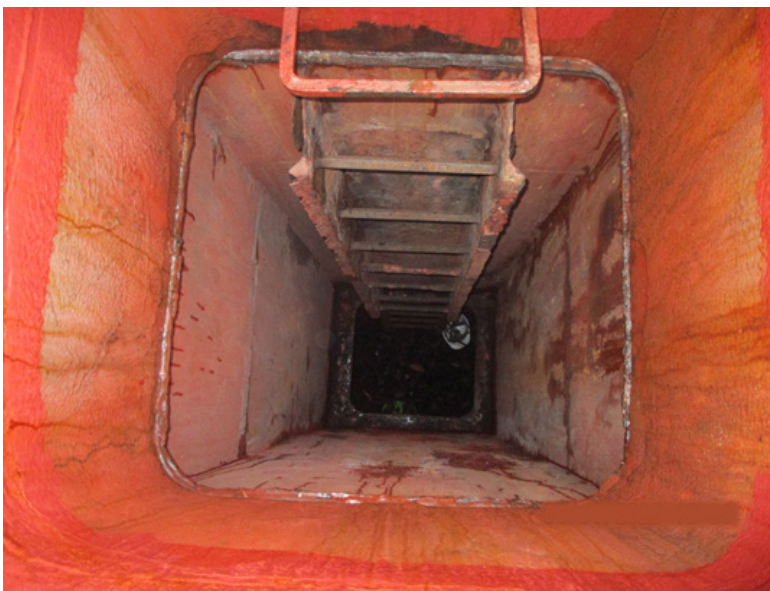
Figure 4: Photo of the aft access ladder, taken from the main deck. Note the coal in the cargo hold covering the lower section of the vertical ladder and the platform.

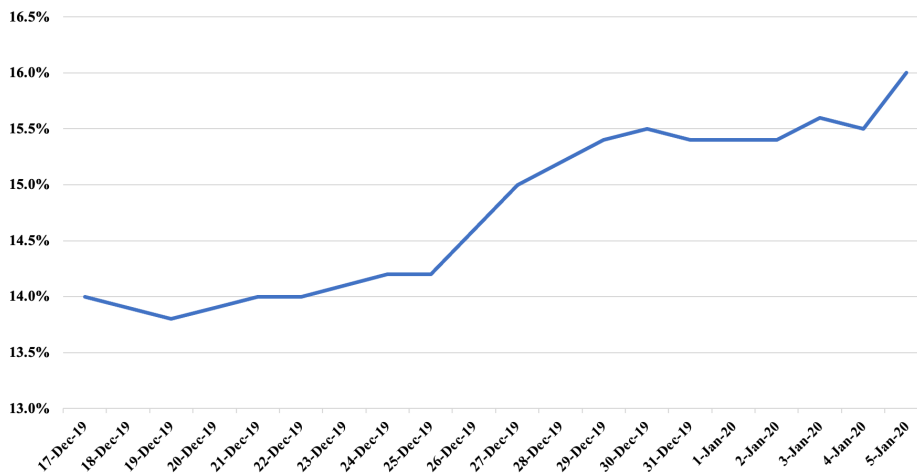
29. KG ASIA had adequate span gas for checking and calibrating the portable gas detectors, which was valid until May 2021.
30. Atmospheric testing of all cargo holds was conducted daily between 17 December 2019 and 5 January 2020, with the exception of 18, 23, and 26 December 2019. During this period, the oxygen levels within Cargo Hold No. 1 varied between 14% and 16% (see Figure 5).

Figure 5: Measured oxygen levels within Cargo Hold No. 1.

Atmospheric testing of all cargo holds was conducted daily⁴ during the loaded voyage. No carbon monoxide was detected in any of the cargo holds, while reduced oxygen levels were observed. On the day before the incident, atmospheric testing found that Cargo Hold No. 1 contained 16% oxygen. This is below the 20.6% required by the Company's SMS. While coal cargoes are known to emit carbon monoxide, it is more likely that the Fitter was overcome by a lack of oxygen in the cargo hold and Australian ladder trunk.
