LA DONNA I CASUALTY INVESTIGATION REPORT

Deck Cadet Enclosed Space Fatality

Paradip, India | 14 August 2018

IMO Number: 9591428

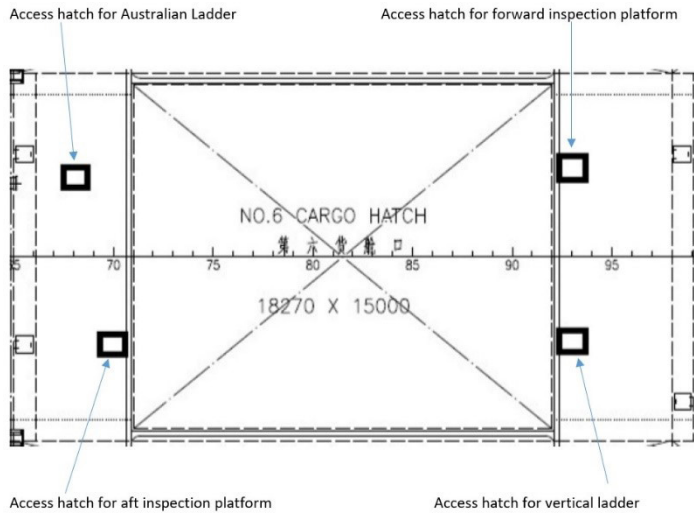
Figure 1: Cargo Hold No. 6 configuration.

access hatch leads to the vertical ladder, and one access hatch leads to the Australian ladder (see Figure 1). The straight ladders are open to the cargo holds while the Australian ladders on board LA DONNA I are contained within an enclosed trunk space. The bottom of the Australian ladder trunk opens to a vertical ladder which leads to the cargo hold tank top.

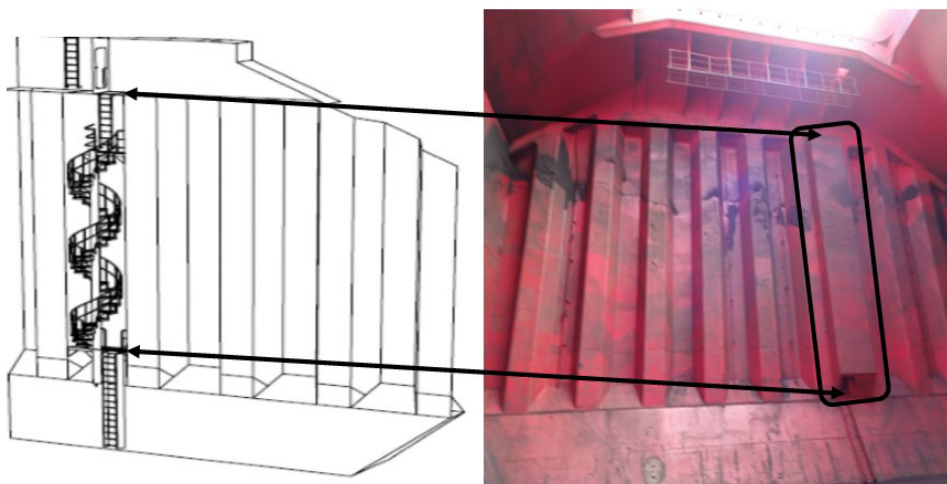
Figure 2: Enclosed Australian ladder on board LA DONNA I.

4. An access hatch from the main deck leads to an intermediate platform by way of a 2.5 m vertical ladder. Another vertical ladder then descends approximately 2.75 m to a platform at the top of the Australian ladder. This second vertical ladder and platform are contained within the same enclosed trunk as the Australian ladder (see Figure 2).

As previously noted, the C/O had stated that all previous ships which he sailed on were fitted with open Australian ladders. Open ladders share a common atmosphere with the rest of the cargo hold, greatly reducing the risk of isolated pockets of hazardous atmosphere from developing. The C/O was not aware that the ship had enclosed Australian ladders nor was he familiar with the unique hazards that this presented. However, it should have been readily apparent that the ladders were located inside an enclosed trunk when the C/O entered the Australian ladder to photograph Cargo Hold No. 1.

3. The Classification Society was requested to review the Australian ladder design and recommend modifications to increase ventilation of the enclosed areas.

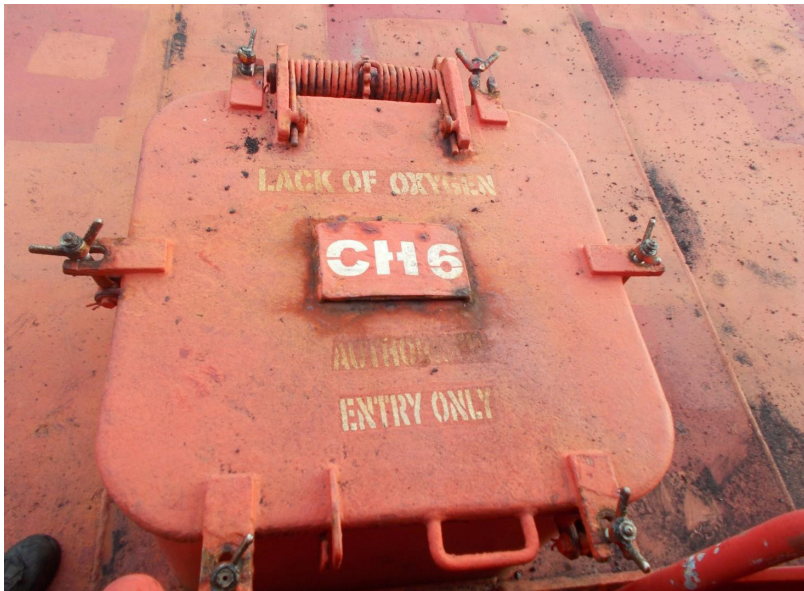
Figure 3: Access hatch for Cargo Hold No. 6.

5. All access hatches for the cargo holds were marked with the warning “LACK OF OXYGEN” regarding the possible presence of an oxygen deficient atmosphere (see Figure 3).

As an added reminder to the crew, each access hatch within the cargo length was marked with the warning “LACK OF OXYGEN” due to the possible presence of a hazardous oxygen deficient. At least some of these hatches, which were entered by the Deck Cadet with the assistance of the OS, were opened just prior to entering. There is also no evidence that these warnings were observed by the C/O prior to entering, and directing the Deck Cadet to enter, the cargo hold ladder trunks.

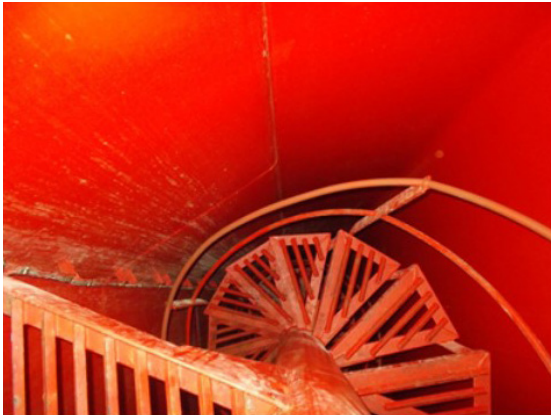
Figure 4: Example of a photograph taken by the Deck Cadet of an Australian ladder.

10. The Deck Cadet proceeded with photographing the cargo holds (see Figure 4). The OS reported that, as the Deck Cadet prepared to enter Cargo Hold No. 3, he reminded him that it would be unsafe to enter without using a SCBA. The OS also reported that the Deck Cadet's response was that SCBA equipment was unnecessary.⁴

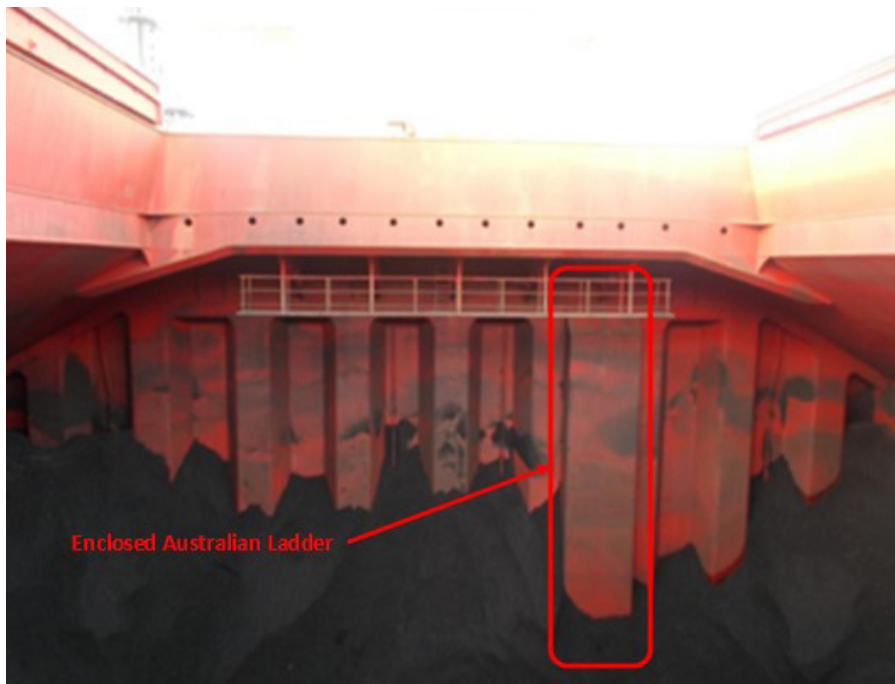
Figure 5: Cargo level in Cargo Hold No. 6 at time of entry.

14. At the time the Deck Cadet entered Cargo Hold No. 6, the hold was partially laden with coal which covered the lower opening of the Australian ladder enclosure (see Figure 5).

At the time of the incident, the coal cargo within Cargo Hold No. 6 completely covered the lower opening of the Australian ladder trunk. In addition, the hatch providing access to this space was kept closed until just before entry was conducted. This resulted in a non-ventilated space existing within the Australian ladder trunk even though the cargo hold was open to the atmosphere for the 24 hours leading up to the incident. The Australian ladder trunk maintained an oxygen deficient atmosphere within that enclosed space.

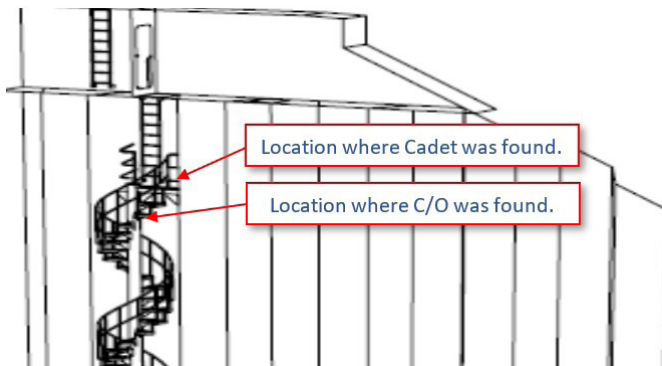
Figure 6: Locations of the C/O and Deck Cadet when they were found.

⁷ Crewmembers report that the C/O was found several steps down the Australian ladder with his shoulders caught on the railing. There were no direct witnesses to the C/O’s loss of consciousness, however, it is presumed that he fell down the Australian ladder until he became caught on the railing stanchion.

- At approximately 1800, the Electrician, after donning an SCBA, entered the Cargo Hold No. 6 Australian ladder access hatch. Shortly after entering, the Electrician requested additional lighting and an Emergency Escape Breathing Device (EEBD) from crewmembers on deck. After obtaining these items, the Electrician fitted the EEBD onto the Deck Cadet and ensured that it was operating properly. The Electrician reported that he observed the C/O unconscious and laying further down on the Australian ladder (see Figure 6).

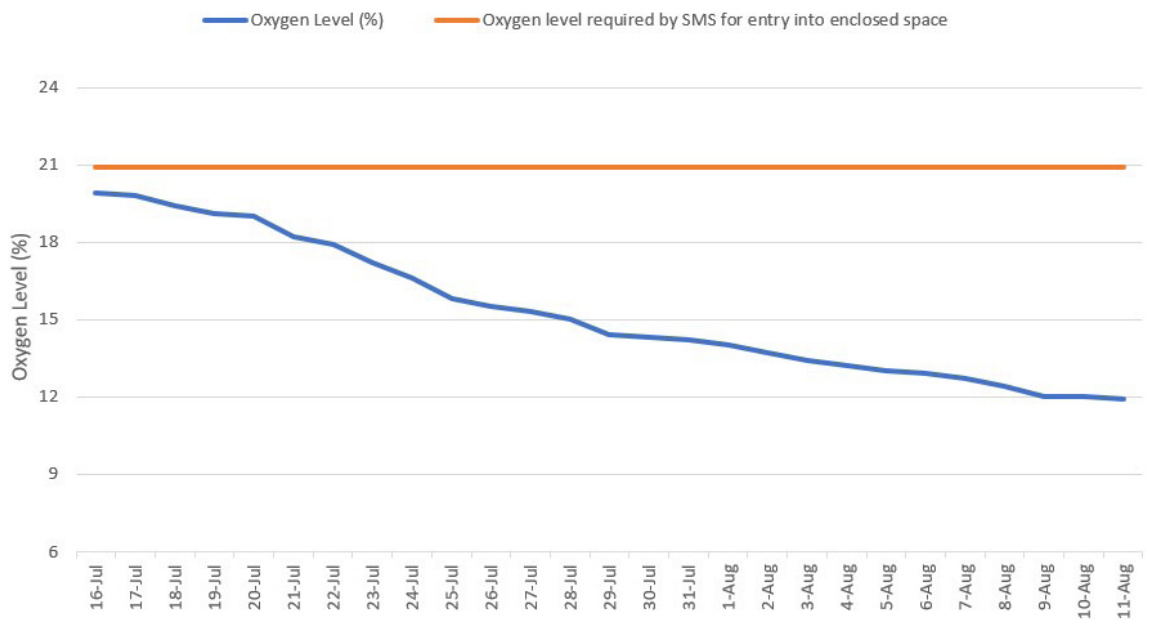
Figure 7: Cargo Hold No. 6’s oxygen levels during this loaded voyage.

38. During the laden voyage, atmospheric measurements of the cargo holds were taken daily as required by the IMSBC Code and the Company’s SMS.⁸ Oxygen levels within all seven cargo holds were found to be decreasing with time (see Figure 7). IMO recommendations for oxygen concentration acceptable for entry into enclosed spaces is 21%.⁹ The Company’s SMS requires that oxygen concentrations be maintained between 20.5% and 21%, with the desired being noted as 20.8%.

Daily oxygen readings were taken within the cargo holds during the laden voyage. These readings indicated a continuous reduction of oxygen concentrations within all holds, and in particular, Cargo Hold No. 6. Three days prior to the incident, Cargo Hold No. 6 was found to contain only 11.9% oxygen, well below the 20.8% oxygen level required by the Company and the 21% oxygen level recommended by IMO. However, there is no indication that this was considered when the C/O made the determination that the enclosed space entry procedures did not need to be followed.
