REPUBLIC OF THE MARSHALL ISLANDS

LINUS P CASUALTY INVESTIGATION REPORT

Enclosed Space Fatality

Pacific Ocean | 24 November 2018

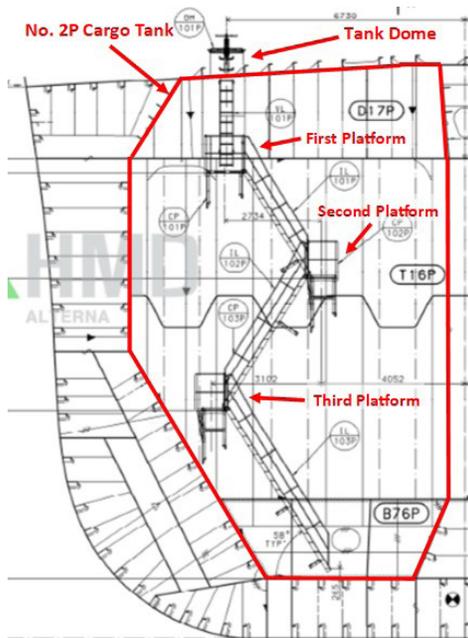
Figure 2: Ladder arrangement for the No. 2P Cargo Tank.

14. The cargo tanks were fitted with ladders accessed through the tank dome. A short vertical ladder led from the main deck to the first platform. Inclined ladders then extended to the tank top. There were two additional intermediate platforms (*see Figure 2*).

30. At around 0110, the C/O and the ASE1 re-entered the cargo tank and found the ASD2 lying on the tank top. Prior to his fall, he was observed on the second platform by the Pumpman who was on the Main Deck. A stretcher was lowered and an EEBD was placed on the ASD2. Then, the low air pressure alarm on the ASE1's SCBA began sounding and both rescuers left the tank.¹¹

Tragically, the ASD2 fell from the second platform to the tank top, likely due to losing consciousness from the oxygen-deficient atmosphere in the tank. Using the available rescue equipment, such as spare SCBAs and additional EEBDs, would have removed the perceived need to share breathing air.

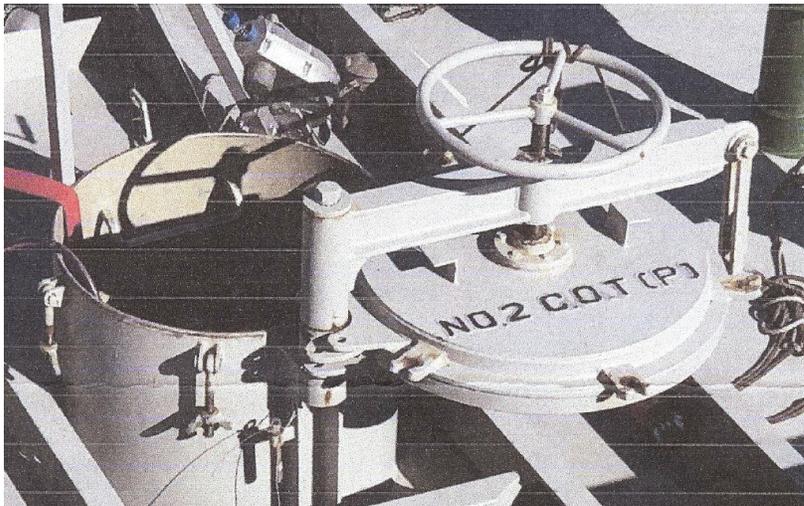
Figure 3: No. 2P Cargo Tank dome open.

19. Due to the high pressure of the fresh water supply, the Pumpman and the ASD1 decided to tie the hose to a rung of the access ladder inside the tank dome (*see Figure 3*). While doing this, a portable radio fell into the No. 2P Cargo Tank from the ASD1's pocket.⁶ The Pumpman reported that the ASD1 told him he was going to retrieve the radio from the tank after getting a flashlight. The Pumpman also reported that he tried to stop the ASD1 from entering the tank.

20. Despite the Pumpman's warning, the ASD1 entered the No. 2P Cargo Tank through the open dome. The Pumpman (on the main deck) reported that the ASD1 quickly became unconscious. He also saw the ASD1's flashlight fall to the tank top. Seeing this, the Pumpman called out to the ASD1. There was no reply.

At the time of the cleaning operations and beginning of Stage 3, the tanks were expected to still be inerted. Gas freeing would follow after Stage 4, since personnel would then need to enter the tanks to be sure they were clean and dry. The C/O failed to identify that the fixed tank washing machines could be supplied through hoses connected to the fire main, as indicated in the Company's SMS. This would have eliminated opening the cargo tank domes and would likely have prevented the incident from occurring.

4. An operational circular was sent to all Company-managed ships to discuss the specific hazards of N₂, physiological effect of oxygen deficiency on the body, and complete prohibition of opening tank domes of inerted tanks.
5. Communication to all Company office staff to check for compliance with enclosed space entry and rescue procedures during all audits and inspections.
6. The Company has hired a third party to carry out a “Human Factor Analysis” to assist with implementing measures to prevent a reoccurrence.
