MANTA HULYA MARINE SAFETY INVESTIGATION REPORT

Collision with the Republic of Tunisia Registered Fishing Vessel RAZI

Mediterranean Sea | 12 February 2022

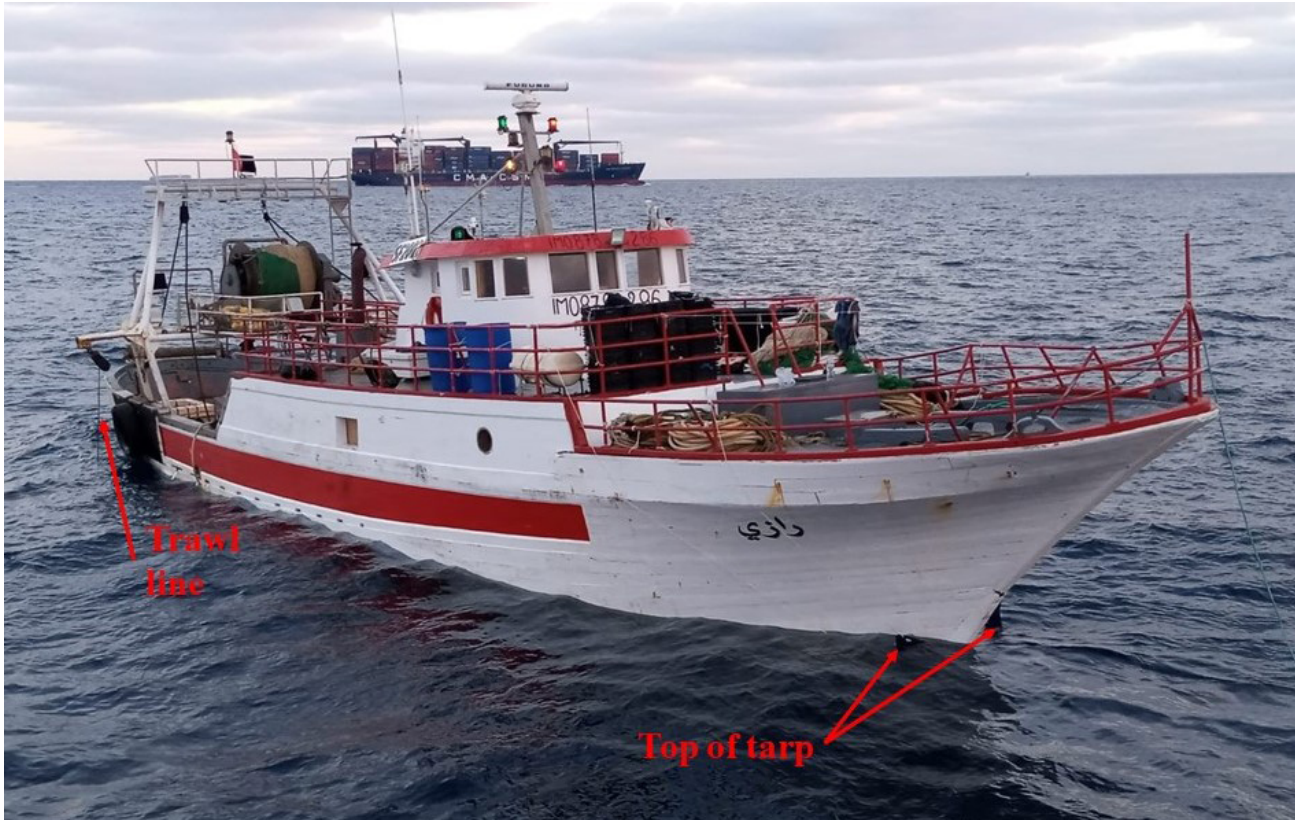
RAZI's Captain stated the vessel's hull began to flood after the collision and that he immediately called the Tunisia Coast Guard. The Captain and crewmembers tried reducing the flooding by heaving to and placing a tarp on the outside of the hull in way of the stem just below the vessel's waterline (see Figure 4).

Figure 4: The location of the tarp over the lower portion of the stem and one of the two trawl lines. Note: In addition to the green light over the white light on the mast, there is also a red over a red light being displayed. The ship in the background is not MANTA HULYA. (Source: Tunisia Coast Guard)

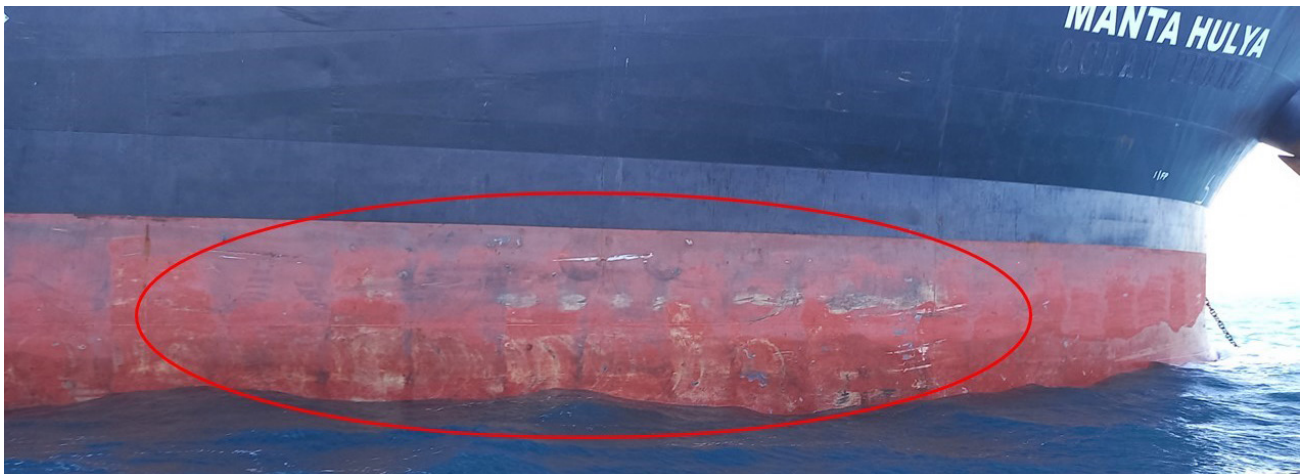
MANTA HULYA's hull received some scratches on the starboard side forward above the load waterline (see Figure 5). No other damage was reported. None of the ship's crewmembers were reported to have been injured.

Figure 5: MANTA HULYA's hull, starboard side forward. The area where the scratches were observed are circled in red. (Source: Tunisia Coast Guard)

MANTA HULYA sustained only minor damage. None of the ship's crewmembers were reported to have been injured.

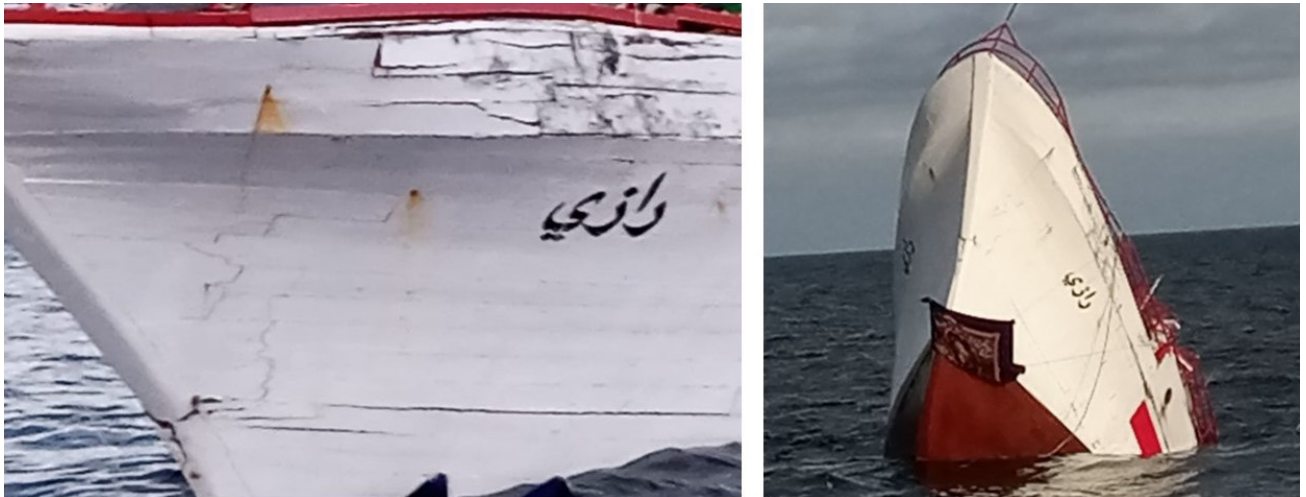
RAZI was reported to have sustained damage on the port side forward both above and below the waterline (see Figure 6) that resulted in flooding of the hull. The damage included the stem and some planks being fractured and some seams being sprung.

Figure 6: RAZI's hull, port side forward showing the damage to the stem and planking. The tarp that RAZI's crewmembers placed over the stem at the vessel's waterline is visible in the photograph on the right. (Source: Tunisia Coast Guard)

MANTA HULYA, which was underway on an easterly heading, and RAZI, which was underway on a northerly heading while engaged in trawling, collided on the high seas approximately 20-25 NM north of Gulf of Tunis. The collision occurred as both vessels were maneuvering to avoid a collision. The collision occurred when RAZI's port bow contacted MANTA HULYA's starboard side in way of the No. 1 S WBT.

Although RAZI's hull was damaged, causing the hull to flood, the fishing vessel remained afloat for approximately 3 hours before sinking. All 10 crewmembers who had been on board were safely rescued before the fishing vessel sank.
