REPUBLIC OF THE MARSHALL ISLANDS

NAN BEI HU SAFETY INVESTIGATION REPORT

Occupational Fatality

Rio Tuba Anchorage, Republic of the Philippines | 16 March 2024

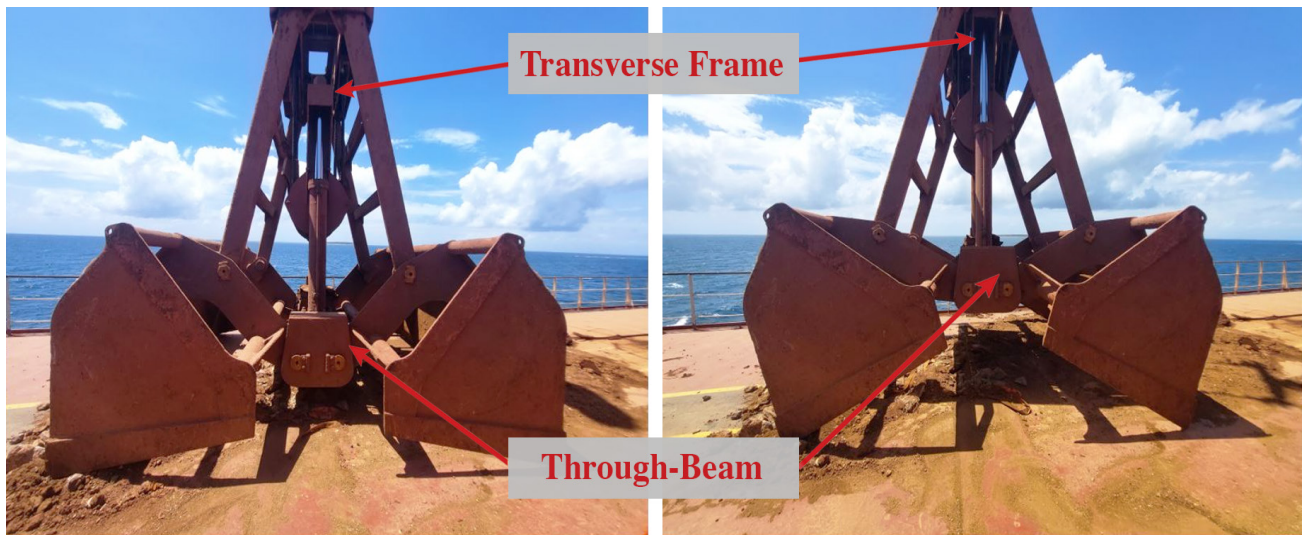
Grab No. 1 was placed on deck in the fully open position so the ship's engineers could drain the hydraulic oil before the shore workers started renewing the grab's hydraulic lines. When the grab was on deck, it was observed that the plastic drum, into which the oil was going to be drained, did not fit under the through-beam of the fully open grab. It was decided

to take tension on the grab wires and lift the transverse frame until the through-beam was high enough above the deck so the plastic drum could be placed beneath the drain plug (see Figure 3).

Figure 3: Grab No. 1 shown fully open on the left and partially closed on the right. The height from deck to the underside of the through-beam when the grab was fully open was 30 cm. The piston rods are extended in both pictures because the weight of the transverse frame is being supported by the deck crane's hoisting wire and the grab wires.

Grab No. 1 was partially open in a non-standard condition due to the hydraulic cylinders not being operational after the ship’s engineers drained the hydraulic oil from the grab. When the grab wires were slackened so the ship’s crewmembers could renew one of the grab wires, the weight of the transverse frame would have pushed the piston rods down into the cylinder barrels. The force of the friction between the scoops and deck plates prevented the transverse frame and through-beam from dropping all the way and fully opening the scoops after the grab wires were slacked.

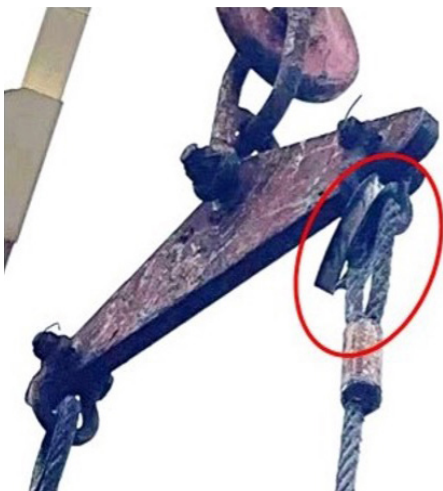
Around the same time, the Bosun and the C/O noticed that the thimble for the eye splice at the working end of one of the grab wires for grab No. 1 was dislodged (see Figure 4). In consultation with the Master, it was decided to renew the grab wire immediately.

Figure 4: Dislodged thimble on grab wire for grab No. 1.

The old grab wire had to be removed before the new grab wire could be installed. The crane hoisting wire was lowered until both grab wires were slack. The crane hoisting wire was left connected to the lifting beam but was not supporting the grab, which remained partially open. The crewmembers then opened the shackle to disconnect the grab wire with the dislodged thimble from the lifting beam (*see Figure 4*).

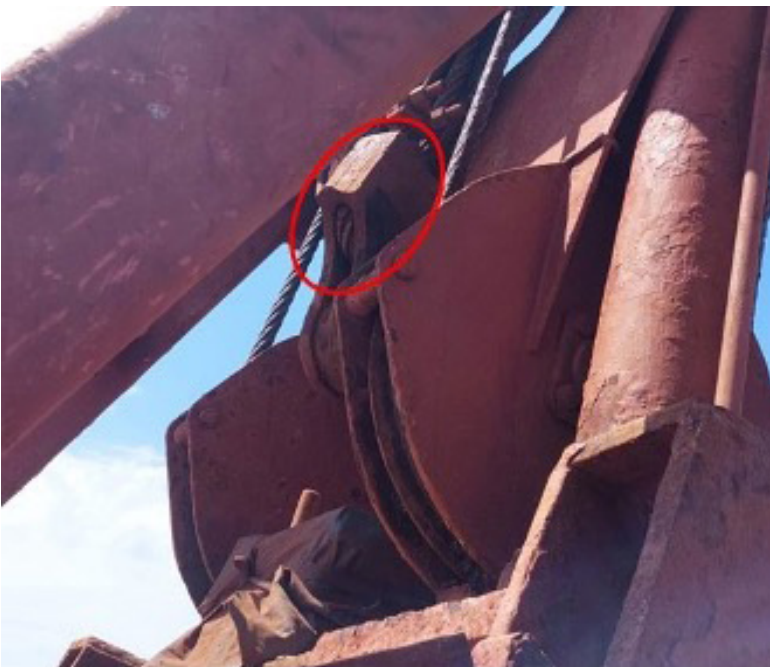
Next, the dead end of the grab wire had to be removed from the wedge socket (*see Figure 5*). The crewmembers used a hammer and crowbar to pry the dead end of the grab wire and wedge from the socket. They were able to create a small space between the wire rope and the wedge but were not able to remove the wire from the socket due to extensive corrosion inside the socket.

Figure 5: Dead end of the grab wire inside the wedge socket (circled in red).

The crewmembers were then going to use an electric grinder to cut the wire out of the socket. Because the only electric grinder available on board was being used by the shore workers, it was decided to use a chain block to pull the wire out of the socket.

The upper hook of the chain block was connected to the grab wire by placing the hook through the space between the wedge and the wire that was created when the crewmembers used the hammer and crowbar to remove the wire from the socket. The other hook was connected to a D-ring on deck. The ASD2 positioned himself under the through-beam, in a squatting position, to operate the chain block. The Bosun and ASD1 were both standing inside the grab, on the outside of the through-beam. The C/O and the ASD3 were standing outside of the grab.
