### OLYMPIA CASUALTY INVESTIGATION REPORT

Collision with Fishing Vessel

South China Sea | 9 March 2021

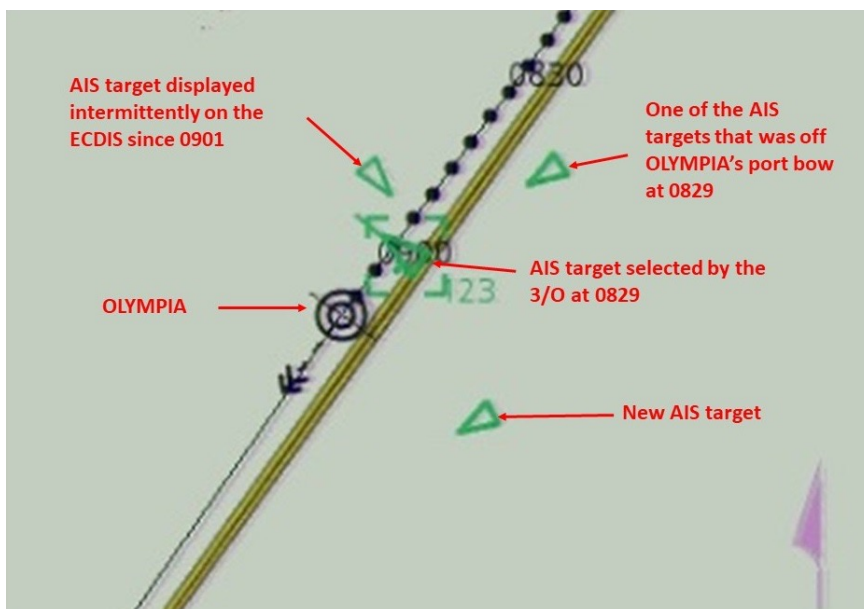
23. The collision occurred in position 13° 08.9' N, 110° 50.0' E, about 80 NM east of Vietnam.
24. Based on the OLYMPIA's VDR information, there is no indication that TB-96666-TS was transmitting AIS information (see Figure 4).

Figure 4: Portion of OLYMPIA's ECDIS display at 0915 immediately before the ship started turning to starboard. The AIS target off the ship's port beam had not previously been displayed.

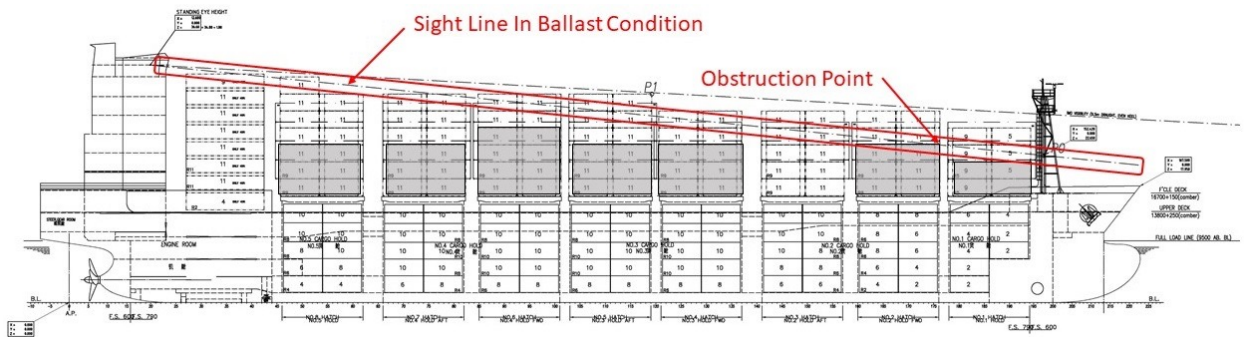
44. Based on the OLYMPIA's stowage plan, there were 168 containers loaded on deck. The sight line from the conning position during the voyage from Shanghai to Sihanoukville corresponded with the sight line when the ship was in ballast (*see Figure 5*).

Figure 5: Sight line from the conning position based on OLYMPIA's deck cargo for the voyage from Shanghai to Sihanoukville. The slots on deck with containers are shown in grey.

The sight line from the conning position during OLYMPIA's voyage from Shanghai to Sihanoukville corresponded with the sight line when the ship was in ballast (*see Figure 5*). The ship was trimmed 1.1 m by the stern, which is less than the trim on arrival in a ballast condition (1.8 m by the stern) that was used to verify compliance with SOLAS regulation V/22.1.1. This suggests the view of the sea from the conning position may have been obstructed by about 200 m<sup>18</sup> and is not considered a causal factor for the collision of OLYMPIA and TB-96666-TS.
