REPUBLIC OF THE MARSHALL ISLANDS

OU YA LENG 6 CASUALTY INVESTIGATION REPORT

Grounding and Total Constructive Loss

Taka Atoll, Republic of the Marshall Islands | 2 January 2019

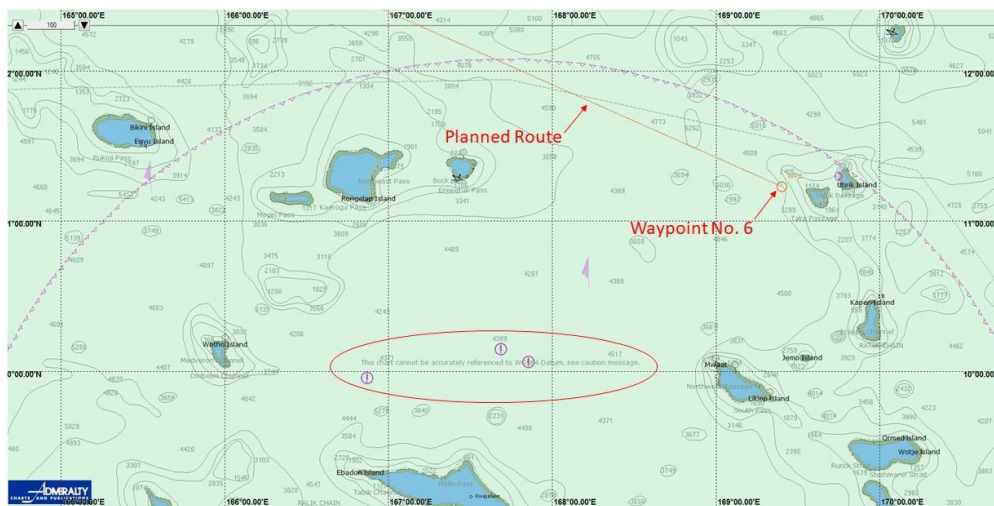
Figure 2: OU YA LENG 6's planned route (orange line) in the vicinity of the Marshall Islands. The vessel's route was plotted by the Administrator on UKHO GB200761. The referenced caution message (circled in red) warns mariners to confirm GPS positions displayed on the ECDIS using other navigational techniques "particularly when closing the shore or navigating in the vicinity of dangers."

The Master planned the route for the voyage from Zhoushan to the fishing grounds in the southeastern Pacific Ocean on the vessel's ECS. The planned route began offshore Zhoushan and consisted of six waypoints, the last one was waypoint No. 6. This waypoint was located approximately 9 NM to the west-northwest of Taka Atoll. The proximity of waypoint No. 6 to Taka Atoll and the small scale of the charts being used for navigation required additional attention be given as OU YA LENG 6 approached this waypoint.

The voyage plan developed by the Master did not include guidance for the vessel's OOWs regarding anything other than the locations of the six waypoints and courses to steer. Notably, the Master had not updated the planned route to include any segments beyond waypoint No. 6. Also, he did not give the duty OOW any instructions to monitor the vessel's position on a regular basis nor provide an indication of his intentions once OU YA LENG 6 reached this waypoint or the need to verify the vessel's position when landfall was made. Given the small scale of the available charts and the proximity of Waypoint No. 6 to Taka Atoll, the absence of such guidance increased the risk of grounding on Taka Atoll.

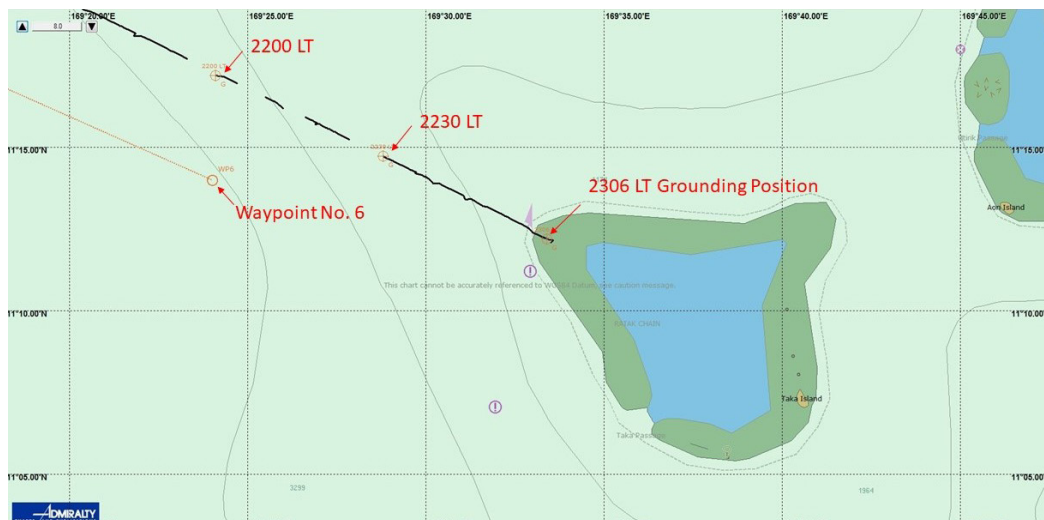
22. Based on AIS information, OU YA LENG 6 was approximately 3-4 NM to the north of the planned route for most of the day on 2 January 2019. No course changes were made from 2000 onwards.
23. The Master stated he issued Night Orders instructing the duty OOW to call him at 2200. He also stated that at 2000 he had reminded the 3/O to call him at 2200. This was when the Master expected the vessel would reach waypoint No. 6. The Master did not leave instructions for the duty OOW regarding whether to change course or reduce speed when the vessel was at this waypoint.
24. Neither the duty OOW reported calling, nor did the Master report receiving a call from the duty OOW at 2200. The duty OOW stated he had focused on the weather conditions and forgot to call the Master. Based on AIS information, OU YA LENG 6 was approximately 10 NM from Taka Atoll at 2200 (see Figure 3).

Figure 3: OU YA LENG 6's track (broken black line) based on AIS information showing the vessel's positions at 2200 and 2230 and where it went aground on Taka Atoll. The planned route is the orange dotted line.

The duty OOW stated that he was focused on the weather conditions and was not monitoring either the time or the vessel's position. As a result, he did not call the Master at 2200 as directed. He was also not aware that OU YA LENG 6 had passed waypoint No. 6 and was closing on Taka Atoll. Further, he did not check the radar or ECS when he saw something ahead of the vessel at 2230. As a result, he remained unaware that OU YA LENG 6 was approaching Taka Atoll and at risk of going aground. This is an indication of an ineffective navigational watch.

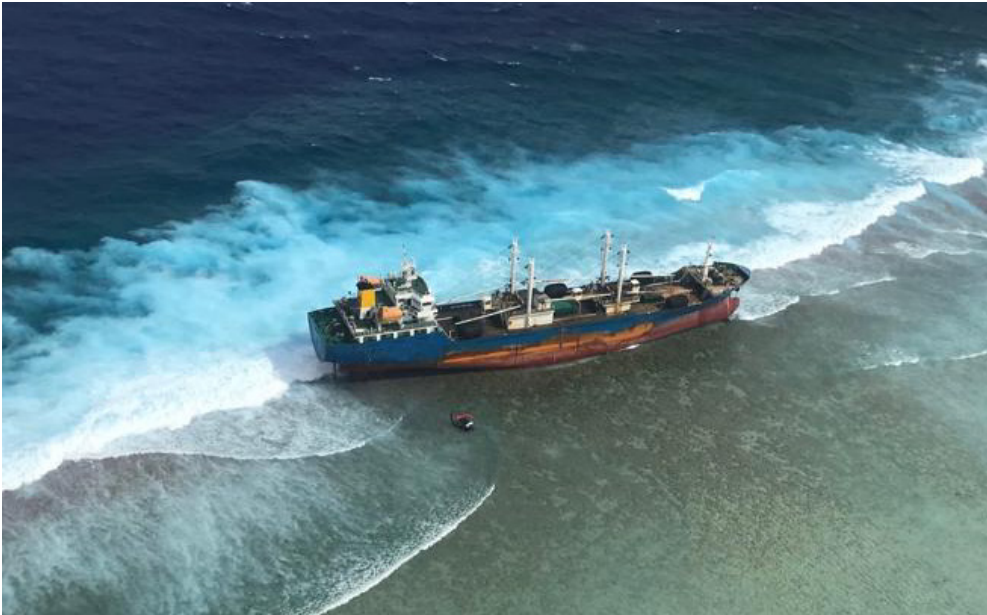
33. Soundings were then taken around the vessel. The water depth off the starboard bow was 0.9 m, 1.1 m midships, and 2.5 m aft. The vessel was reported to be on an even keel (*see Figure 4*).

Figure 4: OU YA LENG 6 aground on Taka Atoll on 3 January 2019. The object off the vessel's starboard side is one of the liferafts. (Source: US Coast Guard)

Based on the statements of the Master and the duty OOW, soundings taken around the hull and photographs taken during the day on 3 January 2019, OU YA LENG 6 went hard aground on Taka Atoll. There is no indication that there was a loss of propulsion, electrical power, or steering prior to the grounding. In addition, all navigation equipment was reported to be working properly. This indicates the causes of the grounding were issues related to the voyage planning and navigation watchstanding.
