### OURANIA LUCK CASUALTY INVESTIGATION REPORT

Fatality During Hold Cleaning

Arabian Gulf | 8 July 2018

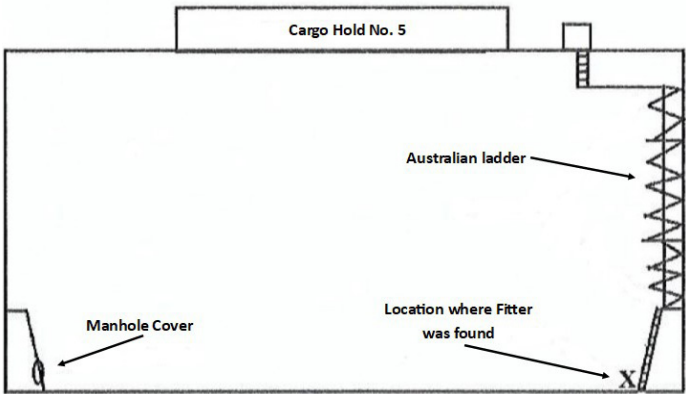
Figure 1: Diagram of Cargo Hold No. 5.

4. The Australian ladder for Cargo Hold No. 5 is accessed by a short, straight ladder from the tank top which leads to a platform at the bottom of the Australian ladder (*see Figure 1*).

It cannot be determined why the Fitter fell from the ladder while exiting Cargo Hold No. 5 as there were no witnesses. Presumably, he lost his balance while on the straight ladder leading from the tank top to the platform at the beginning of the Australian ladder, or while transitioning from the straight ladder to the platform. It is unlikely that he fell from the Australian ladder since fall protection railings were provided along its entire length. The injuries reported during the postmortem examination were consistent with a fall from a ladder.

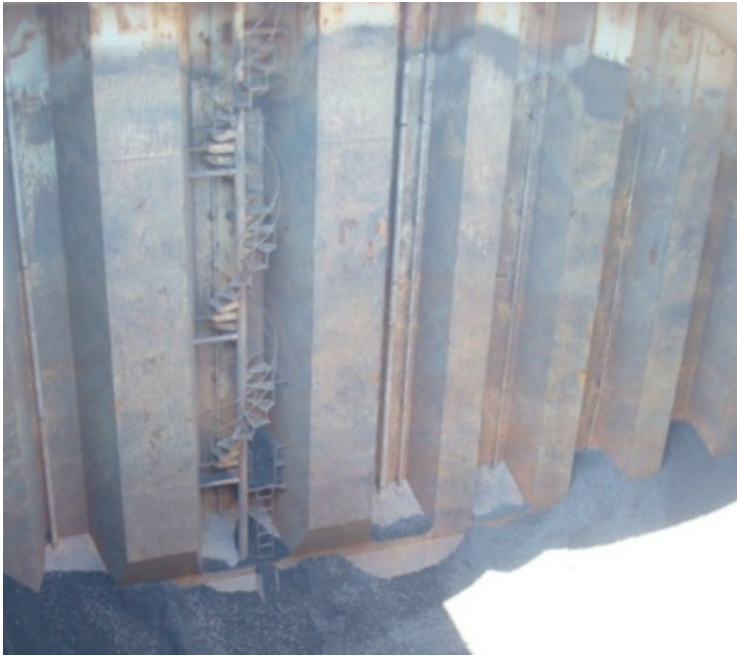
5. The Australian ladder had a railing which provided fall protection, running continuously from the lower platform to the top of the cargo hold (*see Figure 2*).

*Figure 2: Australian ladder fitted in a cargo hold similar to Cargo Hold No. 5 aboard OURANIA LUCK. At the time of the incident, the hold was empty.*
