### PENELOPE CASUALTY INVESTIGATION REPORT

Provision Crane Maintenance Platform Failure with Fatality

Coral Sea | 26 November 2018

IMO Number: 9317822

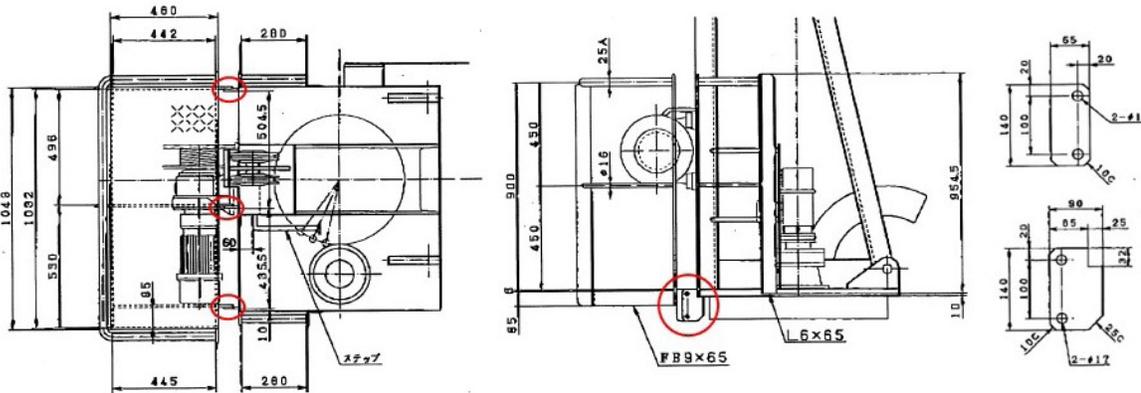
- (a) the design of the connection of the two parts of the lower stage of the portside provision crane was inherently weak and prone to failure. It was based on three short welded brackets and it did not include mechanical connections joining the railing on the two parts of the lower stage;

- The lower stage has two parts: the main platform (welded to the pedestal) and the platform extension. As built, the extension was attached to the main platform by three bolted connections (see Figures 1 and 2). There was no physical connection at the railing of the two parts.

Figure 2: Drawing of the lower stage for the port provision crane. The brackets are circled in red. Note the absence of a physical connection at the railing. On the top right is a drawing of the bracket that is welded to the platform extension and bottom right is a drawing of the bracket that is welded to the main platform.<sup>2</sup>

1. modified the design of the connection between the main platform and the platform extension to include mechanical connections at the railings on the ship's port and starboard provision cranes;<sup>19</sup>
2. amended the crane inspection checklist<sup>20</sup> in the Company's PMS to include inspection of the condition of the upper and lower maintenance platforms;
3. amended the Company's permit and risk assessment for working aloft or over the side<sup>21</sup> to include guidance for assessing locations where a safety line might be attached to avoid additional hazards;
4. provided all ships in the Company's fleet with five full body safety harnesses and fall arrest systems; and

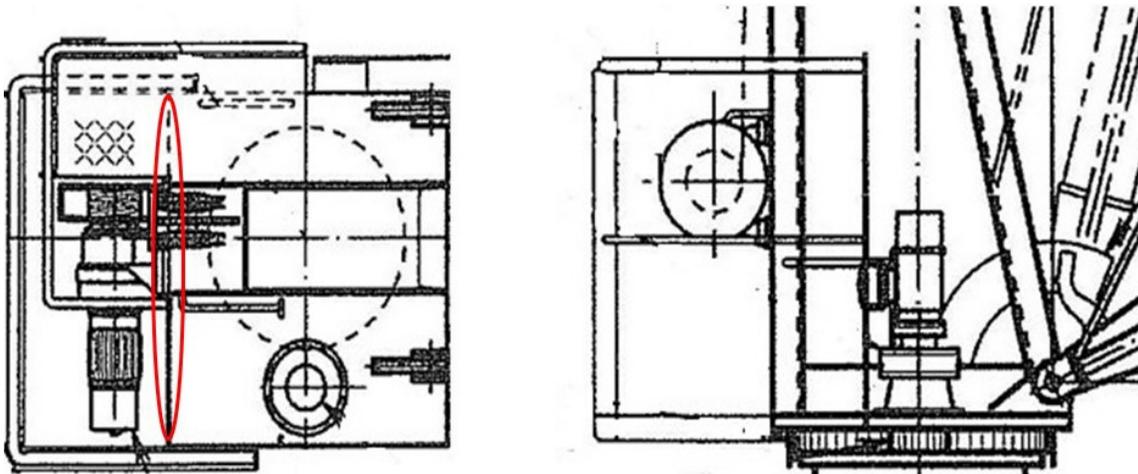
- Each of the three connections had a bracket welded to the main platform and another to the platform extension. The brackets were notched where they were welded to the main platform. Each bracket set had two bolts installed through the holes connecting the extension and the main platform sections (see Figure 2).
- The arrangement drawing included as part of the operations manual for the port provision crane does not indicate that the lower stage consisted of two parts. Rather, it indicates the lower stage is a single part (see Figure 3).

Figure 3: Portion of port provision crane arrangement drawing that is included in the operations manual. The plan view (left), which includes the upper stage, has a line (circled in red) indicating the stage might consist of two parts. However, both the plan view and arrangement view (right) indicate that the two courses of the railing were each a single piece.<sup>3</sup>

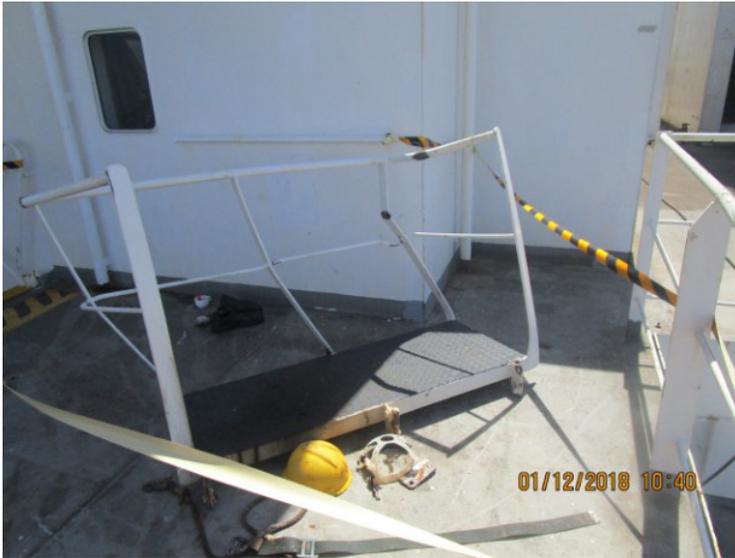
Figure 4: Extension platform near where it landed on the Lifeboat Deck.

11. At approximately 1655, the platform extension detached and fell to the port side Lifeboat Deck. The platform extension was approximately 8-9 m above the Lifeboat Deck before falling.

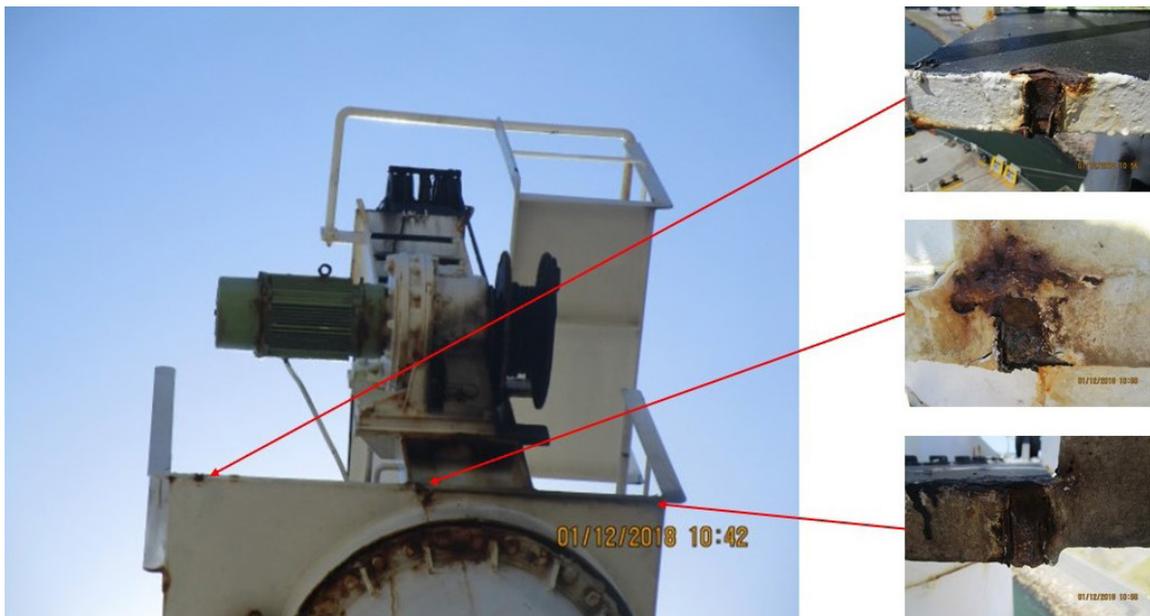
24. When examined as part of the Administrator's marine safety investigation, it was determined that the welds for all three of the main platform brackets had failed. There was heavy corrosion on the main platform where all three brackets were attached to the main platform (see Figure 5). It also appeared that the welds lacked full penetration. The ship's crew reported that the corrosion was not visible prior to the extension falling.

Figure 5: Portside provision crane showing the locations of the failed welds and the corrosion where the brackets were welded to the main platform. The Bridge Deck is to the left of the crane.

Based on the information obtained by the Administrator during the marine safety investigation, it is not known if any of the welds connecting the brackets to the main platform were cracked before the ASD began working on the port provision crane. However, the presence of heavy corrosion where each bracket attached to the main platform indicates water had been able to reach this area over time (*see Figures 4 and 5*). This corrosion would have contributed to the failure of these welds.

Based on how heavy the corrosion was, it is likely that it was present when the crane was last examined by BV on 23 June 2018 and inspected by the ship's crew on 6 September 2018.

If the fillet welds were not wrapped around to close any gaps between the main platform and the brackets, water would have been able to infiltrate these areas causing corrosion. Water could also seep in through a weld crack.

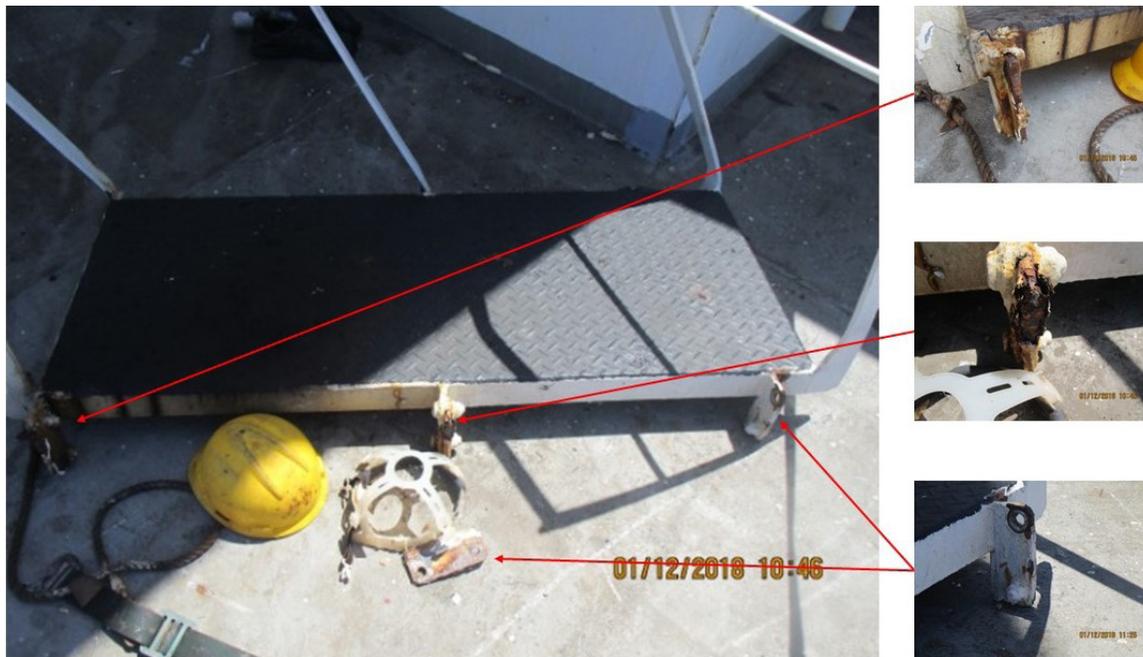
25. Two sets of brackets were intact with the bolts in place. The third set, which had been closest to the Bridge Deck at the time of the incident, was broken apart. One bracket of this set was bent but was still connected to the extension. The bracket that had been welded to the main platform was laying on the deck. The lower bolt was sheared off and the upper bolt was missing. There was heavy corrosion on each of the brackets where they attached to the main platform (see Figure 6).

Figure 6: Platform extension showing the brackets. Also shown is the ASD's safety helmet and safety belt and line. Note that the suspension for the safety helmet was dislodged.

The ASD's fall from height was directly related to the failure of the brackets connecting the platform extension to the main platform, which was welded to the pedestal. Based on the condition of the three bracket sets when they were examined after the incident, it appears that the set nearest the Bridge Deck might have supported the platform extension and ASD for a short period. This is based on how the bracket welded to the extension was bent and that the remaining bolt was sheared (*see Figure 6*).
