PORT STANLEY CASUALTY INVESTIGATION REPORT

Occupational Fatality – Fall from Height

Guangzhou, People's Republic of China | 21 May 2019

IMO Number: 9246463

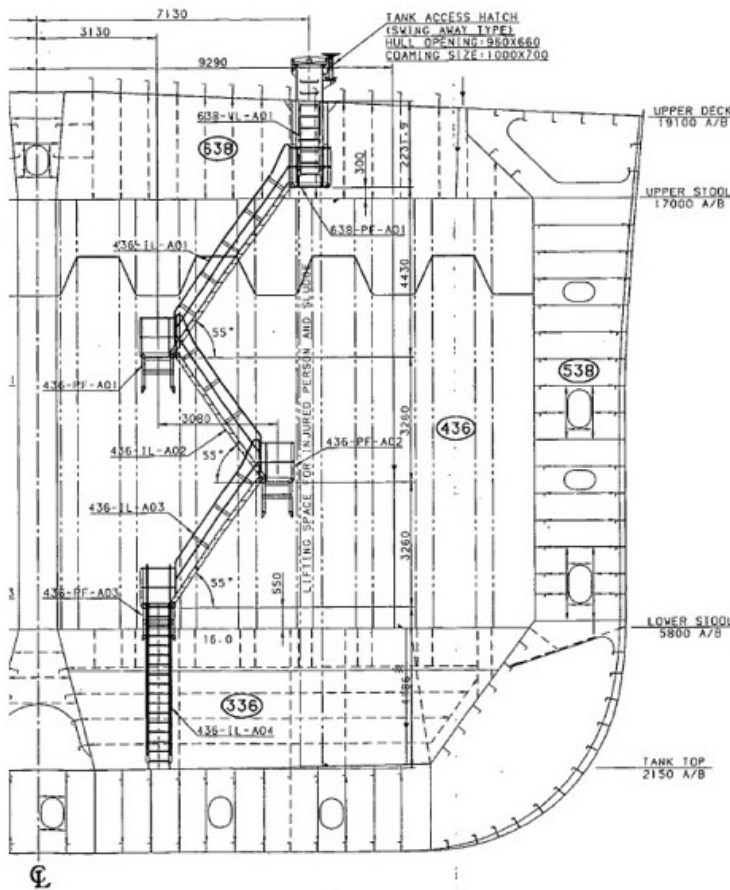
21. The tank was accessed through the tank dome using a vertical ladder that extended down through an opening in the main deck to the first platform. From the first platform there were a series of four inclined ladders with three additional platforms leading down to the tank top (*see Figure 1*).⁴

Figure 1: Forward bulkhead for No. 2 S COT showing the access ladder.

The start of the ASD1's fall was not witnessed. Therefore, it is not possible to determine with certainty how he fell. It is known that the OS1 heard a loud noise and then saw the ASD1 falling within about 15 seconds after the ASD1 entered the No. 2 S COT. He was found lying on the tank top almost directly below the first and third platforms (*see Figures 1 and 2*).

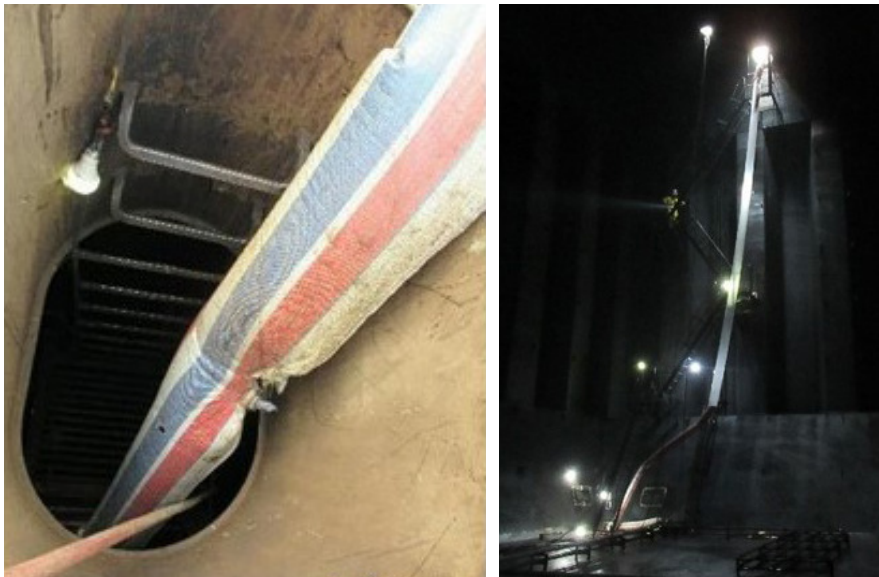
22. The length of the vertical ladder that extended through the tank down to the first platform inside the tank was 2.5 meters (m). The rungs were 600 millimeters (mm) wide and spaced 300 mm apart. The platform was 1 x 1 m. The inclined ladders and the platforms were fitted with guard rails that consisted of an upper rail that was 1,000 mm high when measured from the top of the platform and an intermediate rail that was 500 mm high.⁵
23. On 21 May 2019, the ventilation duct and electrical cable passed through the tank dome and extended to the tank top (see Figure 2).

Figure 2: The entrance to No. 2 S COT (left) showing the vertical ladder inside the tank dome and the ventilation duct and cable. The access ladder inside the tank (right) showing the forward bulkhead, lighting and ventilation duct extending to the bottom of the tank. The pictures were taken on 22 May 2019. It was reported that the ventilation duct, cable, and lighting had not been moved since the ASD1's fall.

25. The portable lights rigged by the shipyard extended from the second platform to the bottom of the ladder (see Figure 2). Portable lighting was not provided for the first platform.
26. The OS1 stated that crewmembers had previously discussed how the ladders into the COTs were obstructed by the ventilation ducts and cables, and that it was difficult to enter and exit the tanks. It was not clear that their concern was discussed with the C/O, the Master, or the Fleet Superintendent.
27. The permanent means of access to the tank was found in good condition and free of defects when inspected after this incident.

There were lights in the tank, but they were located below the first platform. There was also a light inside the tank dome (see Figure 2). The ladder and the first platform would have been lit by sun light passing through the entrance to the tank. Although it cannot be determined with certainty, the ASD1's vision may have been impaired as his eyes adjusted from the bright daylight on deck to the relatively dark interior of the tank (see Figure 2).¹⁰ Any impairment of his vision due to the change of lighting could potentially have interfered with his ability to see as he first entered the tank.

¹⁴ An opening can be seen in *Figure 2*.

It is a common practice to pass ventilation ducts and electrical cables through tank entrances when work is being conducted inside. This can create a potential safety hazard. There is no indication that it had been identified by the Fleet Superintendent, the Master, or the C/O, nor communicated to them by the crewmembers, who reportedly had discussed this amongst themselves. It is noted that this hazard could have been addressed by passing the ducts and electrical cables through other available openings, such as those for the COT washing machines.¹⁴

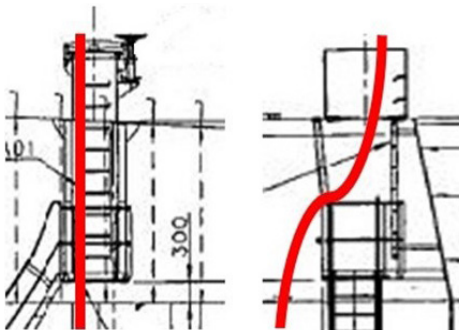
24. The ventilation trunk and electrical cable extended down along the inboard side of the vertical ladder and across the first platform. Both the ventilation duct and the electrical cable passed over the top course of the safety rail around the first platform (see Figures 2 and 3).

Figure 3: Detail of the entrance to No. 2 S COT showing the vertical ladder, the first platform, and the location of the ventilation duct (red line). The duct is not drawn to scale.

The ventilation duct and electrical cable extended down along the inboard side of the vertical ladder and across the first platform (*see Figure 3*) obstructing access to the inclined section of the ladder leading to the second platform. This would have required the ASD1 to go over, around, or under the duct after he was on the platform, or to pass over it while he was still descending the vertical ladder. Although it cannot be established how the ASD1 may have tried to move past the ventilation duct, there is sufficient available information to conclude that the duct likely interfered with the ASD1 as he was entering the tank.
