### PRISMA MARINE SAFETY INVESTIGATION REPORT

Fatal Fall from Height

Baltic Sea | 29 January 2025

Official Number: 10700

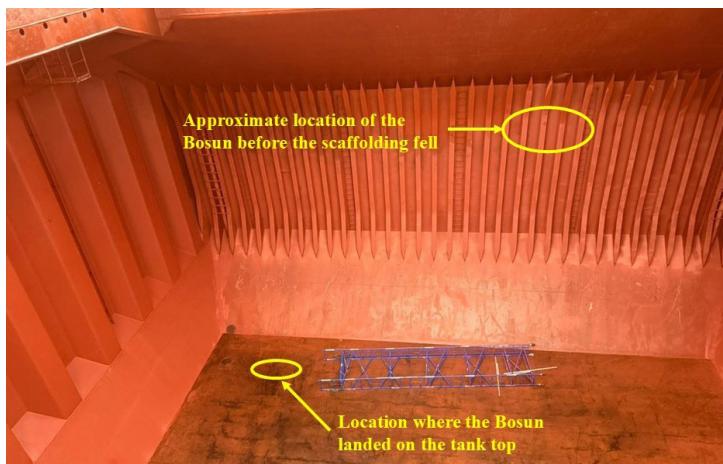
After moving the scaffolding, the ASD1 and ASD2 locked the wheels and started to extend the two stabilizer arms. The scaffolding with the Bosun on it suddenly fell as the two stabilizer arms were being extended. At approximately 2200, the OS2, who had not witnessed the scaffolding being moved, heard a loud noise from inside CH No. 3. He looked down inside the cargo hold, saw the scaffolding lying on the tank top, and reported by radio that the scaffolding had fallen.

Figure 2: The approximate location of the Bosun before the scaffolding fell and location where the Bosun landed on the tank top inside of CH No. 3.

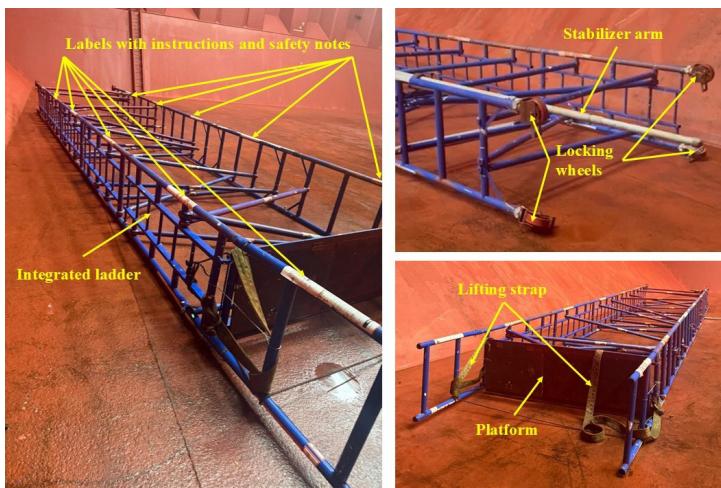
The scaffolding in use on board PRISMA consisted of two vertical frames that were connected by horizontal and diagonal braces. One of the vertical frames had an integrated ladder. The platform was 2,000 mm long and 1,350 mm wide and was connected to the horizontal members of the vertical frames by hooks located at each of the platform's four corners. Locking wheels were fitted at the bottom of the vertical frames (*see Figure 3*).

*Figure 3: The scaffolding that was in use in CH No. 3 on 29 January 2025.*

No apparent defects or failures were observed, and all four wheels were found locked when the scaffolding was examined as part of the Administrator's investigation.

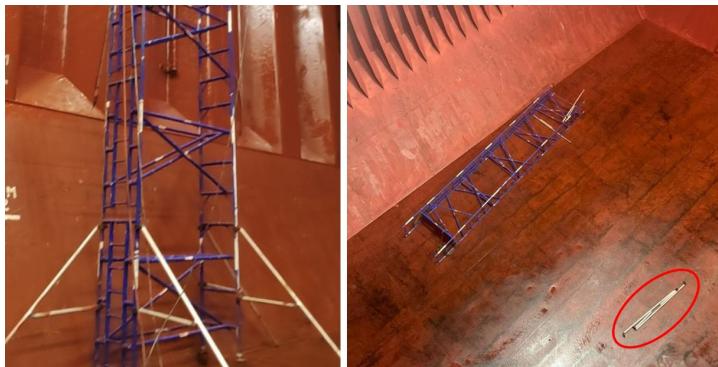
The scaffolding was fitted with four stabilizer arms that, per the manufacturer's instructions, were supposed to be secured in place when the scaffolding was being used (*see Figure 4*). The manufacturer also required that the four wheels be locked. Two of the four stabilizer arms were removed in accordance with the Bosun's instructions when it was set-up before being used in CH No. 3 on 29 January 2025. The ASD1 and ASD2 did not question the Bosun when they were instructed to remove the two stabilizer arms.

Figure 4: The photograph on the left shows the scaffolding in use previously on board PRISMA with all four stabilizer arms in place. The photograph on the right shows the scaffolding lying on the tank top in CH No. 3 after it fell. The two stabilizer arms that had been removed are circled in red.

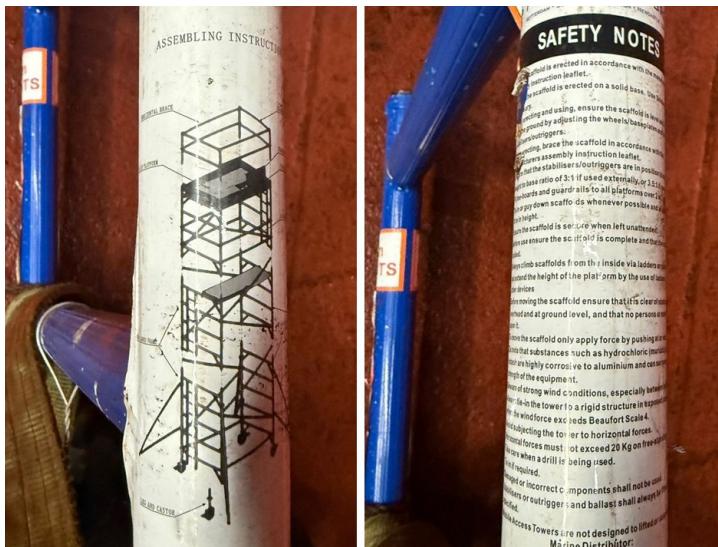
Labels that were affixed by the manufacturer along the length of each of the two vertical frames (see Figure 3) had instructions and safety notes that included guidance and cautions regarding the proper set-up and use of the scaffolding (see Figure 5). The instructions included an image of the scaffolding with four stabilizer arms secured in place. These safety notes included the below information.

1. “Before use ensure the scaffolding is complete (i.e., fully assembled) and the wheels locked.”
2. “Before moving the scaffolding ensure that it is clear of obstructions overhead and at ground level, and that no persons or material are upon it.”
3. “Avoid subjecting the scaffolding to horizontal forces and that when moving it, it should only be pushed at the base.”
4. “Stabilizer arms or outriggers and ballast should always be secured in place as specified.”

Figure 5: Labels affixed to the scaffolding by the manufacturer.

Both the scaffolding manufacturer's instructions for setting up and using the scaffolding, which include the safety notes on the labels affixed on the scaffolding, and the best practices in the UK MCA's COSWP contained provisions addressing the inherent instability of scaffolding. These included the scaffolding manufacturer's instruction for the scaffolding to be fully assembled, which included the use of all four stabilizer arms and that all wheels be locked before it is used. Additionally, both the scaffolding manufacturer's instructions and the recommended best practices in the UK MCA's COSWP unequivocally state that no person or material should be on the scaffolding when it is being moved.
