### SEAFOX DEEMA CASUALTY INVESTIGATION REPORT

Lifting Gear Structural Failure with Fatality

Persian Gulf | 16 March 2020

Official Number: 2098

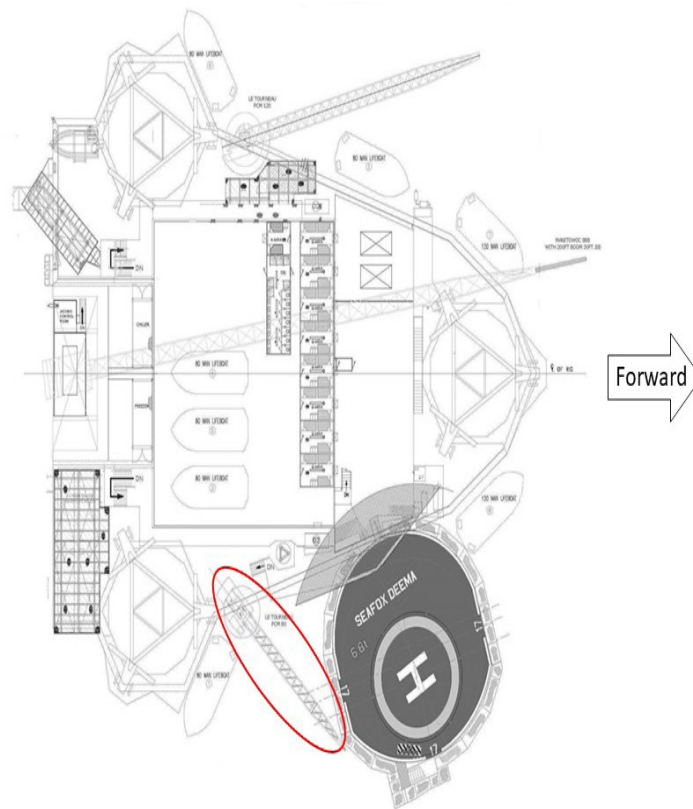
Figure 1: Top deck of SEAFOX DEEMA showing the location of the three deck cranes. The starboard crane (circled in red) was located aft of the helideck. Source: Seafox, SEAFOX DEEMA, General Arrangement – Top Deck, Drawing SF-DEEMA-GA-007, issued 6 May 2015.

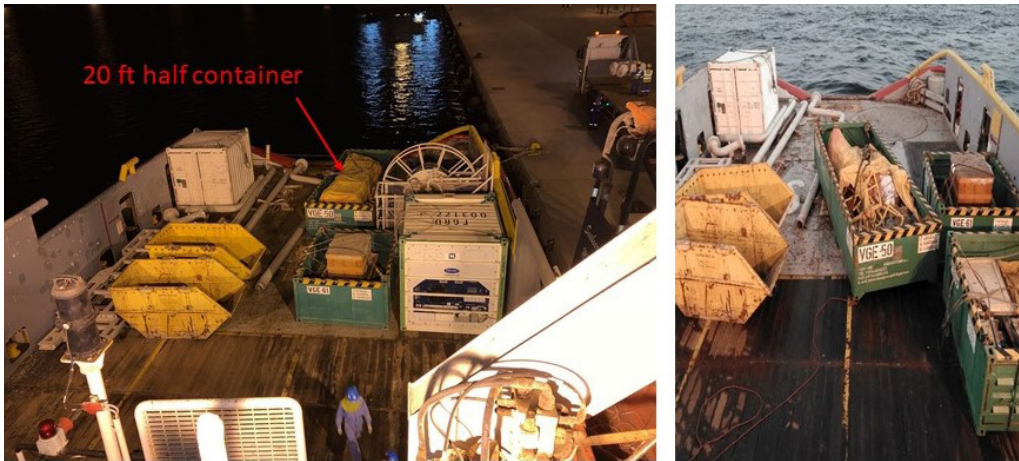
Figure 3: Aft deck of ASTRO SIRIUS showing the location of the 20 ft half container and reel (left) after being loaded on board at Ras Laffan, the State of Qatar for transport to SEAFOX DEEMA. The same 20 ft half container after it fell onto the deck (right).

37. The hook disconnected from the sling between the time that the container and crane fell onto the deck of ASTRO SIRIUS and when the crane sank.
38. None of the personnel who remained on board SEAFOX DEEMA after the crane fell or crewmembers on board ASTRO SIRIUS reported receiving any injuries.
39. The reel that was supposed to be transferred to SEAFOX DEEMA and the 10 ft empty container that had been offloaded to ASTRO SIRIUS during the first lift were pulled overboard by the boom as it slid off the OSV (see Figure 3).

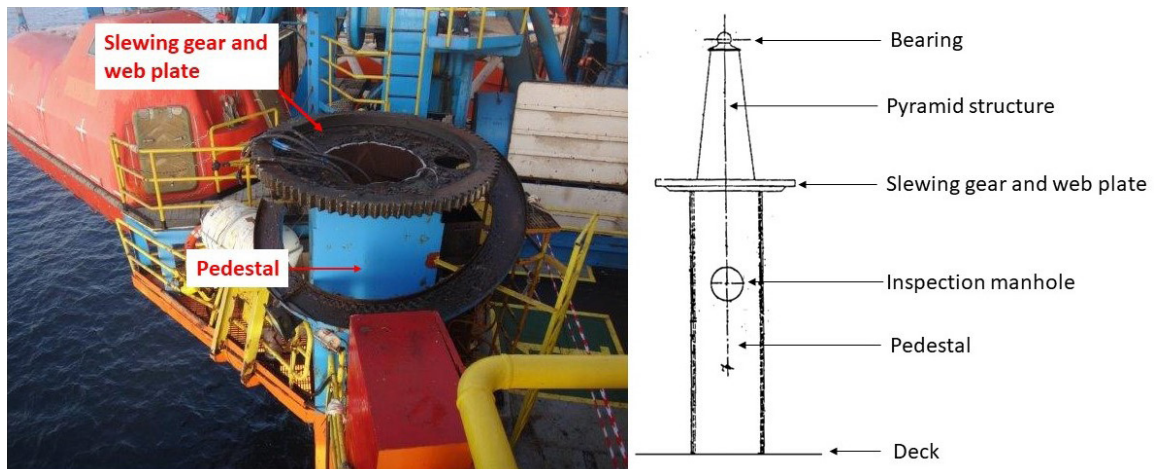
48. The lower section of the starboard crane pedestal along with the slewing gear and web plate remained connected to SEAFOX DEEMA after the incident. The pyramid structure<sup>17</sup> located at the top of the pedestal was missing (see Figure 4).

Figure 4: The starboard deck crane pedestal with slewing gear and web plate after the incident (left). A drawing of the pedestal showing the pyramid structure (right).

The pedestal sheared off just above the slewing gear and web plate (*see Figures 4 and 5*). This is an area where the crane's manufacturer had previously determined that a different model crane with a similar design was prone to fatigue cracking that could cause a potentially catastrophic failure. The manufacturer made this determination after cracks were found during an inspection of a 20-year-old crane.

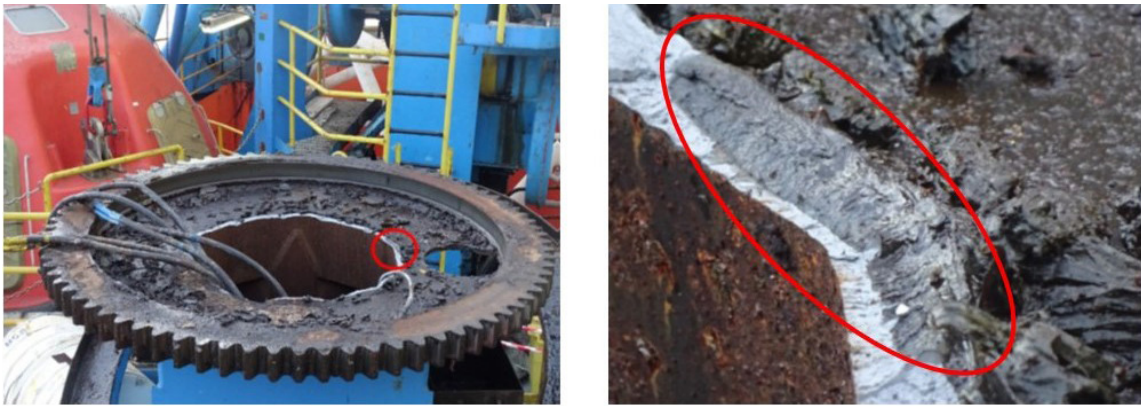
49. It was reported that a visual examination of the welds connecting the pedestal to the unit did not reveal any apparent cracks or other indications of weld failures.
50. The fracture occurred in the middle of the plates that had formed the pyramid structure just above the welds connecting the slewing gear and web plate to the pedestal. The visual inspection of the fracture surface identified an area that had been previously welded (see Figure 5).

Figure 5: Top of the remaining section of the pedestal and a close-up of the area where the weld was found. The welded area is circled in red.

89. During the post-incident inspection, it was observed that the manhole discussed in service letter SIL M-114 had been installed in the starboard crane pedestal. During this inspection, it was also observed that the weld material and possible crack (*see Figures 5 and 6*) were in the areas discussed in the service letters.

Based on the inspection of the pedestal following the incident, indications of a prior repair and a possible crack were found at different locations on the fracture surface (*see Figures 5 and 6*).

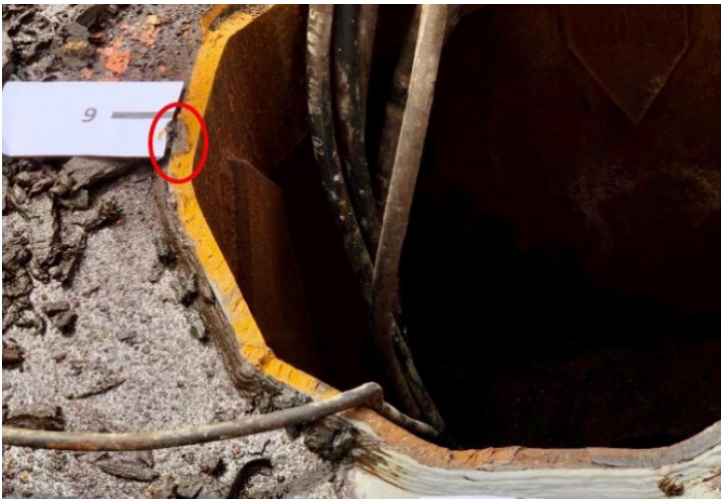
51. The visual inspection also identified an area stained by grease, an indication of a possible crack (see Figure 6).

Figure 6: Top of the remaining section of the pedestal showing the area stained by grease (circled in red).
