REPUBLIC OF THE MARSHALL ISLANDS

SHAMAN WISDOM MARINE SAFETY INVESTIGATION REPORT

Occupational Fatality

North Pacific Ocean | 5 June 2024

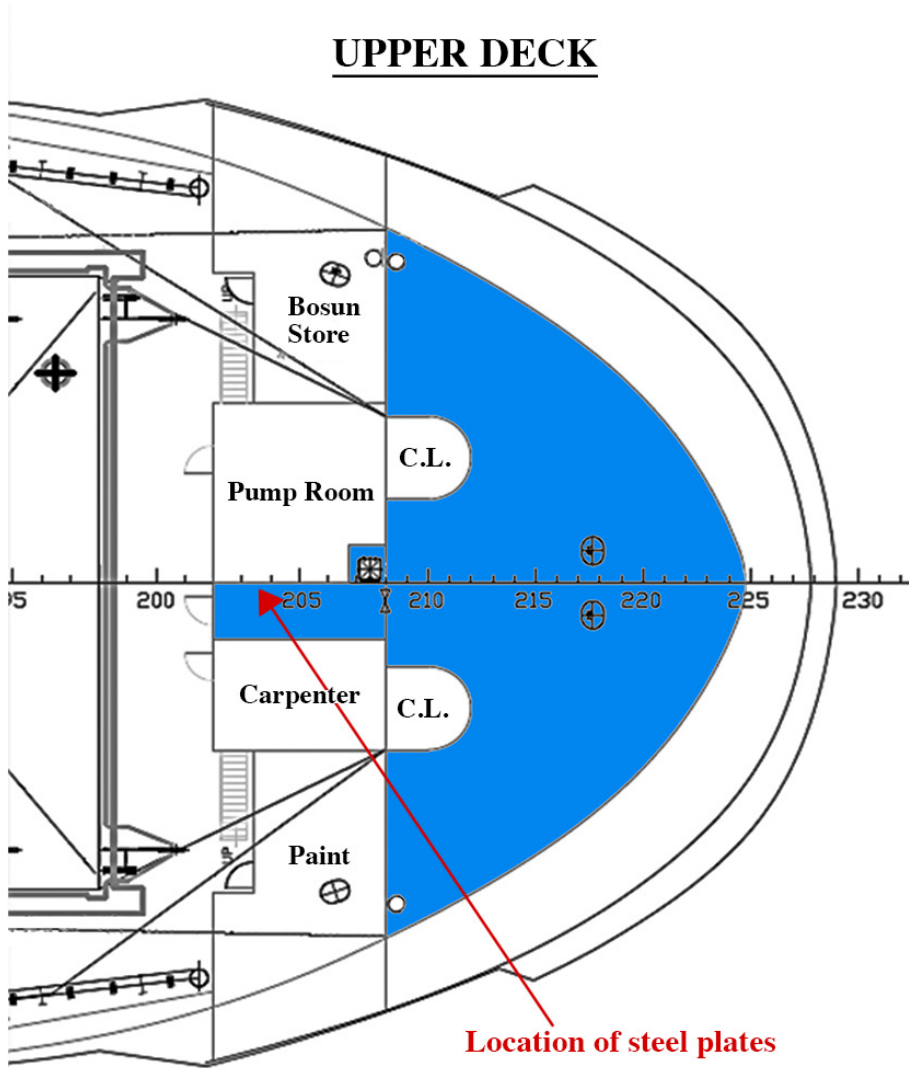
Around 0820, crewmembers started with the assigned activities on deck. The ASD1 and ASD2 went to the entrance of the Forecastle Store where steel plates of different sizes and weights were vertically stowed against a heavy deck plate that was spot-welded to the port side longitudinal¹ bulkhead (see Figure 2).

Figure 2: The perimeter of the Forecastle Store is indicated in blue. The arrow indicates the position of the steel plates near the entrance of the Forecastle Store.

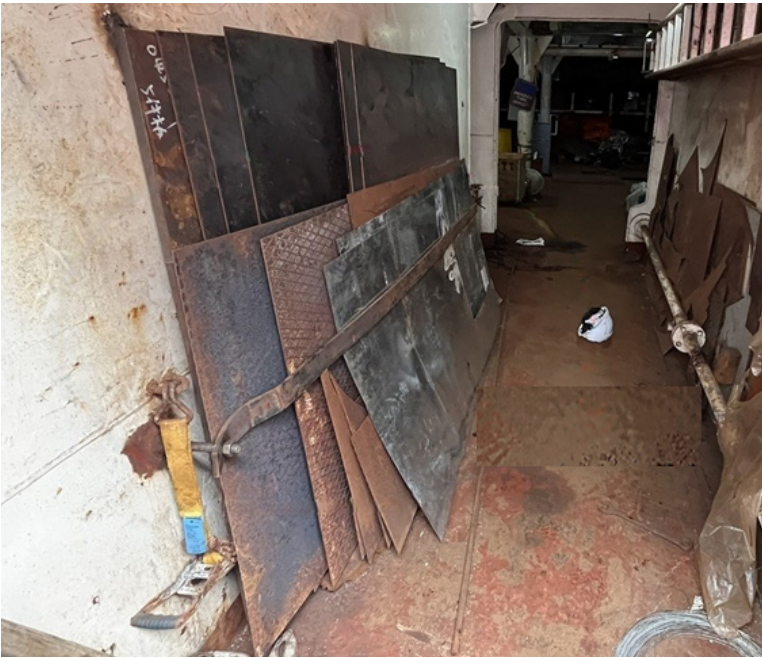
Figure 3: Steel plates stored inside of the Forecastle Store. The ASD1's safety helmet is lying where it was found after the incident.

The ASD1's safety helmet was lying next to him and did not show any marks of a heavy impact by the steel plates. The chin strap was attached to the helmet and the clasp was closed when the helmet was found.

The steel plates were stored vertically against the longitudinal bulkheads leading into the Forecastle Store. The storage rack consisted of a retaining bar that slid over two threaded rods that were welded to the bulkhead (*see Figure 3*). The retaining bar, which was made of flat iron, was held in place on the threaded studs by a nut on either end. A standard nut was threaded onto the stud nearest the door leading to the Forecastle Store. A wing nut was turned onto the opposite stud.

The steel plates were brought on board on or around 4 May 2024 when SHAMAN WISDOM left dry dock at Dalian, China. One heavy steel plate was spot-welded against the longitudinal bulkhead. The other received steel plates, which measured approximately 150 x 155 cm and 150 x 200 cm, were stowed against the steel plate that was spot-welded to the longitudinal bulkhead. Smaller steel plates, that were of varying sizes, were then placed in front of the new steel plates. No wood or wedges were used to equally spread the tension of the retaining bar against the steel plates (see Figure 3).

The ASD1's safety helmet was found lying on the deck next to him, after he was struck by the falling steel plates. The safety helmet did not show any marks of a heavy impact by steel plates. Most probably his helmet was not properly secured and fell off either before or just as his head contacted the steel plates that were stowed on the opposite longitudinal bulkhead.

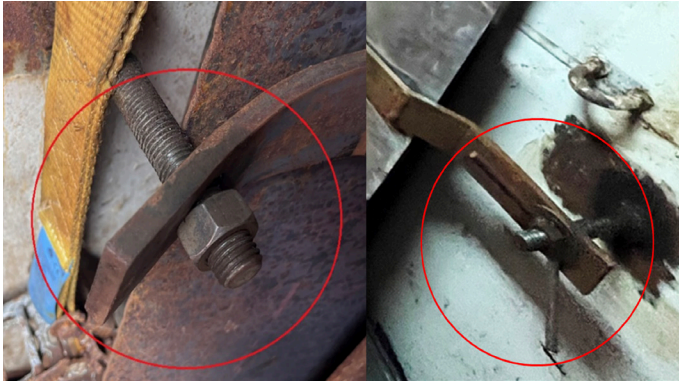
The retaining bar was bent on the end closest to the entrance to the Forecastle Store and did not fit straight onto the threaded stud (see Figure 4). No stopper was in place on the floor or bulkhead to prevent the steel plates from falling after the retaining bar was removed.

Figure 4: The standard nut was threaded onto the stud closest to the entrance of the Forecastle Store (left) and the wing nut was threaded on the opposite stud furthest from the entrance to the Forecastle Store (right). These threaded studs and nuts were used to secure the retaining bar in place.

It was reported that the retaining bar, which was made of flat iron and susceptible to bending, suddenly pushed the nut closest to the Forecastle Store entrance off the threaded stud, before it was completely removed by the ASD2. The way the steel plates were stored required that pressure be applied at both ends of the retaining bar to push the retaining bar onto the threaded studs. This pressure caused the retaining bar to bend around the area where the stack of steel plates was deepest (see *Figure 3*) and placed the retaining bar in tension when the nuts were screwed onto the studs to hold the steel plates in place. As the ASD2 loosened the nut, this pressure most probably caused the retaining bar to suddenly spring off the stud. Wood or wedges filling the gaps between the steel plates and the retaining bar could have equally spread the tension of the retaining bar against the steel plates and could have prevented the retaining bar to bend around the plates, provided that the studs were long enough.

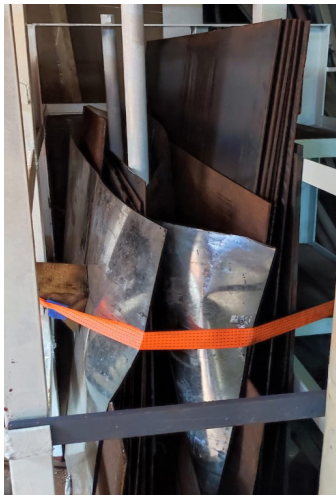
Figure 5: New storage racks on board all Company managed vessels.

1. In response to this very serious marine casualty, the Company has taken the following Preventive Actions:
- (a) Relocated the storage rack for steel plates to a safer position on board their entire fleet and secured them to prevent any risk of the plates falling (*see Figure 5*).
