SHAMAN WISDOM SAFETY INVESTIGATION REPORT

Occupational Fatality

North Pacific Ocean | 5 June 2024

IMO Number: 9563407

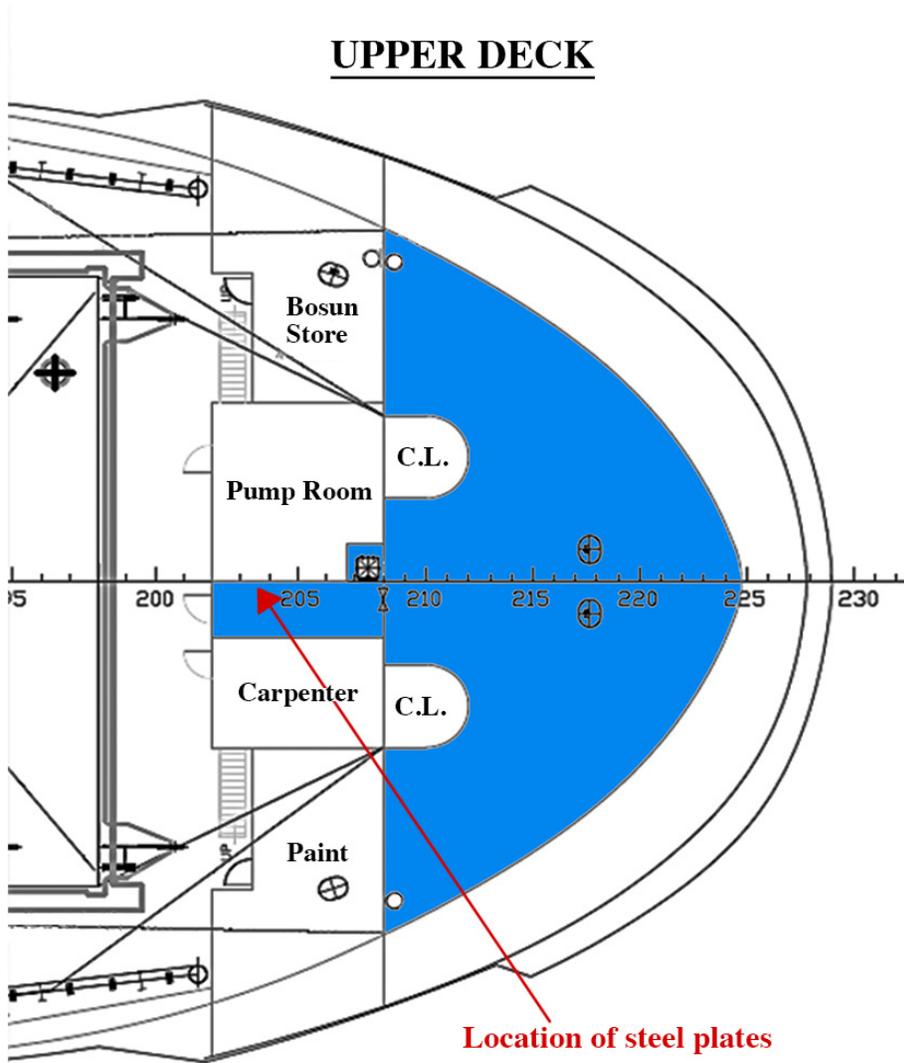
Around 0820, crewmembers started with the assigned activities on deck. The ASD1 and ASD2 went to the entrance of the Forecastle Store where steel plates of different sizes and weights were vertically stowed against a heavy deck plate that was spot-welded to the port side longitudinal¹ bulkhead (see Figure 2).

Figure 2: The perimeter of the Forecastle Store is indicated in blue. The arrow indicates the position of the steel plates near the entrance of the Forecastle Store.

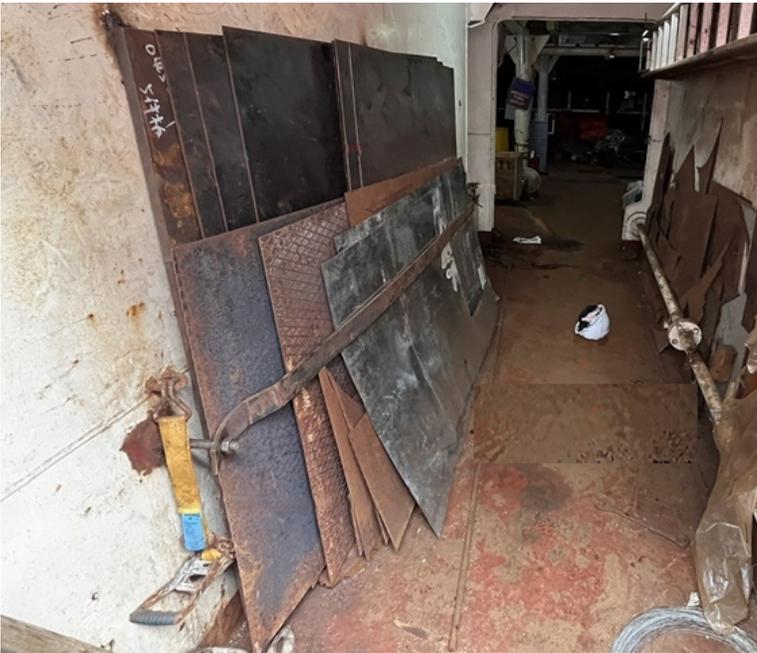
The weight of the heaviest free-standing steel plates was between 50–80 kg each. A retaining bar bolted onto a threaded rod that was welded to the bulkhead, in front of and behind the steel plates, kept the steel plates in position. At the side of the entrance door, the retaining bar was tightened with a nut, requiring a spanner to loosen it. At the other end of the retaining bar, a wing nut with long wings was used. There was no mechanical means in place to prevent the steel plates from falling when the retaining bar was being removed (see Figure 3).

Figure 3: Steel plates stored inside of the Forecastle Store. The ASD1's safety helmet is lying where it was found after the incident.

The steel plates were stored vertically against the longitudinal bulkheads leading into the Forecastle Store. The storage rack consisted of a retaining bar that slid over two threaded rods that were welded to the bulkhead (*see Figure 3*). The retaining bar, which was made of flat iron, was held in place on the threaded studs by a nut on either end. A standard nut was threaded onto the stud nearest the door leading to the Forecastle Store. A wing nut was turned onto the opposite stud.

The steel plates were brought on board on or around 4 May 2024 when SHAMAN WISDOM left dry dock at Dalian, China. One heavy steel plate was spot-welded against the longitudinal bulkhead. The other received steel plates, which measured approximately 150 x 155 cm and 150 x 200 cm, were stowed against the steel plate that was spot-welded to the longitudinal bulkhead. Smaller steel plates, that were of varying sizes, were then placed in front of the new steel plates. No wood or wedges were used to equally spread the tension of the retaining bar against the steel plates (see Figure 3).

The ASD1's safety helmet was found lying on the deck next to him, after he was struck by the falling steel plates. The safety helmet did not show any marks of a heavy impact by steel plates. Most probably his helmet was not properly secured and fell off either before or just as his head contacted the steel plates that were stowed on the opposite longitudinal bulkhead.

1. In response to this very serious marine casualty, the Company has taken the following Preventive Actions:
- (a) Relocated the storage rack for steel plates to a safer position on board their entire fleet and secured them to prevent any risk of the plates falling (*see Figure 5*).

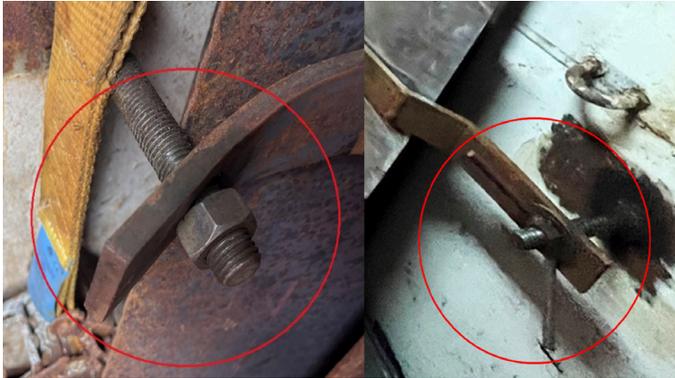
The retaining bar was bent on the end closest to the entrance to the Forecastle Store and did not fit straight onto the threaded stud (see Figure 4). No stopper was in place on the floor or bulkhead to prevent the steel plates from falling after the retaining bar was removed.

Figure 4: The standard nut was threaded onto the stud closest to the entrance of the Forecastle Store (left) and the wing nut was threaded on the opposite stud furthest from the entrance to the Forecastle Store (right). These threaded studs and nuts were used to secure the retaining bar in place.

It was reported that the retaining bar, which was made of flat iron and susceptible to bending, suddenly pushed the nut closest to the Forecastle Store entrance off the threaded stud, before it was completely removed by the ASD2. The way the steel plates were stored required that pressure be applied at both ends of the retaining bar to push the retaining bar onto the threaded studs. This pressure caused the retaining bar to bend around the area where the stack of steel plates was deepest (see *Figure 3*) and placed the retaining bar in tension when the nuts were screwed onto the studs to hold the steel plates in place. As the ASD2 loosened the nut, this pressure most probably caused the retaining bar to suddenly spring off the stud. Wood or wedges filling the gaps between the steel plates and the retaining bar could have equally spread the tension of the retaining bar against the steel plates and could have prevented the retaining bar to bend around the plates, provided that the studs were long enough.

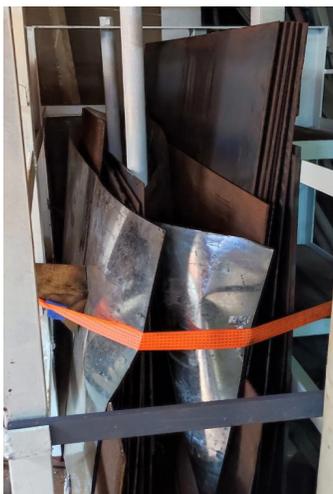
Figure 5: New storage racks on board all Company managed vessels.
