STELLAR BANNER CASUALTY INVESTIGATION REPORT

Grounding and Constructive Total Loss

Offshore Ponta da Madeira, Brazil | 24 February 2020

Official Number: 6941

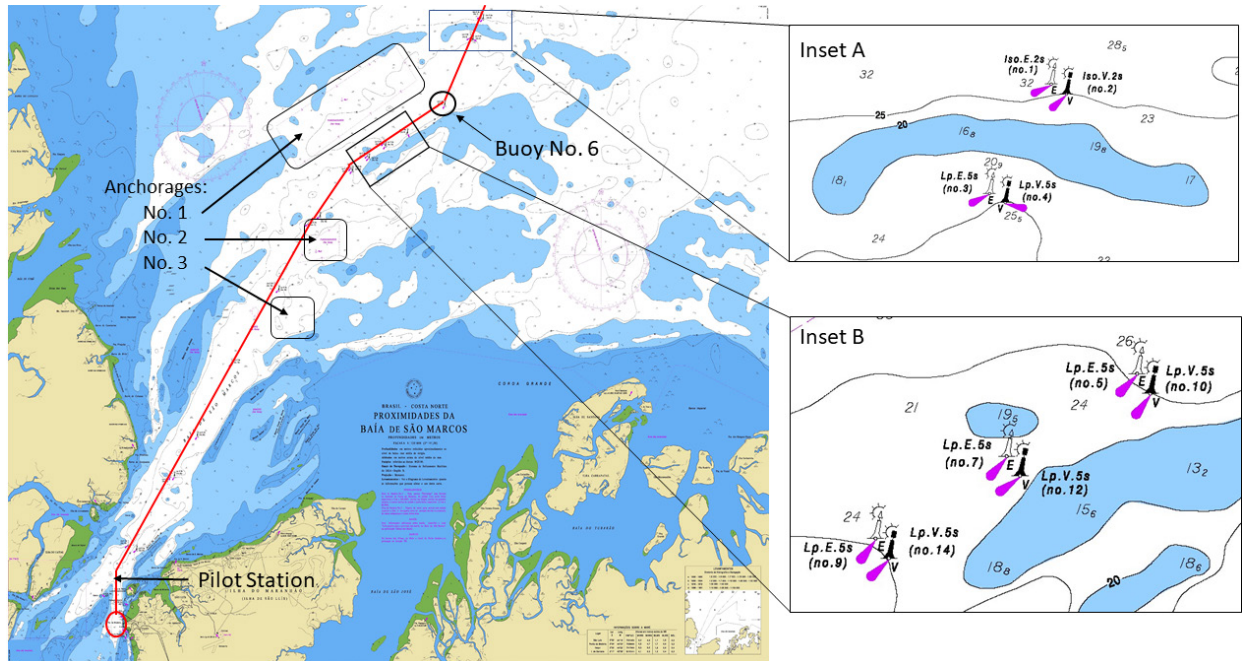
Figure 2: Baía de São Marcos. The location of the Ponta da Madeira Terminal is shown by the red circle and the approach channel is indicated by the red line. Also shown is the sandbar at the channel entrance (Inset A), the narrowest portion of the channel (Inset B), the locations of the Pilot Station, and the three designated anchorages are also shown. (Source: Chart No. 410 issued by DHN.)

17. The channel's outer approaches cross over a sandbar and are marked by two pairs of buoys, Nos. 1 and 2 and Nos. 3 and 4 (see Figure 2, Inset A).⁴ The charted depths of water over the sandbar are 16.8-19.8 m. The charted depths for the rest of the channel are greater than 20 m.

- (ii) provide a meaningful evaluation of the bridge team's performance with respect to the principles of BRM.
2. It is recommended that DHN:
- (a) Consider including the limits of the dredged channel between buoys Nos. 1-4 of the Baía de São Marcos approach channel along with the dredged depth and maintenance information on ENC BR321600 and Chart No. 410 per the relevant IHO standards.

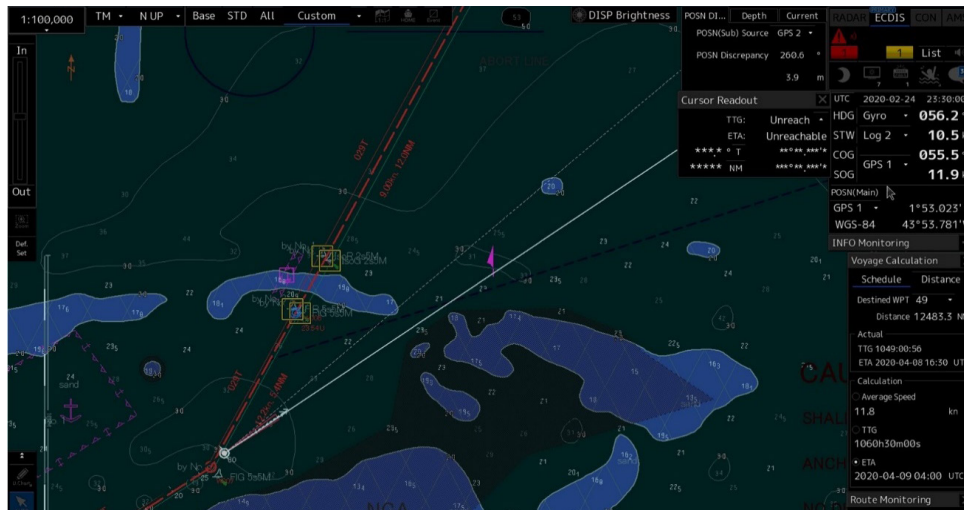
65. Based on the Master's statement, he had decided to leave the marked channel since it was after high tide and there was deeper water outside the channel. The charted depths outside the channel were all greater than 20 m (see Figure 3). Based on the VDR audio recording, the Master did not tell the 3/O why he decided to leave the marked channel, nor did the 3/O ask the Master why he had decided to not follow the planned route.

Figure 3: Position of STELLAR BANNER at 2030 when passing buoy No. 6 as shown on ENC BR321600. The charted depths in the gap between the two sandbanks are 21-23.5 m. The lighter colored areas are where the charted depths are 20 m or less. (Source: STELLAR BANNER VDR information.)

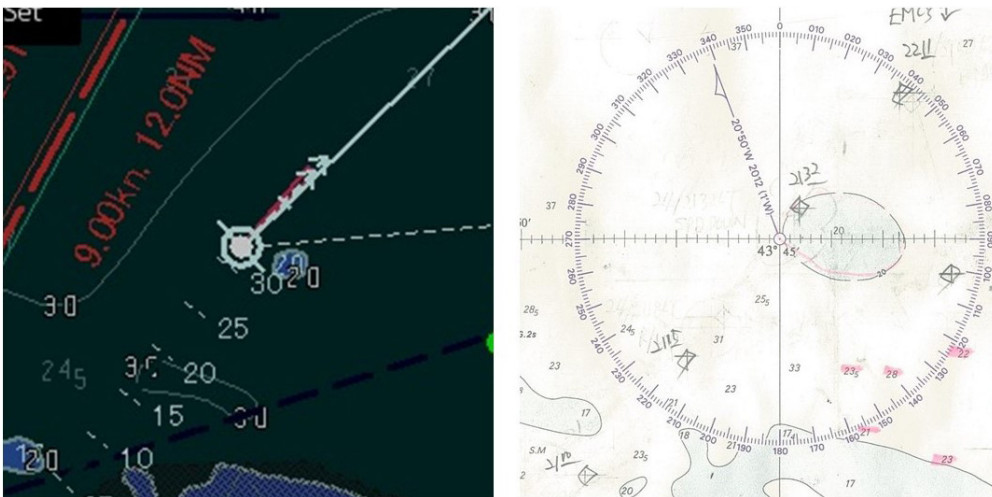
Figure 4: STELLAR BANNER's position at 2132 as displayed on ENC BR321600 (left) and BA Chart 543 (right). The two images are not to scale. Note the use of a dashed line to show the depth contour on BA Chart 543.

76. The dimensions of the 20 m shoal that was off STELLAR BANNER's starboard side at 2132 is shown on ENC BR321600 and Chart No. 21600 as approximately 0.5 NM by 0.5 NM. This same shoal is shown on BA Charts 543 and 3958 as about 1.6 NM by 2.3 NM. The shoal is centered on the same position on all three paper charts and the ENC.
77. The contour for this shoal is shown with a solid line on charts issued by DHN. It is shown with a dashed line on charts issued by the BA.
78. The soundings in this area are widespread.
79. At 2133, the ship's main engine speed dropped from 57-58 RPM to 54 RPM for around 30 seconds. Within a minute the ship's speed over ground dropped from just over 12 knots to about 7 knots. Based on the audio recording from the VDR, the Master said “2.3 m” in the form of a question.

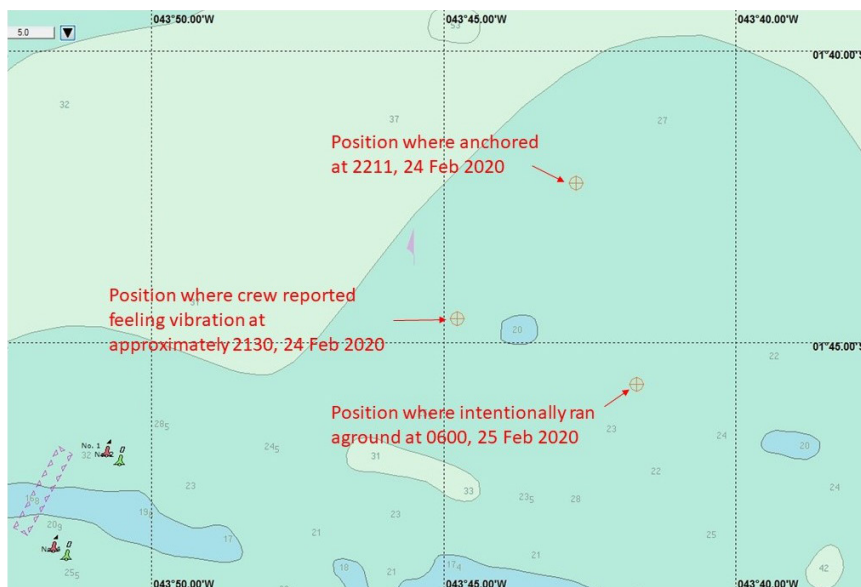
85. At 2211, STELLAR BANNER anchored in position 01° 42.26' S, 043° 42.74' W. The closest charted depth was 27 m (see Figure 5). This position was approximately 3 NM to the northeast of where the crewmembers reported feeling a vibration.

Figure 5: Positions where the crewmembers reported feeling vibration, where STELLAR BANNER was anchored, and where it was intentionally run aground. These positions are shown on ENC BR321600.

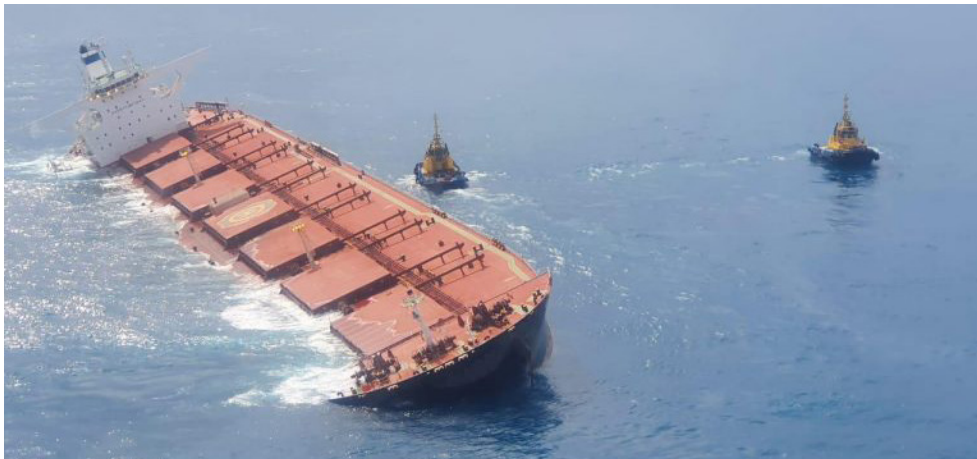
103. By 27 February 2020, the starboard deck was awash with water reaching the cargo hold hatch coamings (*see Figure 6*). Members of the salvage team began going aboard and started preparing to lighter the ship.

Figure 6: STELLAR BANNER aground with starboard deck awash on 27 February 2020. (Source: Brazilian Navy.)

109. On 4 June 2020, KR surveyors attended the ship to conduct a damage survey, which included an underwater hull inspection conducted by divers and a remotely operated underwater vehicle. The WBTs and voids were inaccessible and were not examined internally. Documented damage included:

- (a) Starboard side main deck plates along the entire cargo length were distorted. The average depth of the observed distortion was 500 mm with a maximum depth of 1,000 mm.

- (b) Starboard side shell plates between the base line and a draft of 12 m along the entire cargo length were distorted and fractured. The average depth of the distortion was 10,000 mm with a maximum depth of 12,000 mm.

- (c) Starboard side bottom shell plates along the entire cargo length between the starboard longitudinal bulkhead and the turn of the bilge were distorted and fractured. The average depth of the distortion was 10,000 mm and with a maximum depth of 12,000 mm.

- (d) The bottom shell plates along the entire cargo length between the No. 4 port bottom longitudinal and the starboard longitudinal bulkhead were distorted and fractured. The average depth of the distortion was 2,000 mm with a maximum depth of 4,000 mm.

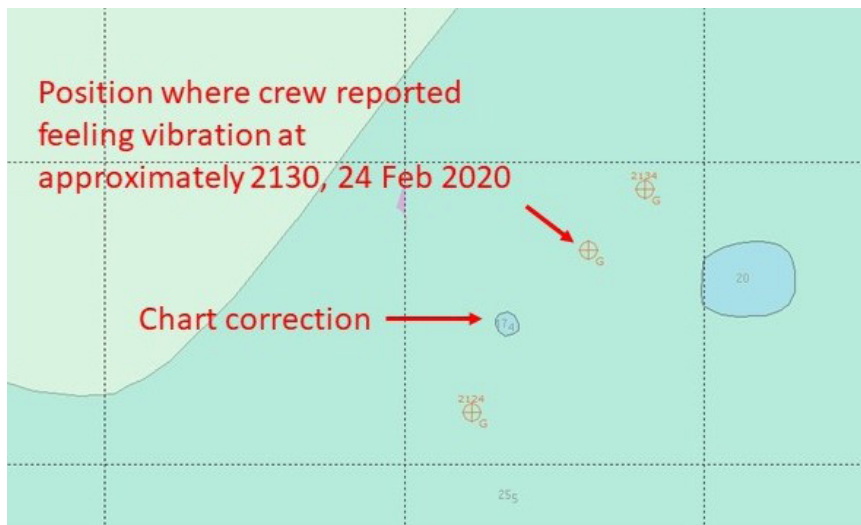
141. In February 2021, DHN issued a correction to Charts Nos. 21020 (INT 2003) and 21600 (INT 2109) to insert a sounding of 17.4 m in position 01° 45.1' S, 043° 45.3' W.⁴² A similar correction was made to BR321600, which was the ENC being used onboard STELLAR BANNER when the grounding occurred (*see Figure 9*). The date of the survey or source of the correction was not reported.

Figure 9: BR321600 showing the 17.4 m sounding and the positions of STELLAR BANNER at 2124, 2130, and 2134 on 24 February 2020.

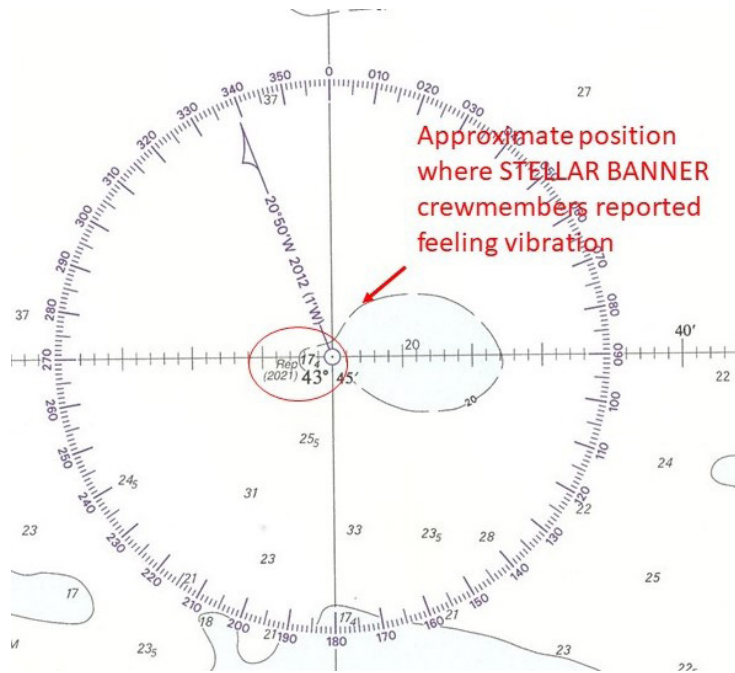
142. In April 2021, the UKHO issued a correction to BA Chart 543 to insert a sounding of 17.4 m and extend the 20 m approximate contour to enclose position 01° 45' 06" S, 043° 45' 32" W (see Figure 10).⁴³ The correction was based on the correction issued by DHN in February 2021.

Figure 10: BA Chart 543 showing the addition of the 17.4 m sounding and the extension of the 20 m approximate contour.

A hydrographic survey of the area in the vicinity of STELLAR BANNER's position at approximately 2130 was not conducted after this incident. However, based on the available information, it is considered likely that the depths near the ship's position at the time were less than 23 m. It is also possible that the actual size of the 20 m shoal was larger than depicted on ENC BR321600 (*see Figures 4 and 5*). It is noted that DHN issued a correction to ENC BR321600 to include the addition of a 17.4 m sounding that was near STELLAR BANNER's positions between 2124–2130 on 24 February 2020 (*see Figure 9*). In addition, the UKHO issued a correction for BA Chart 543 to include this 17.4 m sounding and to extend the 20 m approximate contour that the ship was inside when crewmembers reported feeling a vibration (*see Figure 10*).

3. It is recommended that the UKHO:
- (a) Consider including the limits of the dredged channel between buoys Nos. 1-4 of the Baía de São Marcos approach channel along with the dredged depth and maintenance information on BA Chart 543 provided they are included on Chart No. 410.
