STELLAR DAISY CASUALTY INVESTIGATION REPORT

Loss of Buoyancy and Foundering with Multiple Loss of Life

South Atlantic Ocean | 31 March 2017

Official Number: 3486

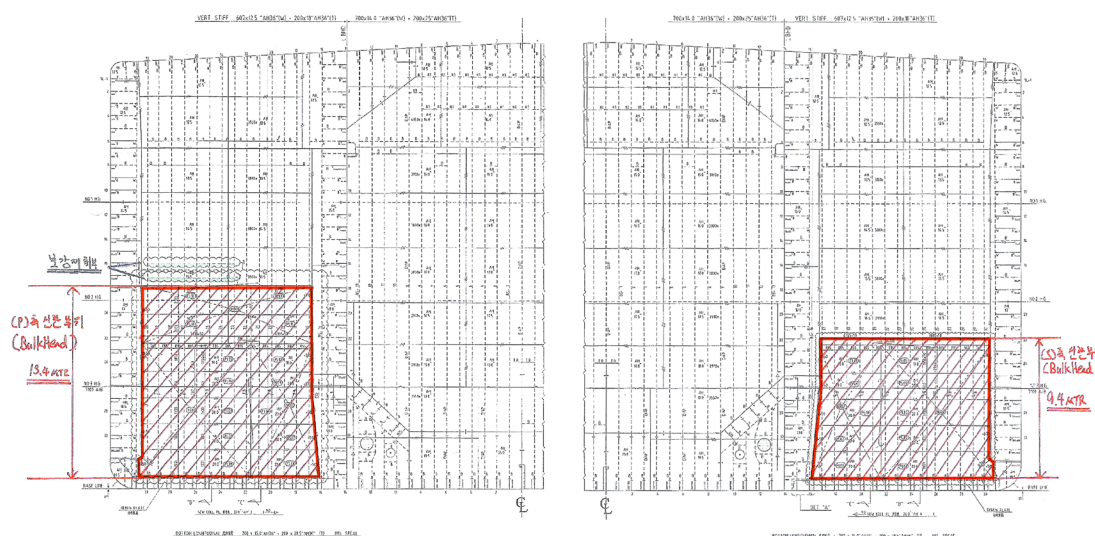
Figure 8: Transverse bulkhead at frame No. 65 starboard (left) and port (right). The side shown is the No. 3 P/S WBTs. The hatch marks denote the damaged area.

54. Based on the findings of the damage survey conducted by the KR surveyor who attended STELLAR DAISY at the Zesco Shipyard in August 2016 and the Master's Statement of Facts, KR conducted a failure analysis to determine the cause of the observed damage of the transverse bulkhead at frame No. 65.⁹⁴ During the Administrator's marine safety investigation in the loss of STELLAR DAISY, KR informed the Administrator it determined the damage of the transverse bulkhead at frame No. 65 was caused by the force of buoyance pushing against the bottom shell as the ship worked in the seas and that the damage should be renewed to original scantlings.⁹⁵ KR also informed the Administrator it considered the damage of the transverse bulkhead at frame No. 65 to be isolated.

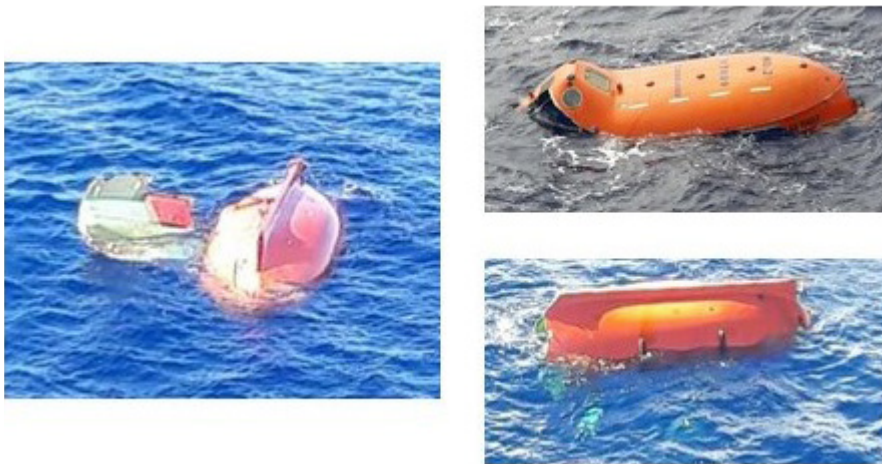
103. ELPIDA also reported sighting two life boats.¹⁴¹ Both life boats were floating capsized. The top of STELLAR DAISY's No. 2 life boat was separated from the hull (see Figure 14). There were no indications that members of STELLAR DAISY's crew were on board either of the life boats. Two additional life rafts were also sighted.¹⁴² One was reported to be floating upright in good condition without any of STELLAR DAISY's crew onboard and the other was capsized.¹⁴³

Figure 14: STELLAR DAISY's life boats. The No. 1 life boat is on the left. The top and the hull of the No. 2 life boat, which were found floating separately, are on the right.

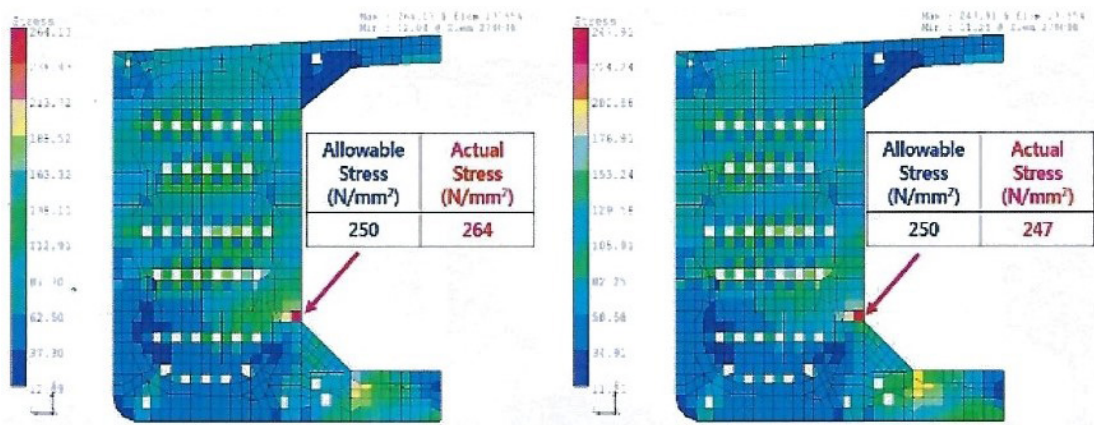
111. KR determined that the FEA results indicated that the stresses in way of Cargo Holds Nos. 3F and 3A was within the limits allowed by the KR Rules for Steel Ships. An area of stress exceeding the allowed limits was identified in the web of the swash bulkhead located at frame No. 79 in way of where the hopper plate is welded to the longitudinal bulkhead. This frame is located at the middle of Cargo Hold No. 2 (see Figure 15). Similar areas of stress were not identified in the other frames included in the model of the half-breadth of the hull in way of Cargo Hold No. 2. KR determined that the stress was localized. The FEA was also conducted, using the as built scantlings, to determine if the results were related to the diminution of the structure due to corrosion. The stress in this area was determined to be slightly below the allowed limits and in compliance with KR Rules for Steel Ships.

Figure 15: Stresses at frame No. 79 based on 2015 thickness measurements (left) and at time of conversion (right).

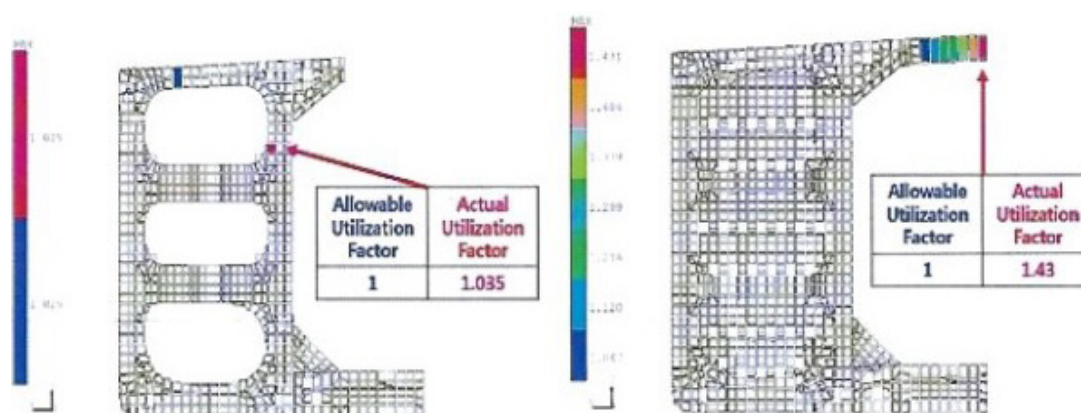
Figure 16: Locations where the structure did not meet the buckling criteria at frame No. 68 (left) and frame No. 79 (right).

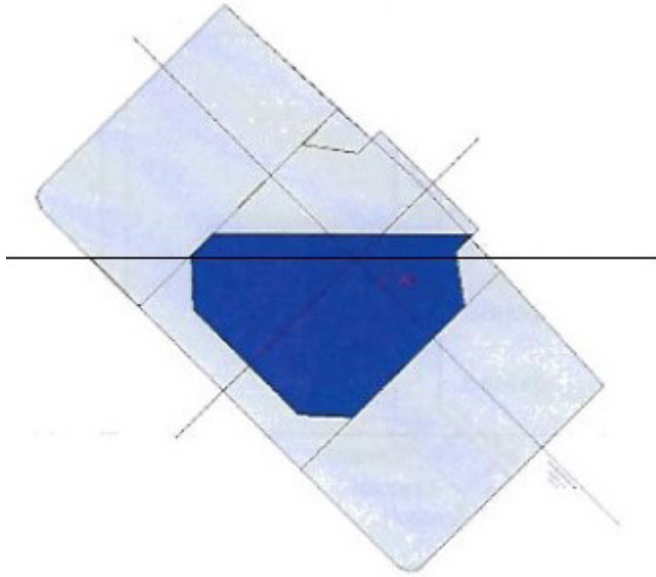
plate and longitudinals exceeded the scantlings required to support the increased pressure, the as built scantlings for the longitudinal bulkhead plate and longitudinals did not meet the required scantlings. Based on this analysis, KR determined that the longitudinal bulkheads could fail between transverse frames following a cargo shift.

Figure 17: Assumed shape of cargo pile after shifting when ship's list was 45° to port. The change of draft due to flooding is not shown.

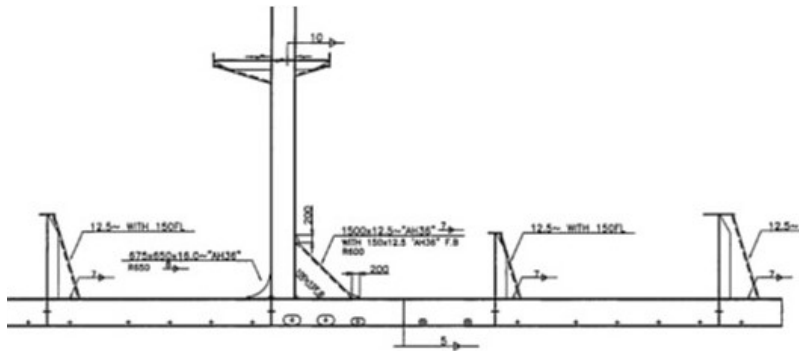
120. Cracks were found in bottom longitudinals in way of a transverse bulkhead on other ships that either had brackets forward of the bulkhead only or had brackets on both sides of the bulkhead. STELLAR DAISY had 1,500 x 1,500 x 12.5 mm brackets fitted with a 150 x 12.5 mm buckling plate on the forward side of the transverse bulkheads and smaller 675 x 650 x 16 mm soft toe brackets on the aft side of the bulkheads (*see Figure 18*). KR determined that 21 of the cracks reported in bottom longitudinals were not fitted with a bracket. The other 17 extended from the toe of the bracket. In addition, on some of the converted VLOCs two or more adjacent bottom longitudinals were found cracked in the same tank.

Figure 18: Bottom longitudinal brackets in way of the transverse bulkhead in the wing tanks.

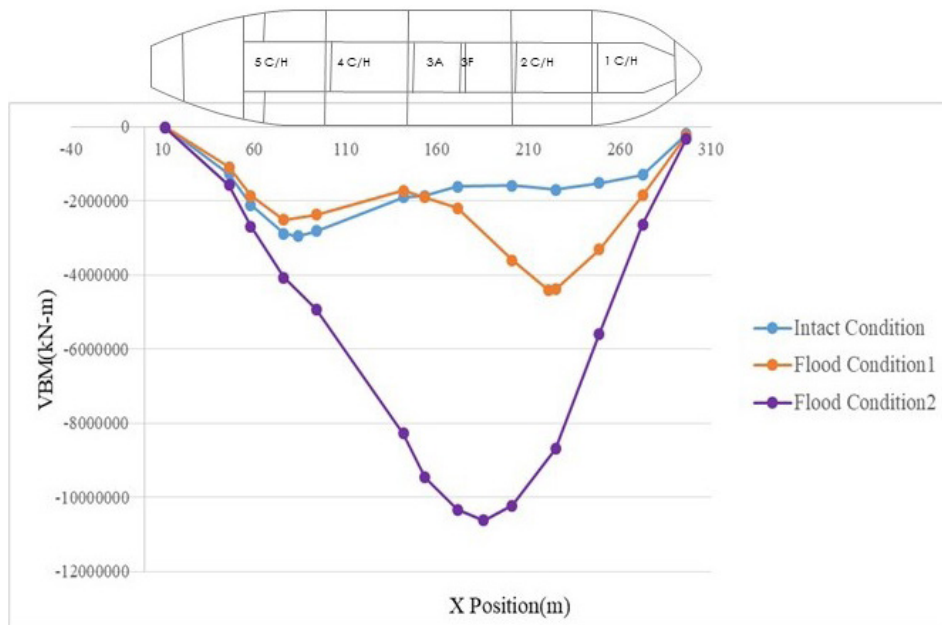
122. KR determined that with No. 2 P WBT flooded, the bending moment would have been 81% and the shear force would have been 66% of the maximum at-sea values. With Nos. 2 and 3 P WBTs flooded, the calculated bending moment was 192% and the shear force was 80% of the allowed at-sea values. Using the calculated bending moments based on the ship's loaded condition as a reference, the maximum still water bending moment increased by approximately 100% when No. 2 P WBT was flooded and by 400% when Nos. 2 and 3 P WBTs were flooded. The location of the maximum bending moment was at frame No. 55 when the ship was in an intact condition, between frame Nos. 78 and 79 when No. 2 P WBT was flooded and between frame Nos. 78 and 79 when Nos. 2 and 3 P WBTs were flooded (see Figure 19).

Figure 19: Still water bending moments.

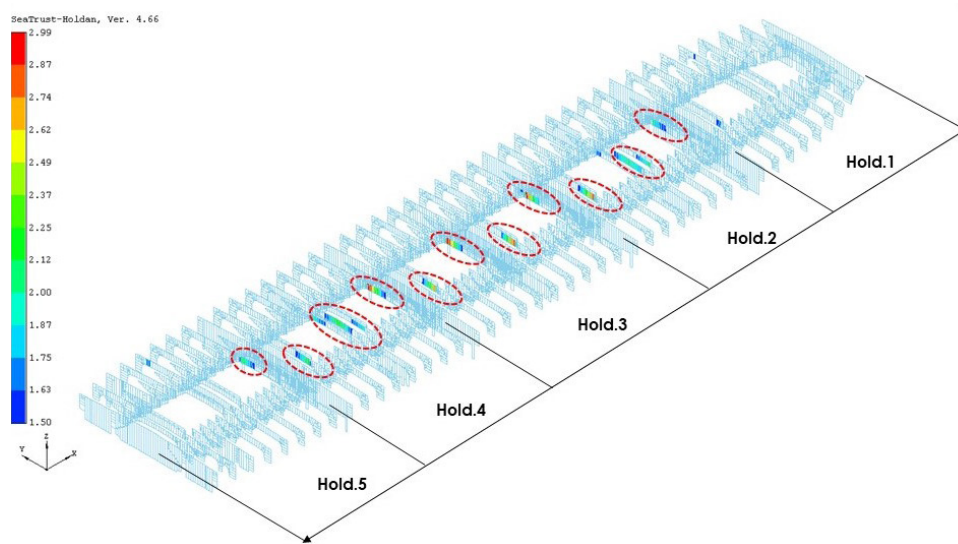
123. KR evaluated the potential for the ship's transverse structure to buckle when No. 2 P WBT was flooded to the point where the ship would have been in equilibrium per ICLL 1966 as amended by the Protocol of 1988, regulation 27(13). Taking into consideration the ship's loaded condition and the weather conditions that existed from 29–31 March 2017, it was determined that portions of the transverse structure between the hatch openings for Cargo Holds Nos. 2-5 would likely buckle (*see Figure 20*). KR also determined that buckling of the transverse structure would likely have begun before the tank was flooded to the point where the ship would have been in equilibrium.

Figure 20: Areas of potential buckling of the transverse structure with No. 2 P WBT flooded.

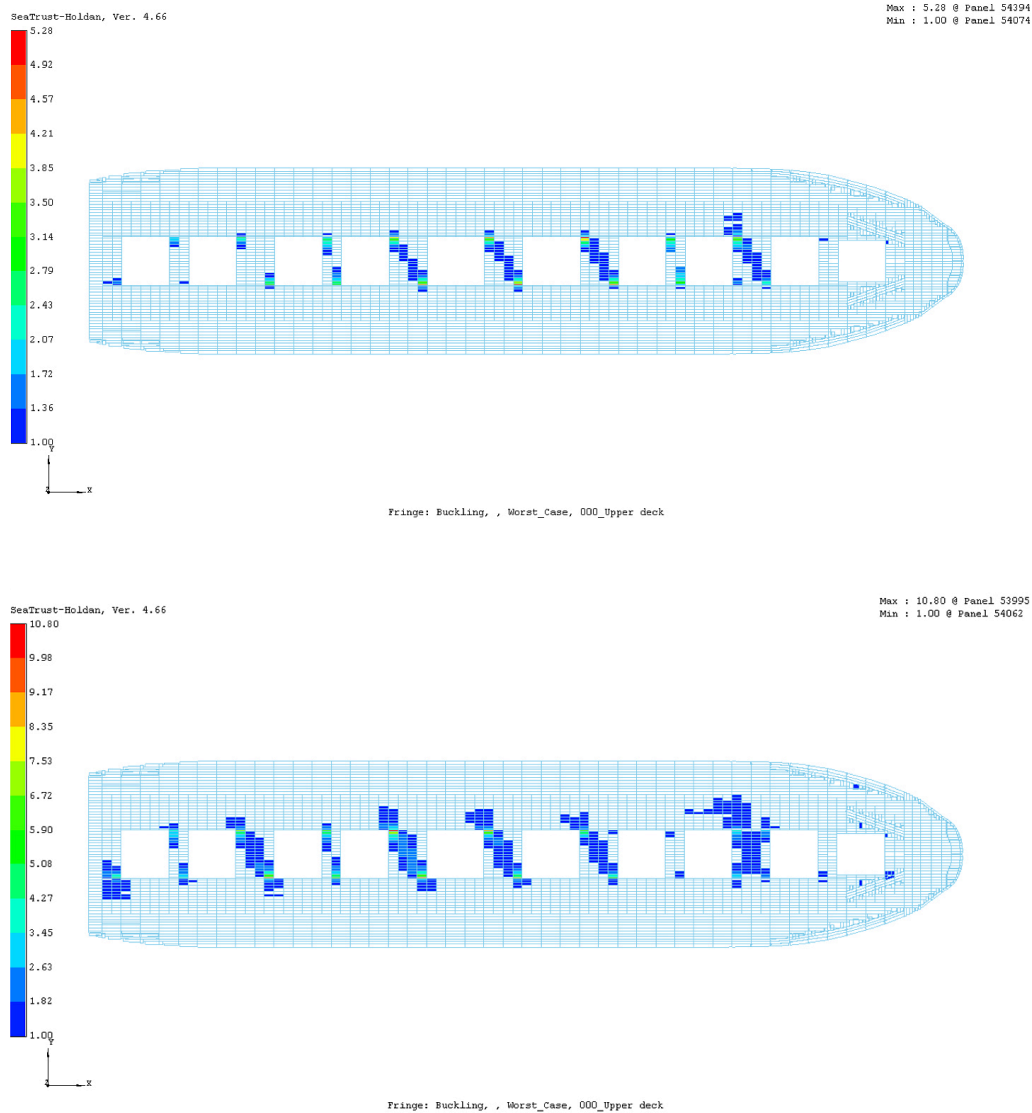
125. The buckling analysis was also conducted with both the No. 2 P and No. 3 P WBT flooded. The analysis indicated that buckling of the transverse structure between hatch openings would be more severe than with only the No. 2 P WBT flooded. It was also determined that multiple transverse bulkheads between cargo holds would likely collapse. The analysis also indicated that deck plate outside of the line of hatch openings would also be damaged. In addition, the deflection of the hatch coamings and covers would become more severe (*see Figure 21*).

Figure 21: Areas of the deck where the buckling criteria was exceeded with No. 2 P WBT flooded (upper) and with Nos. 2 and 3 P WBTs flooded (lower).

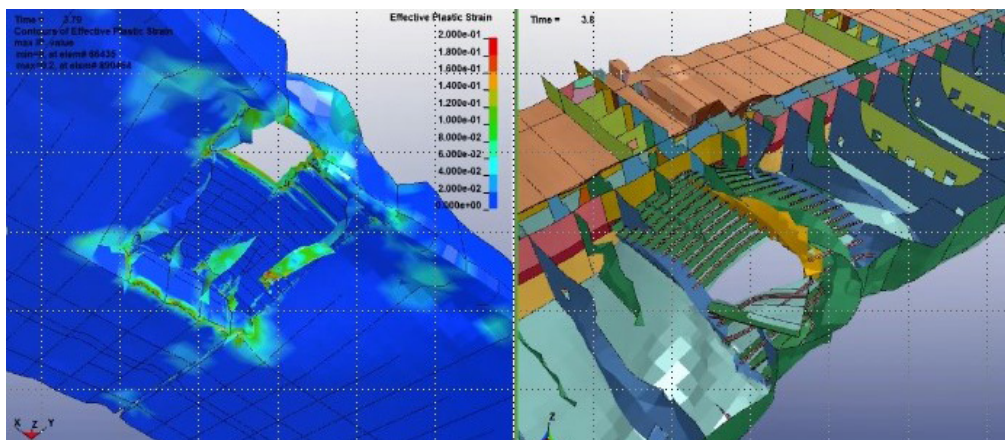
Taking into consideration STELLAR DAISY's repair history and the number of cracks in bottom longitudinals that were identified on other converted VLOCs, managed by Polaris Shipping and classed by KR, after the loss of STELLAR DAISY, the flooding of No. 2 P WBT likely was the result of one or more cracks in bottom longitudinals that either were not detected when the tank was last inspected in October 2016 or that developed after the inspection. As the crack, or cracks, grew, the pressure on the bottom shell as the ship rolled under the influence of the high GM_0 would have imposed additional stresses on the hull structure that could cause latent cracks in other bottom longitudinals to grow or for a fatigued bottom longitudinal to fail. As a result, the size of the crack would likely increase and potentially lead to a loss of shell plate and cause massive, uncontrollable flooding (see Figure 22).

Figure 22: Graphic showing potential damage to the bottom plate and internal structure based on a transverse brittle fracture originating forward of the transverse bulkhead at frame No. 75. The hole in the bottom of No. 2 P WBT is approximately 15 m².
