SUN MASTER CASUALTY INVESTIGATION REPORT

Fatal Fall from Height

South China Sea | 15 June 2020

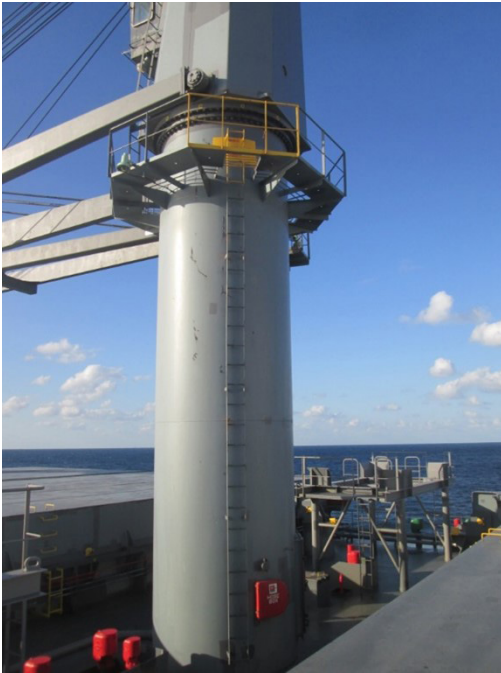
12. Deck Crane No. 4 is fitted with a working platform which extends around the pedestal, just below the turntable. This platform is 10 meters (m) above the deck and is fitted with a two-tier guardrail about 1 m high. Access to the platform is by a vertical ladder attached to the pedestal (*see Figure 2*) which passes through an access hatch.

Figure 2: Deck Crane No. 4. The yellow paint on the platform and guardrail was added following the incident.

1. A special safety meeting was held on board SUN MASTER to discuss the Company's requirements for working aloft.
2. The door in the floor of the platform and the guardrail were painted yellow. A sign was also posted in the vicinity to require the door be closed while working on the platform.
3. A safety campaign was conducted with all ships in the Company's managed fleet to discuss the lessons learned and to increase overall safety awareness.
4. All crews of Company-managed ships were required to complete an additional training course on personal safety.

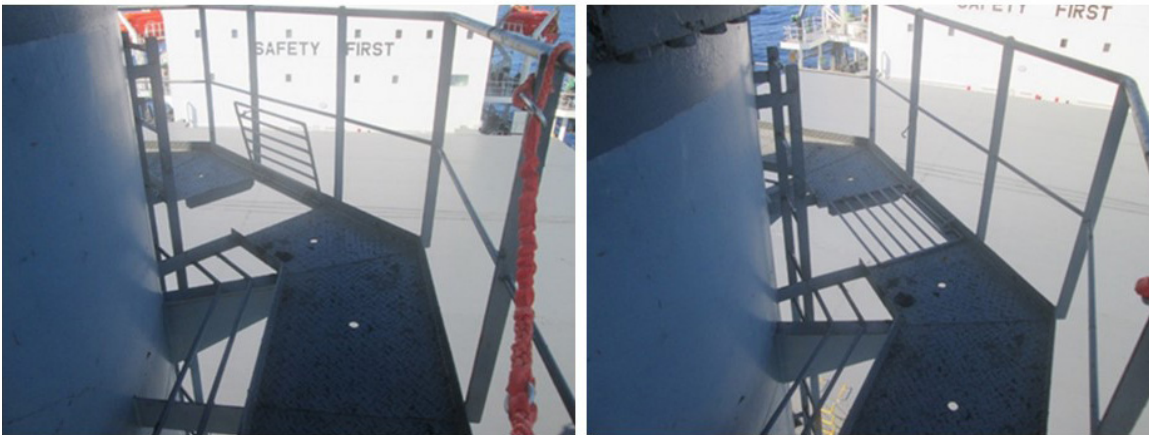
13. The access hatch has a hinged cover that opens upwards towards the guardrail (see Figure 3). No barriers or other safety warnings were provided around the hatch opening while the cover was open.

Figure 3: Platform access hatch in the open (left) and closed (right) positions.

Following the incident, the ladder and platform for Deck Crane No. 4 were inspected by the crewmembers. It was reported that both were in good condition and free of any loose debris or grease contamination. There were no other safety devices or warnings to prevent a fall through the access hatch opening while the cover was open at the time of the incident.

The access hatch cover was opened by the OS1 to climb through and was still open when he fell about 15 minutes later. He was found lying on the main deck directly below the opening, indicating that he likely fell through the opening and not over the railing.

It is possible that the OS1 was focused on greasing the turntable while moving around the platform and accidentally stepped into the uncovered opening, falling to the deck below.

It is recommended that the Company review all ships in their managed fleet to identify similar ladder and access arrangements so that appropriate preventive action may be implemented, such as guarding and/or warnings.
