### SUPER RUBY CASUALTY INVESTIGATION REPORT

Fatal Fall from Height

Mumbai Outer Anchorage | 12 October 2021

IMO Number: 9308120

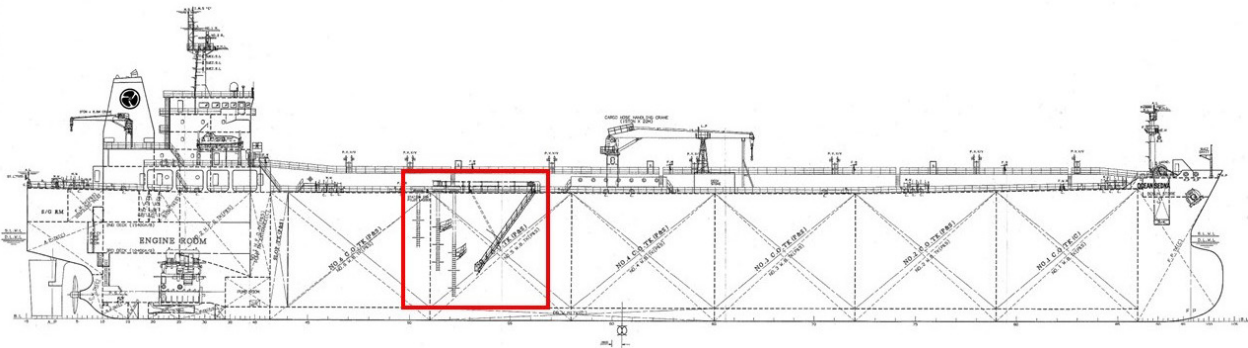
Figure 1: SUPER RUBY General Arrangement. The location of the pilot boarding area is shown in the red square.

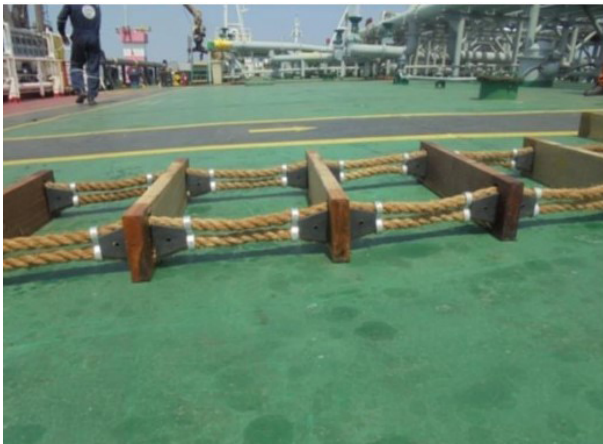
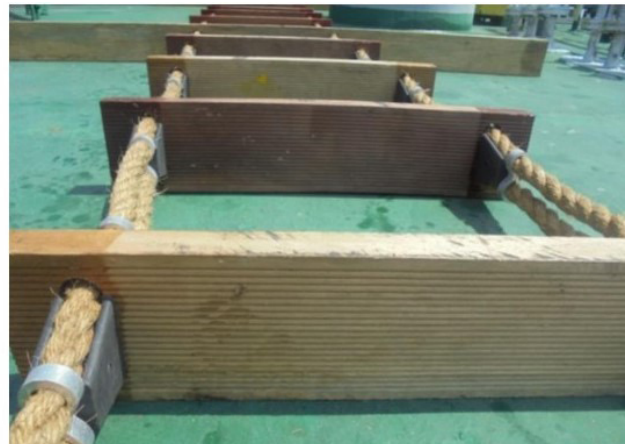
20. The Certificate of Compliance for SUPER RUBY's port side pilot ladder was dated 14 September 2021 in accordance with the requirements of IMO Assembly Resolution A.1045(27), *Pilot Transfer Arrangements* as required by SOLAS regulation, V/23.1.1.2. The ladder had been placed in service on board the ship less than a month before the Superintendent fell while using it.
21. The pilot ladder was found in good condition when it was inspected after the Superintendent fell (*see Figure 2*).

Figure 2: SUPER RUBY's port side pilot ladder.

Based on the information available to the Administrator it cannot be determined why the Superintendent stopped climbing or why he fell from the pilot ladder. Although DHANSHREE was reported to have been rolling, there is no indication that the tug contacted the pilot ladder either when the Superintendent transferred from the tug to the pilot ladder or while he was on it. This suggests that the rolling of the tug did not contribute to the Superintendent falling. Additionally, the weather was reported to be good with clear skies when the incident occurred. This, along with the fact that the pilot ladder was found in good condition and without any defects when it was inspected after the Superintendent fell, indicates that his fall was likely not due to the material condition of the pilot ladder.
