### SYNERGY BUSAN MARINE SAFETY INVESTIGATION REPORT

Ordinary Seafarer Fall Overboard

East China Sea | 19 December 2023

IMO Number: 9450571

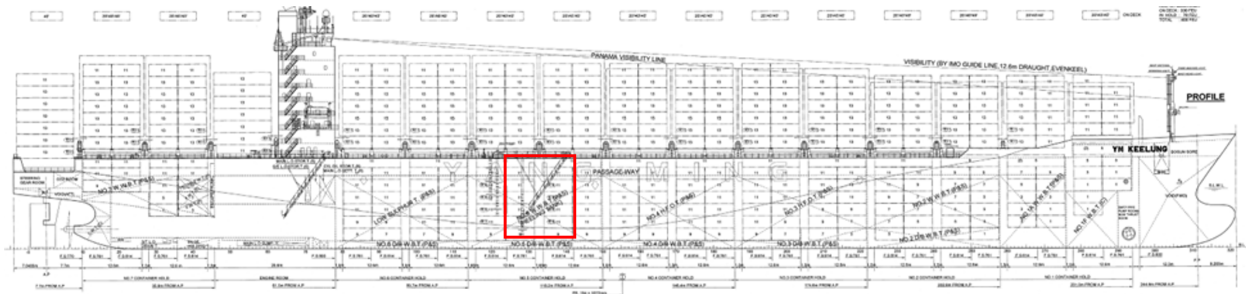
Figure 1: General Arrangement plan of SYNERGY BUSAN with the location of the gangway position outlined in red.

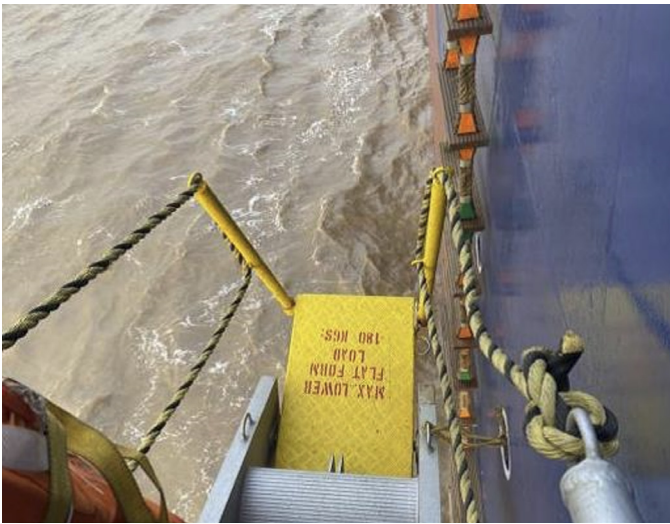
At 2013, the ASD3 looked down onto the accommodation ladder from the Main Deck and witnessed the OS1 fall from the accommodation gangway platform and into the water below. It was estimated that the OS1 fell approximately 7 m.

Figure 2: The accommodation gangway platform where the OS1 fell.

The ASD3 stated that the OS1 fell from the accommodation gangway platform into the water below. Following the incident, the accommodation ladder was inspected and reported to be compliant with no defects. The steps of the accommodation ladder were reported to be wet due to the weather conditions at the time. It could not be determined if the wet steps contributed to the fall.

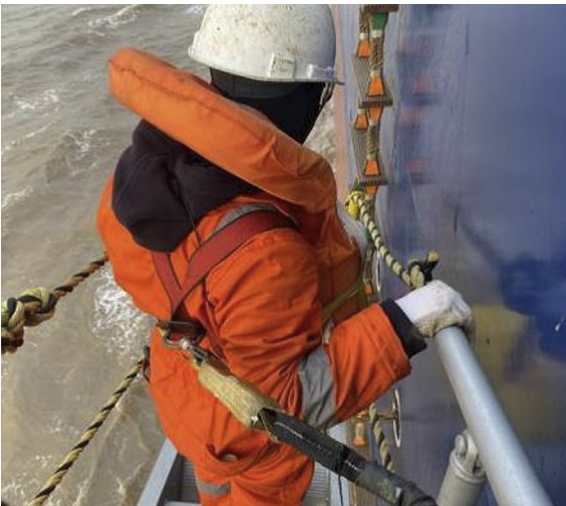
The OS1 was not wearing a safety harness or fall prevention equipment as required (*see Figure 3*). It was reported as common practice for a safety harness with lifeline or fall prevention equipment not to be worn by crewmembers when rigging the combination pilot ladder. It was also reported by several crewmembers that it was uncomfortable and restricted movement when working on Deck.

Figure 3: Photograph of crewmember wearing PPE while working over the side on the accommodation ladder after the incident.

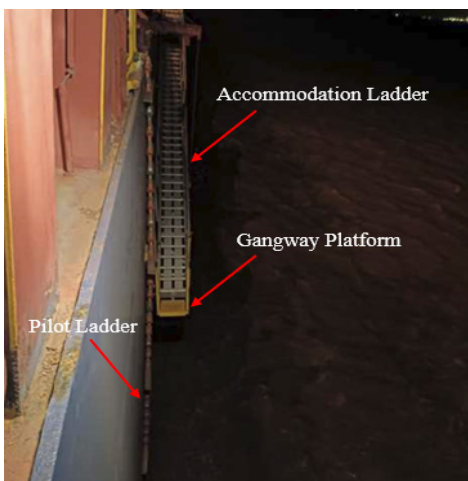
The pilot egress location used at the time of the incident consisted of two parts. An accommodation ladder inclined at an approximate angle of 30° from the main deck, leading aft, and a pilot ladder in vicinity of Bay 38, positioned vertically over the ship side at a height of approximately 9 m (*see Figure 4*).

Figure 4: Starboard side combination pilot ladder.

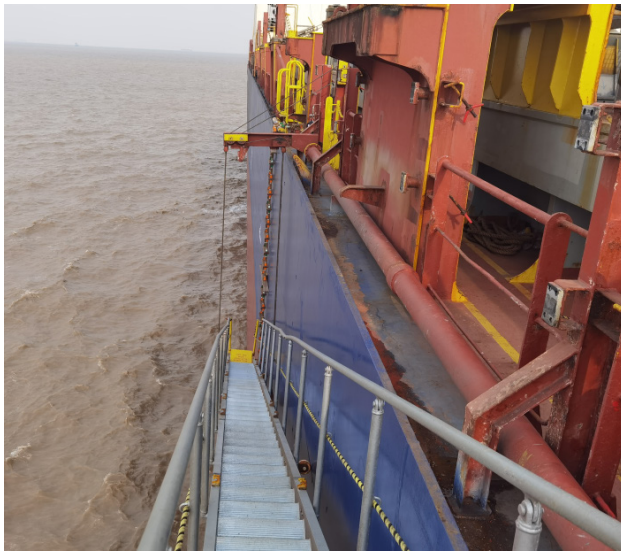
Before the accommodation ladder is ready for use, rope between the stanchions must be rigged and attached to a secure point at the top and bottom of the accommodation ladder. Additionally, the gangway platform must be adjusted to ensure it is parallel with the water. The outboard and inboard side of the combination ladder had a fixed, horizontal handrail supported by equally spaced vertical stanchions which provide support while ascending and descending the inclined ladder (see Figure 5). The combination of handrail, rope, and stanchions reduce the risk of a fall from the side of the accommodation ladder.

Figure 5: Starboard side accommodation ladder.

On 12 December 2023, the accommodation ladder was inspected and load tested by COSCO Shipping Heavy Industry (Zhoushan) Co., Ltd. without remark. Following the incident, both the accommodation ladder and the pilot ladder were found to be clean, free from debris, and structurally intact.
