TAMAR CASUALTY INVESTIGATION REPORT

Fire with Loss of Life

Atlantic Ocean | 24 April 2017

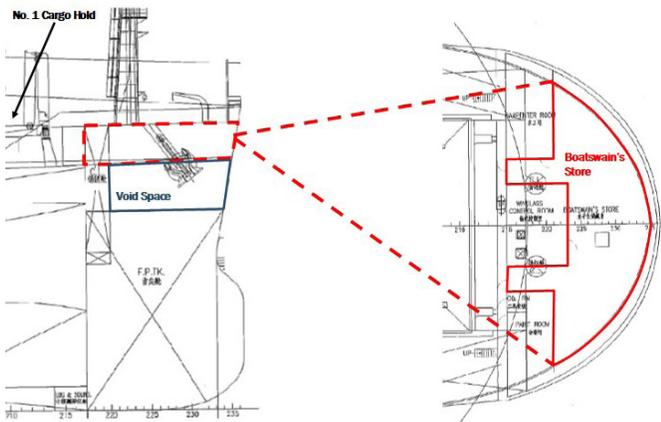
2. TAMAR has five cargo holds with folding hatch covers.
3. The Boatswain’s Store is located forward with access through two watertight doors on the upper deck. The Windlass Control Room and Carpenter Room are accessible from within the Boatswain’s Store (see Figure 1).

Figure 1: General arrangement plan showing Cargo Hold No. 1 and the Boatswain’s Store.

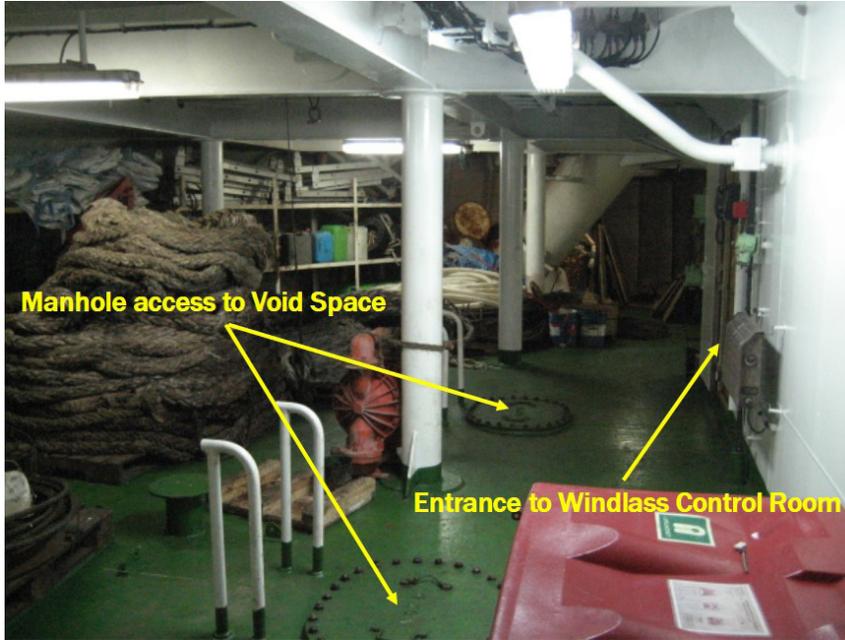
4. A void space is located below the Boatswain's Store (see Figure 1) and is accessed by two manholes located within the Boatswain's Store (see Figure 2).

Figure 2: Boatswain's Store (viewed from port side).

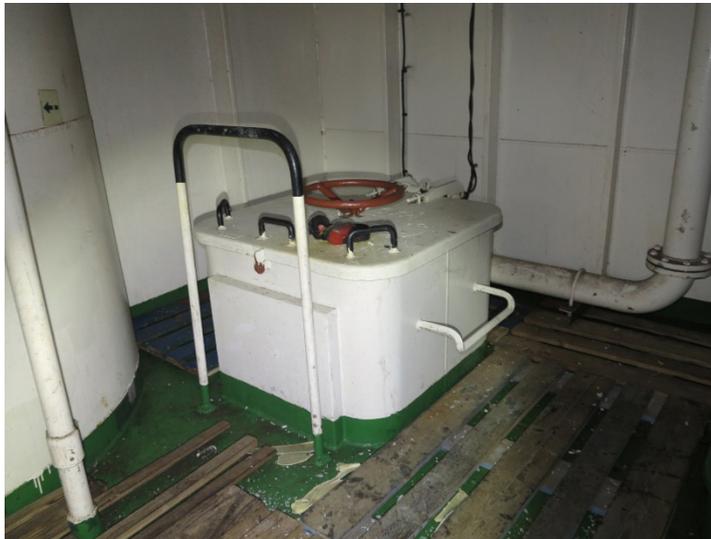
5. The access hatch for the Cargo Hold No. 1 forward ladder is located within the Windlass Control Room (see Figure 3).

Figure 3: Access hatch to the Cargo Hold No. 1 forward ladder located within the Windlass Control Room.

- 45. Following the incident, the access hatch cover for the Cargo Hold No. 1 forward ladder was found to not seal tightly. When closed, the coaming and the cover gasket had a gap between them, resulting in air leaking from the hold into the Windlass Control Room. Following the incident, flammable gasses (up to 18% LEL) were detected entering the Windlass Control Room from the access hatch.

The access hatch for the Cargo Hold No. 1 forward ladder was in the Windlass Control Room inside the Boatswain’s Store. Following the incident, it was noted that the access hatch did not seal tightly, even when fully tightened. Air movement from the cargo hold into the Windlass Control Room was felt and subsequently

tested with gas detection equipment. It was found that the air entering the Windlass Control Room from the hold contained up to 18% LEL. While this concentration of flammable gas is theoretically not high enough to ignite, it would likely build up over time in the Windlass Control Room and the Boatswain's Store. There was no access to these spaces for several days before the incident and it is likely that flammable gasses accumulated until they reached ignitable levels.

Crewmembers stated that the forward ladder for Cargo Hold No. 1 was not used regularly as there was another more convenient access point. As the forward ladder access hatch was protected from the elements and seawater, it probably did not receive the same preventative maintenance as the on-deck hatches.

SOLAS 74 Ch. II-1/3-6 requires safe access to cargo holds accessible from an open deck. The ship's classification society confirmed that TAMAR's design and construction complied with this regulation since the aft ladder was accessible directly from the open deck. When the cargos carried were dangerous and hazardous materials, fitting the hold access ladder in an enclosed space was a risk not considered by SOLAS, the IMSBC Code, nor TAMAR's design.

This casualty may not have occurred had the access hatch for the forward ladder been designed and constructed to lead directly to an open deck.

4. It is recommended that the Administrator consider submitting a proposal to the IMO to amend the IMSBC Code, Resolution MSC.268(85) to require that openings of bulk cargo holds utilized for the carriage of cargoes with a propensity to give off flammable or toxic gases be designed and maintained in a manner which prevents harmful gases from accumulating in work spaces above or below deck.

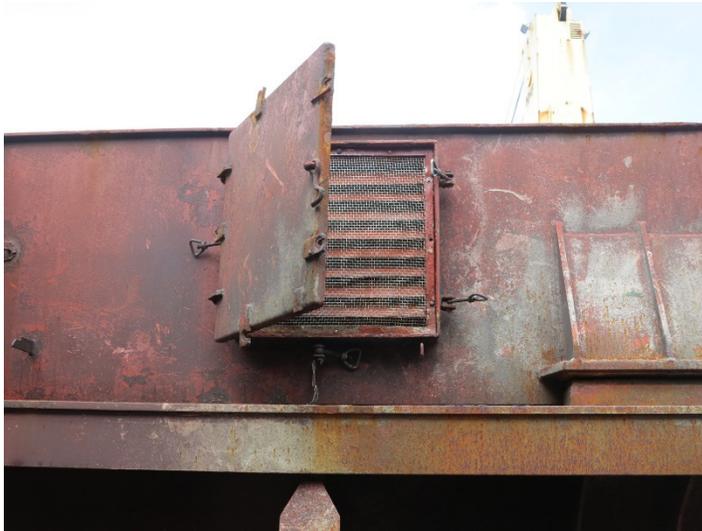
6. Each cargo hold cover has ventilation hatches fitted with watertight covers. Cargo Hold No. 1 has two ventilation hatches on the forward side of the hold cover and two on the aft side (*see Figure 4*).

Figure 4: Ventilation hatch on the forward starboard side of the Cargo Hold No. 1 hatch cover.

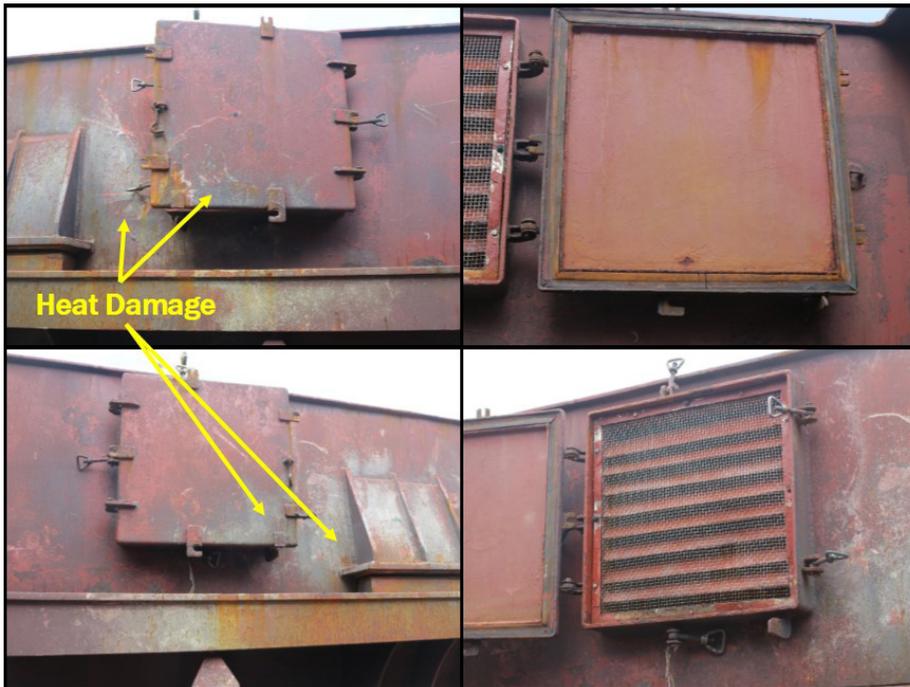
37. The port and starboard covers of the ventilation hatches for Cargo Hold No. 1 had heat damage to the outside of their covers. The insides of the ventilation hatch covers and their screens did not show any damage from exposure to fire, heat, or smoke. This indicates that the ventilation hatches were closed at the time of the explosion (*see Figure 5*).

Figure 5: Port and starboard ventilation hatches for Cargo Hold No. 1. Heat damage present on exterior side of hatch only.
