TIGRIS CASUALTY INVESTIGATION REPORT

Fatal Fall on Stairs

North Sea | 26 August 2020

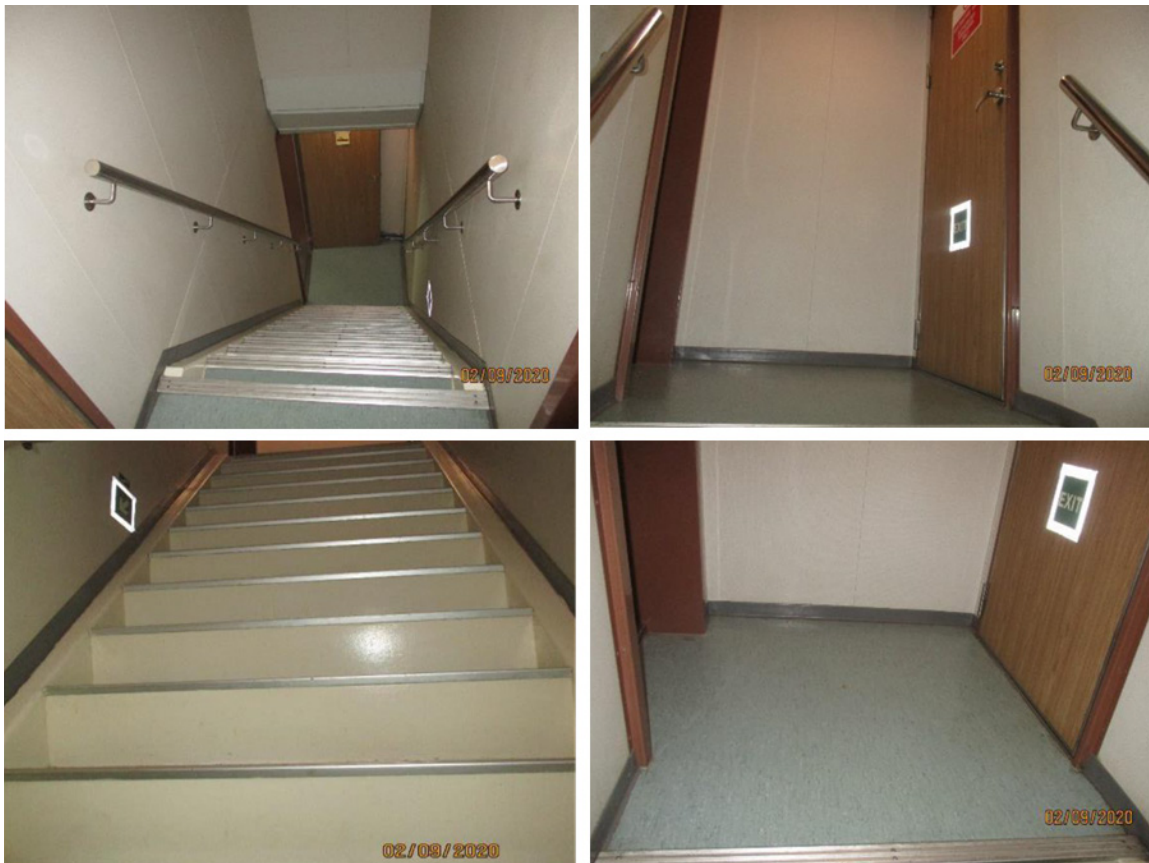
Figure 1: Stairs between the B deck and the Bridge of TIGRIS.

20. The stairs that the Master fell from run between the B deck and the Bridge (*see Figure 1*). A door at the bottom of the stairs separates the landing from the B deck corridor.

21. There is a landing at the top of the stairs, and a door separating it from the Bridge. At the time of the incident, the door at the bottom of the stairs was held open by a magnetic holdback. The Bridge door was closed.
22. Continuous handrails are on both sides of the stairs. These end at the top of the steps, but do not extend onto the landing.

The handrail on both sides of the stairs ended at the top of the steps and did not extend onto the landing (*see Figure 1*). The handrail closest to the Bridge door would have likely been behind or to the side of the Master as he was attempting to open it.

2. Causal factors that may have contributed to this very serious marine casualty include:
 - (a) the handrails on the stairs between the B deck and the Bridge did not extend onto the landing outside the door.

1. A safety alert was sent to all ships in the Company's managed fleet to raise awareness and share the lessons learned from this incident.
2. A fleet circular was sent to all ships in the Company's managed fleet to remind crewmembers of the importance of adjusting heading and speed when encountering heavy weather to reduce pitching and rolling.
3. A safety campaign focusing on ladder and stair safety was implemented. The safety campaign stressed the precautions to be taken during heavy weather and required a safety poster to be displayed on each deck near stairs inside the Accommodation.
4. This incident and lessons learned have been included as a case study for use at the Company's training facility.
5. The Company's drill schedule was amended to include training on medical evacuation of injured personnel.
6. A handrail was installed on the bulkhead near the Bridge door on TIGRIS.
