### TRF MANDAL MARINE SAFETY INVESTIGATION REPORT

Enclosed Space Fatality

Arabian Sea | 23 July 2022

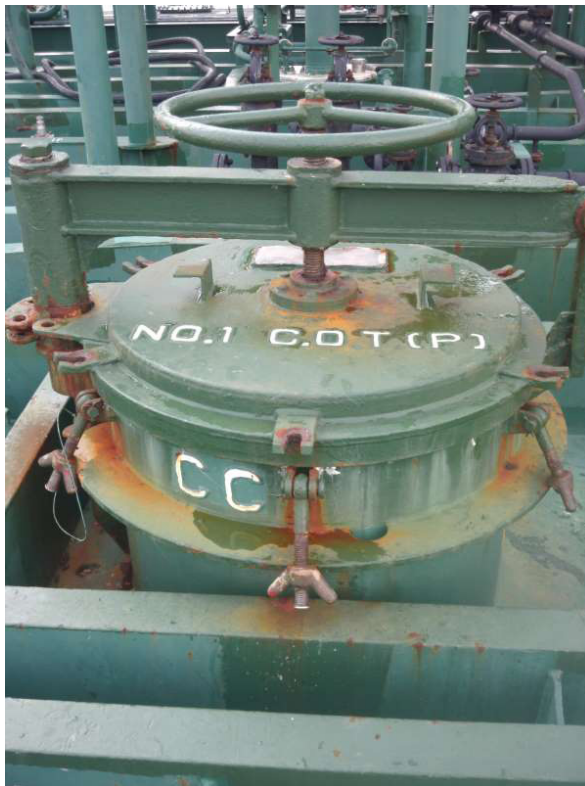
17. After ambient sea water washing was completed, the C/O directed the Bosun and an ASD to open the access hatch to COT No. 1P (see Figure 2). Once open, the C/O inspected the underside of the access hatch. Based on what he observed, he determined that the planned chemical recirculation was needed.

Figure 2: COT No. 1P access hatch and trunk.

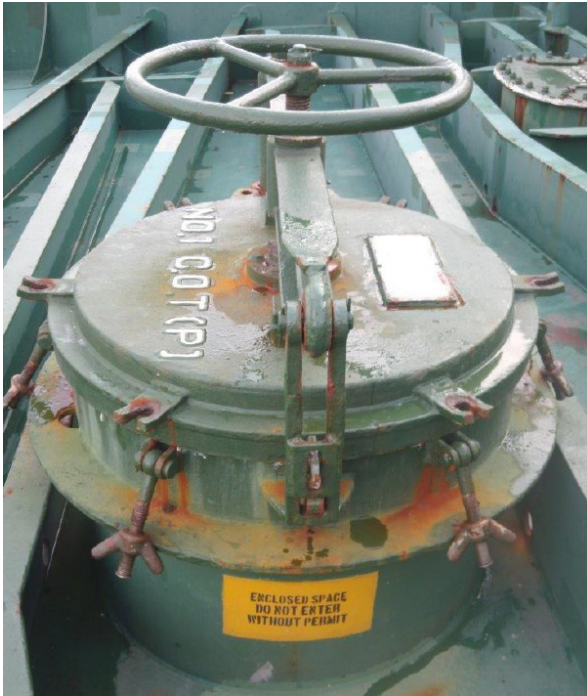
31. A warning statement reading “ENCLOSED SPACE DO NOT ENTER WITHOUT PERMIT” was on the outside of the access trunk leading into COT No. 1P (see Figure 3). There was not a similar warning on the inside of the trunk.

Figure 3: COT No. 1P access hatch showing warning label.

32. The warning label was on the same side of the access trunk as the hinge for the hatch cover and the access ladder for COT No. 1P.

The access hatches for all COTs on board TRF MANDAL were marked with a warning which indicated that the tank was an enclosed space, and that entry was not allowed without a permit. The warning labels are on the side of the access hatch and brightly colored. The warning label on COT No. 1P would have been clearly visible even with the access hatch open.

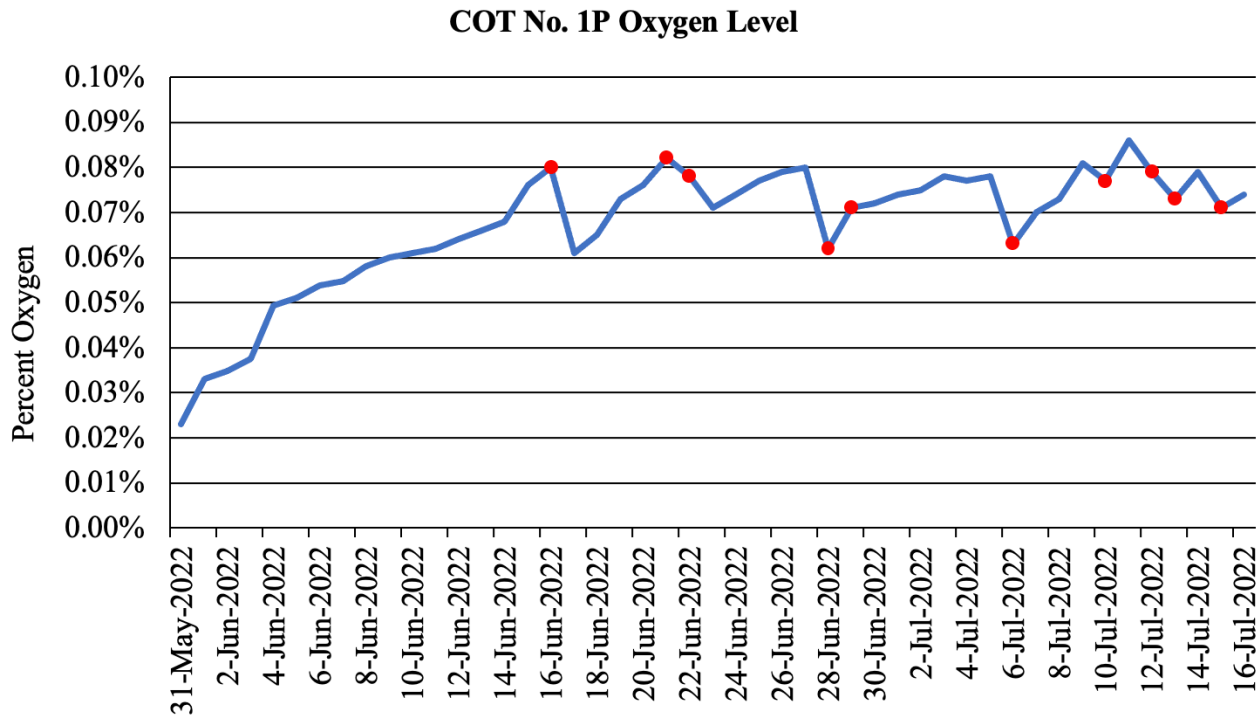
33. Atmospheric testing of COT No. 1P was conducted daily while the tank contained Neodene 14. Oxygen levels remained below the required 0.1% at all times (see Figure 4). During the voyage, 99.9% nitrogen was added to COT No. 1P on 10 occasions to maintain the low oxygen level.

Figure 4: Oxygen levels in COT No. 1P. Dates which nitrogen was added to the COT are indicated in red.

The last cargo carried in COT No. 1P was Neodene 14. The instructions received by the ship from the Charterer required that the oxygen in the tank be maintained below 0.1% during loading, transport, and discharge. The ship's nitrogen generator, shore supplied nitrogen, and nitrogen bottles were used to maintain the atmosphere below this required level (see Figure 4). The atmosphere of COT No. 1P was checked during the Administrator's investigation. It was found that COT No. 1P contained only 7% oxygen two days after the incident. Atmospheric testing was not conducted at the time of the C/O's entry; however, the oxygen concentration would have been between 0.07% (last recorded testing on 16 July 2022) and 7% (testing conducted on 25 July 2022). This is significantly below the 21% recommended by IMO Resolution A.1050(27).
