VALARIS DS-17 MARINE SAFETY INVESTIGATION REPORT

Occupational Fatalities

Las Palmas, Canary Islands, Kingdom of Spain | 21 April 2023

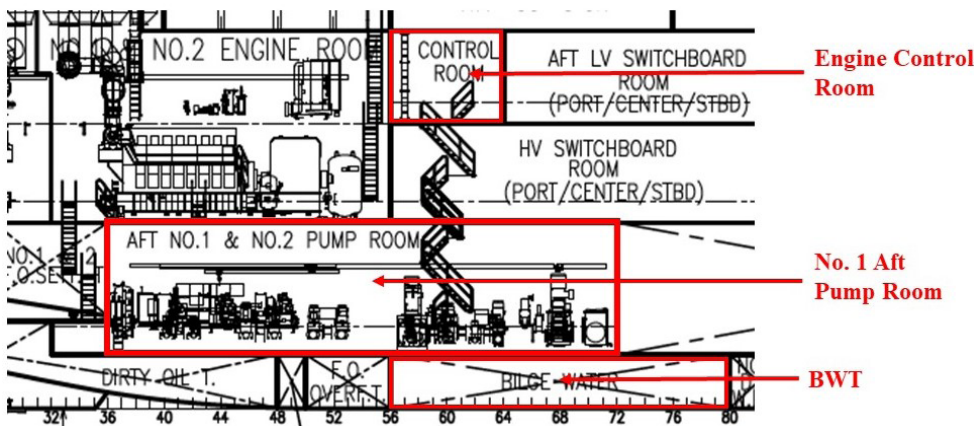
The BWT had a capacity of 268.3 m³ and was located on the centerline below Nos. 1 and 2 Aft Pump Rooms (see Figure 2). Access hatches (i.e., manhole covers) for the BWT were located on the tank top in the Nos. 1 and 2 Aft Pump Rooms. The tank top was 2.6 m above the bottom shell. The BWT was naturally vented to the atmosphere. The vent head was located on the main deck and was 16 m above the tank top. The BWT was not fitted with sample points for testing the atmosphere in the tank’s ullage space. Both the Nos. 1 and 2 Aft Pump Rooms had permanent mechanical ventilation.

Figure 2: Locations of the BWT, Nos. 1 and 2 Aft Pump Rooms, and the Engine Control Room on board VALARIS DS-17.

The BWT tank top formed a physical barrier between the Nos. 1 and 2 Aft Pump Rooms and the BWT (*see Figure 2*).³⁰ This physical barrier was broken when the 2/E No. 1 and Motorman opened the BWT access hatch. Removing this

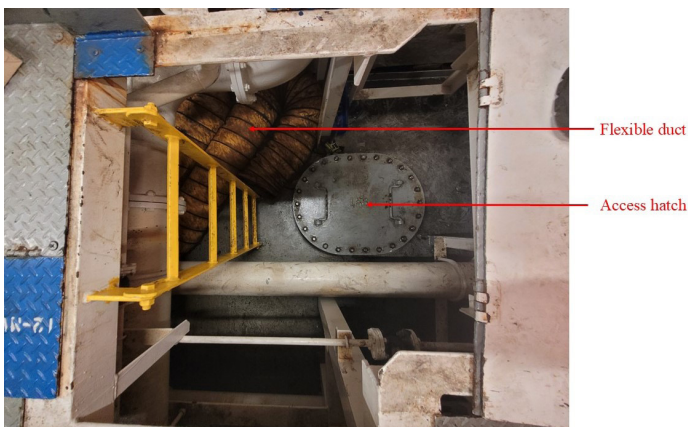
Figure 3: The BWT access hatch and vertical ladder for accessing the tank top in the No. 1 Aft Pump Room. There is also a vertical ladder inside the BWT.

A portable blower with an attached flexible duct was observed on the tank top in the vicinity of the BWT starboard side access hatch after the 2/E No. 1 and the Motorman were removed from the tank (see Figure 3). Based on information provided by rescue team members, it could not be determined if the 2/E No. 1 and Motorman had lowered the duct into the BWT or if they had started the blower.
