REPUBLIC OF THE MARSHALL ISLANDS

YENISEI RIVER MARINE SAFETY INVESTIGATION REPORT

Occupational Fatality

Pyeongtaek, Republic of Korea | 2 May 2024

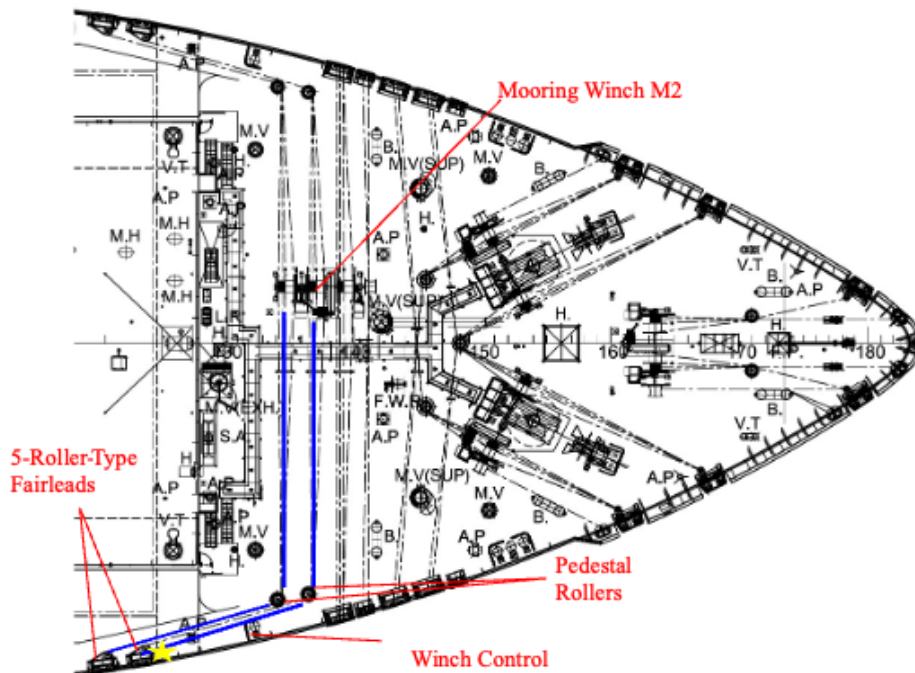
Figure 2: Forward mooring station. The blue lines show how the two fore springs were running. The yellow star represents the location where the ASD1 was standing.

As soon as the ship had stopped moving ahead, the ASD1 and the OS1 started to adjust the chafing sleeves of the spring lines on their own initiative. The ASD1 was positioned close to the roller fairlead, in between the outer fore spring and the railing. The OS1 was positioned on the other side of the fairleads, in front of the 2/O-1.

Due to the astern motion of the ship when the engines were put ahead, the ship slowly started moving ahead four minutes later at 0955, resulting in the fore springs becoming tensioned and thus creating a potential hazard. The forward movement of the ship was observed on the speed log on the Bridge, but it could not be determined if this information was communicated to the 2/O-1 and 2/O-2, by means of the handheld radios, at the mooring stations on deck. The ASD1 and the OS1 were not alerted to keep clear of the mooring lines when the ship started moving ahead.⁹ Very shortly after the ship started moving ahead, the Master ordered the 2/O-1 to pay out the fore springs. Consequently, the 2/O-1 ordered the ASD2 at the winch operation station (see Figure 2) to pay out the lines.

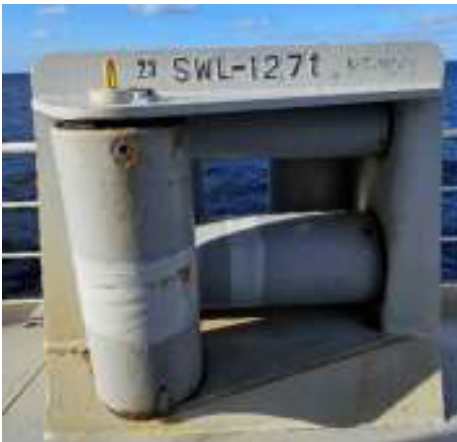
The ship's fore springs were guided by pedestal rollers, which were found in good working condition and greased in April 2024, and 5-roller type universal fairleads (see Figure 3). The roller fairleads are subject to weekly inspections, in accordance with the ship's PMS, to confirm the external condition and the freeness of movable parts. A photographic report is sent to the office on a monthly basis. The latest report was dated 10 April 2024 and showed no shortcomings.

Figure 3: Five-roller universal fairlead on board YENISEI RIVER. This fairlead was involved in the accident.

It was not witnessed how the ASD1 became stuck between the moving fairlead roller and the spring line and how he was further pulled into the water.

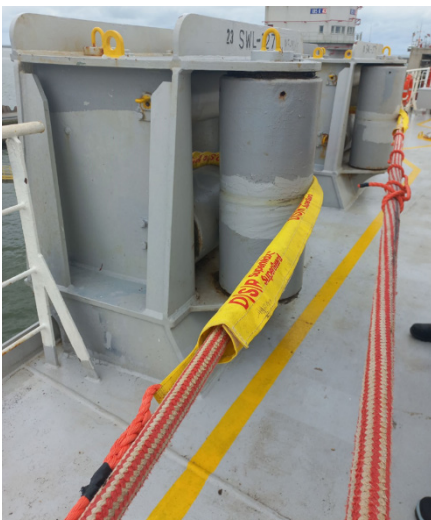
Figure 4: Chafe sleeve on the outer fore spring where it passes through the fairlead.

The ASD1 was positioned behind the fairleads (*see Figure 4*). The ASD1, who was leaning forward and completely covered by the fairleads, was not visible to the supervising 2/O-1. One of the identified safeguards in the risk assessment was to keep the mooring gangs in visual contact with the supervising Officer.¹⁰

On board YENISEI RIVER, the adjusting of the chafing sleeves generally happened upon the initiative of the mooring crew when the ship was in its final position. It could not be determined if the supervising Officer generally confirmed when the ship was in its final position before the adjustment of the chafing sleeves started. Neither the mooring plan nor the risk assessment addressed the positioning of the chafing sleeves. Consequently, the positioning of the chafing sleeves was not discussed during the mooring training or the Toolbox Talk. This led to a situation where the crew was exposed to moving fairlead rollers and mooring lines before the ship had reached its final position.

1. Causal factors that contributed to this very serious marine casualty include:
 - (a) ineffective communication between the Bridge, the supervising officers, and the mooring crew as the ship was being positioned on the jetty; and
 - (b) safe adjustment of the chafing sleeves was not addressed during the risk assessment nor the Toolbox Talk.

1. The Company is recommended to include:
 - (a) the positioning of chafing sleeves in the risk assessment related to mooring operations; and
 - (b) warnings about ship movements in the mooring communication procedures.

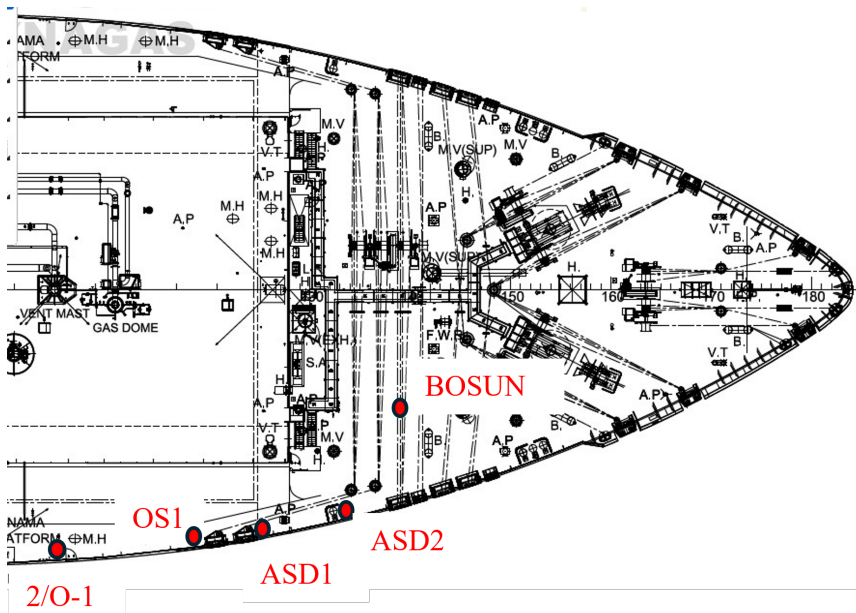
Figure 6: Position of the members of the forward mooring team.

The OS1 and the ASD1 were positioned close to the roller fairleads (see Figure 6). The OS1 was positioned on the outside of the inner spring line and the ASD1 was positioned between the outer spring line and the ship's guardrail.

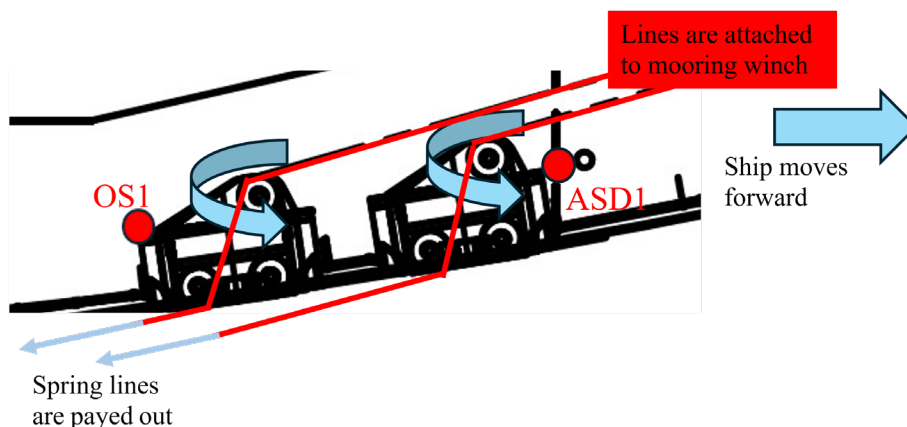
The forward movement of the ship and the slacking of the lines caused the vertical fairlead rollers of the respective fairleads to turn in an anti-clockwise direction (see Figure 7).

Figure 7: Movement of the vertical roller of the fairlead.
