BARRAMUNDI MARINE SAFETY INVESTIGATION REPORT

Occupational Fatality of Bosun

South China Sea | 3 July 2021

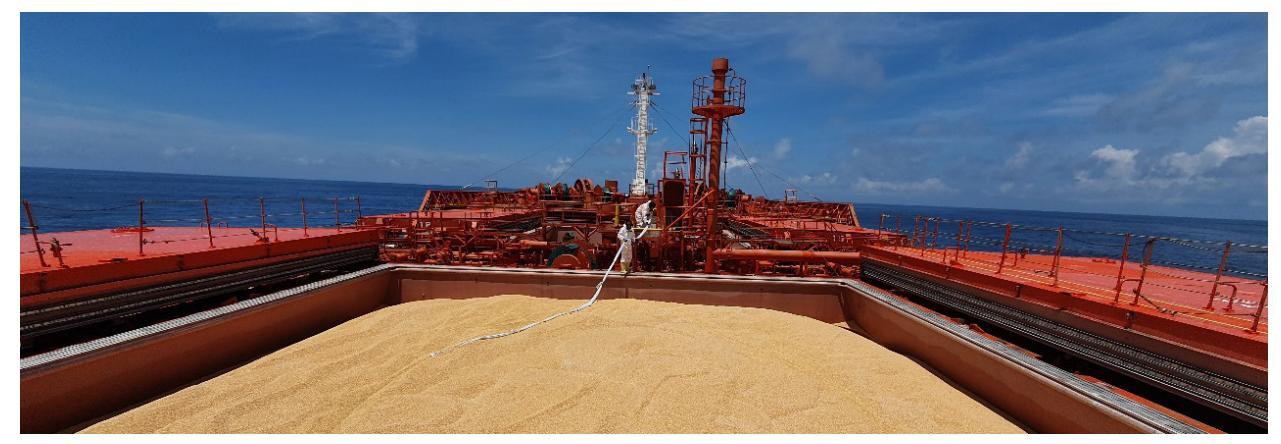
- 37. The Bosun and ASD1 then removed the fumigant from Cargo Hold No. 2 *(see Figure 2)*. The C/O watched them while he was measuring the concentration of phosphine near Cargo Hold No. 3 and on top of the cargo in that hold. He reported that the concentration of phosphine on top of the cargo in Cargo Hold No. 3 was 0 ppm.

Figure 2: The Bosun and ASD1 removing the second of two lengths of tubes of fumigant from Cargo Hold No. 2. The apparent wind was from 10-15° off the ship's starboard bow.
